Geotechnical Assessment

Project: Alterations & Additions
85 Palmgrove Road, Avalon Beach NSW

For Alterations & Additions at

85 Palmgrove Road, Avalon Beach NSW

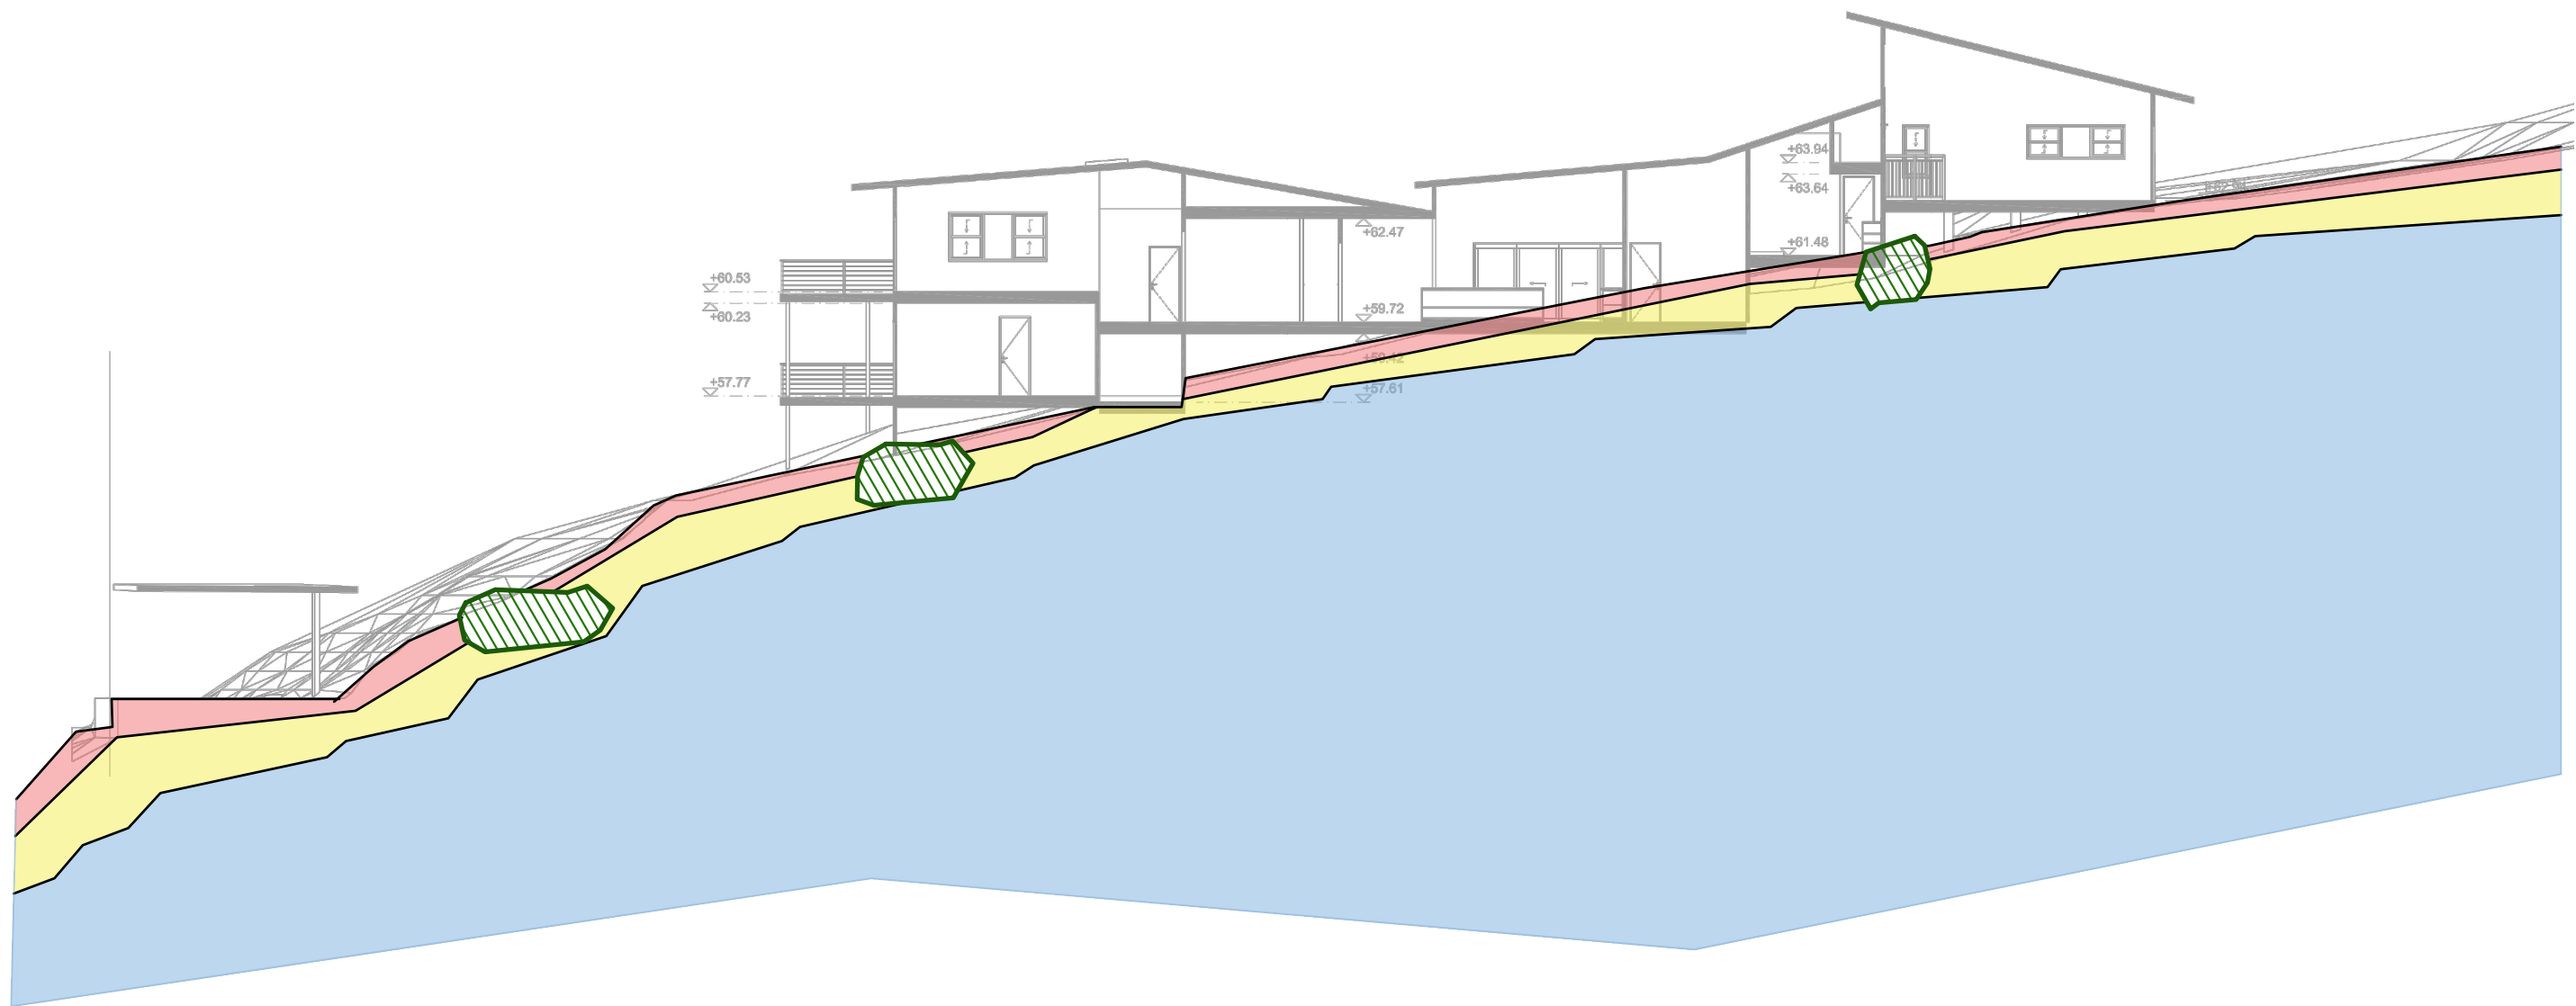
INFERRED GEOLOGICAL SECTION
SCALE NTS

The soil profile consists of shallow uncontrolled silty fill and silty topsoil (O & A Horizons), silty clay (B Horizon) and weathered low strength bedrock (C Horizon). There are numerous partially detached and potentially fully detached joint blocks and sandstone boulders exposed at the surface and embedded in the upper profile at the front of the existing house and rear of the existing studio. Based on our observations and the results of testing on site, we would expect weathered low strength weathered bedrock to be found 1.0 – 2.6 metres below current surface levels across the area of the proposed works, & potentially deeper where excavation spoil from the levelled carport area has been placed on the downslope side of the carport.

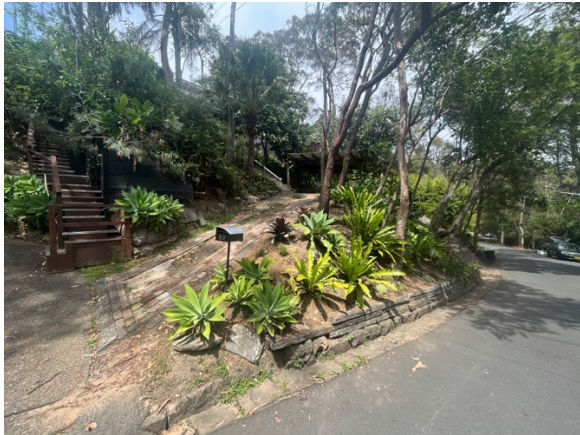
Photo 1: Photo from street frontage looking towards driveway and carport

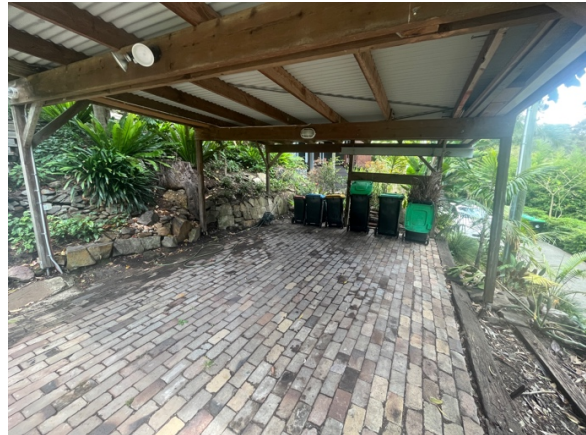
Photo 2: Brick paved carport and area of the proposed new carport

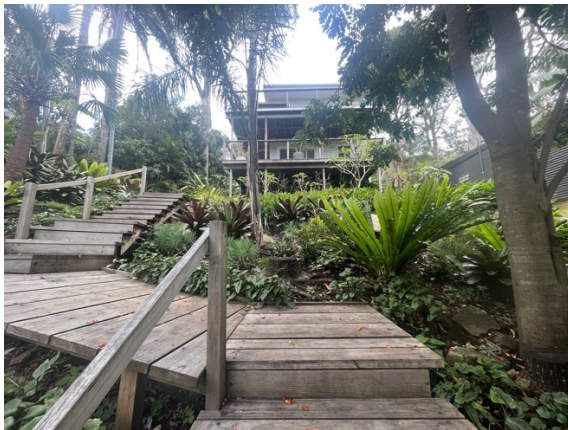
Photo 3: Main residence frontage

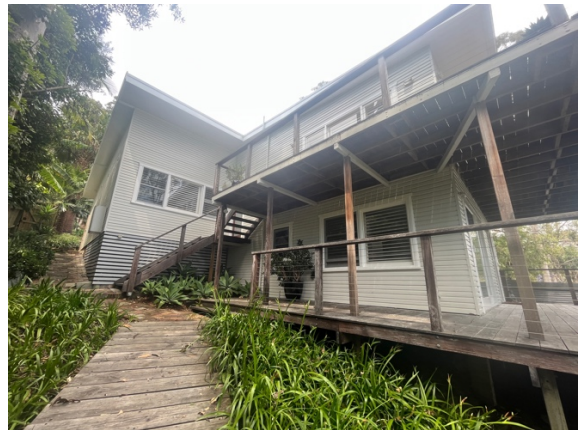
Photo 4: Main residence

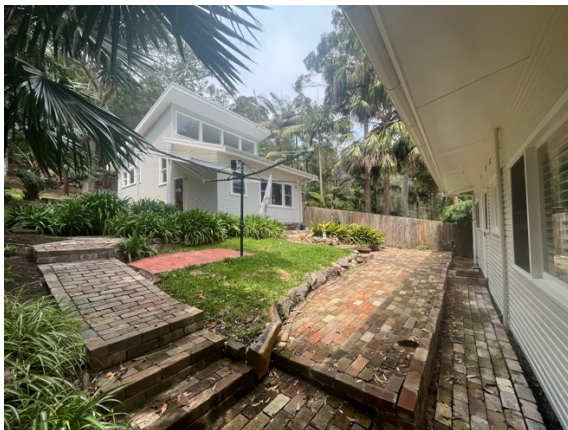
Photo 5: Photo from rear of the main residence looking towards studio

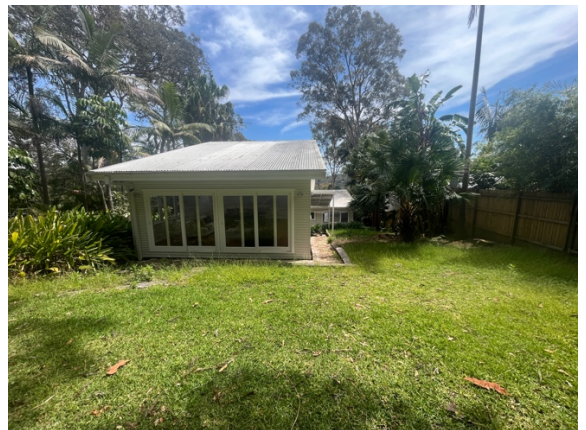
Photo 6: Photo from rear boundary looking towards rear of studio
