**REPORT ON GEOTECHNICAL ASSESSMENT**

**PROPOSED ALTERATIONS AND ADDITIONS**

**325 WHALE BEACH ROAD, WHALE BEACH**

**Project No.: 2025-055**

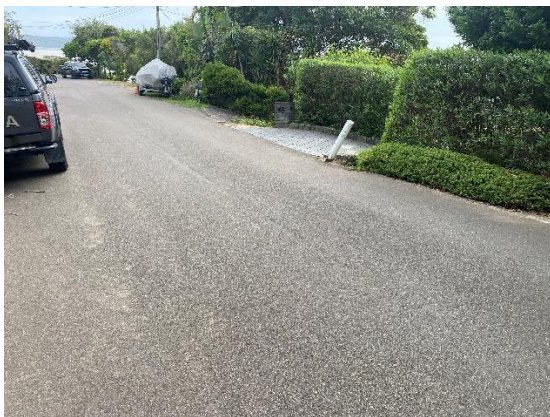
Whale Beach Road comprises a very gently north dipping bitumen pavement with no kerb or guttering, though a slight cross-fall to the west exists. The reserve to the east side contains moderately ( $>10$  degree) east dipping vegetated slopes that extend down into the site with no defined boundary fence at the front of the site. There were no indications of underlying geotechnical instability or hazard within the road pavement, which appears at least 5 years of age, or the sloping gardens within the road reserve.

Photograph: 2 – showing road reserve looking north.

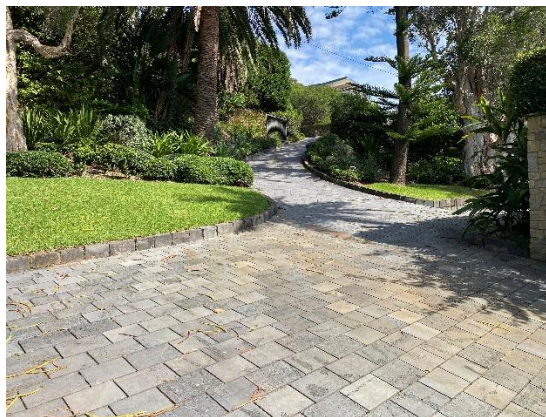
The site is accessed via a gently sloping concrete/paved driveway which extends across slope from the north-west corner of the site to the south-west corner of the house. The front of the property then contains gently east dipping lawns and gardens with low garden/retaining walls adjacent the driveway.

Photograph: 3 – showing front yard looking towards north-west

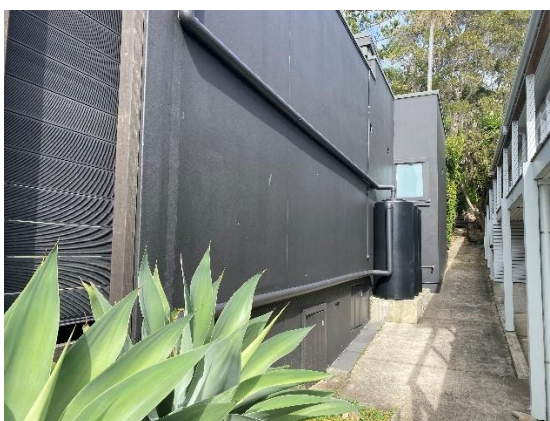
The existing house is a single storey brick and timber structure that extends to within 1.0m of the northern boundary and approximately 4.50m from the southern boundary. Inspection of the sub-floor cavity from an access panel indicates the structure is supported off brick walls to strip footings. Across the entire rear edge of the house is a timber deck that is raised above the rear of the property due to the ground surface slope with a rendered masonry wall supporting the eastern edge of the deck above a narrow garden bed that is itself supported by another rendered masonry retaining wall of up to 1.0m in height.

Photograph: 4 – showing northern side of existing house, looking west.

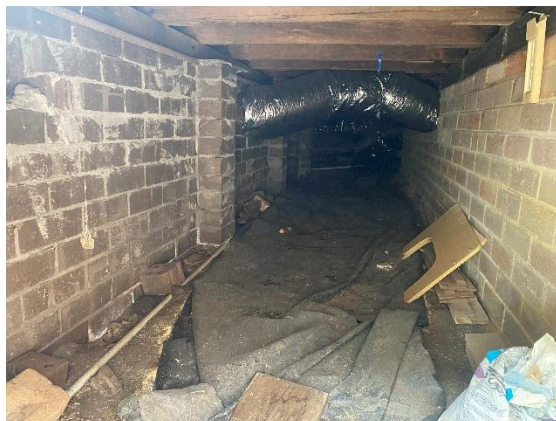
Photograph: 5 – showing subfloor brick footing walls.

The inspection and assessment identified no obvious credible landslip hazards within the site or adjacent properties. The existing residence is of masonry construction and at least 25 years of age and appears to be in good condition, with no signs of cracking or settlement that would indicate foundation movement/deep seated instability. The soil slopes within and around the site have no signs of any previous or impending instability. All visible retaining walls within the site appear generally stable at present. No obvious surface stormwater flow or excess seepage/wet areas were identified.

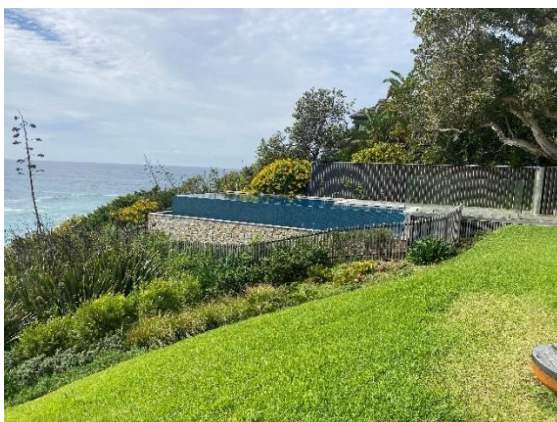
To the rear of the house deck/garden is an undulating lawn that comprises an upper gently sloping narrow terrace with moderate grass covered slopes dipping to the east and north-east. The rear edge of the property contains dense vegetated moderate slopes that dip to the crest of the sea cliffs whilst a recently constructed (<10 year) concrete part inground swimming pool is located in the south-east corner of the property, extending to within proximity of the sea cliffs.

Photograph: 6 – showing rear of property and pool in south-east corner.

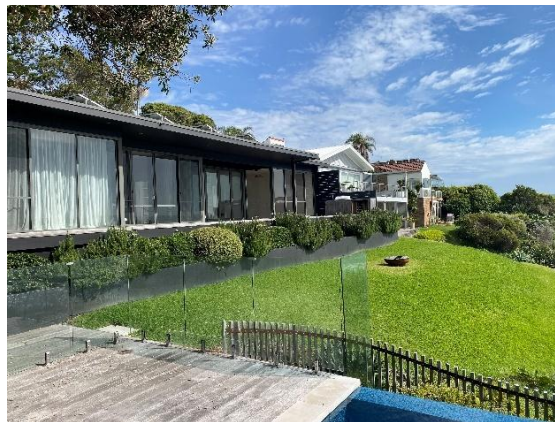
Photograph: 7 – showing rear edge of house, with deck and retained garden above lawn slope

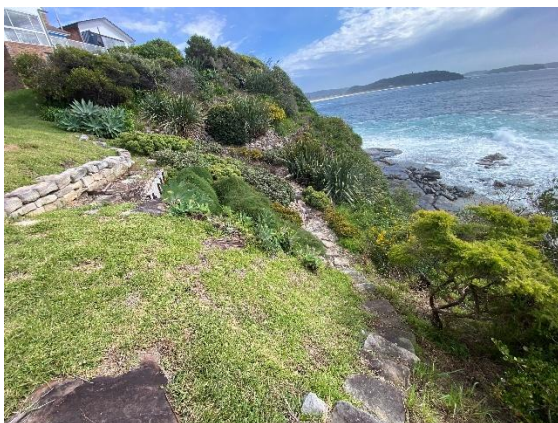
The neighbouring property to the north (No. 327) contains a one and two storey brick and timber house situated on the centre of the block, with the lower floor level below the rear of the structure due to the natural ground surface slope. To the front of the house are a concrete driveway and gently sloping lawns and gardens rising up to a moderately sloping road reserve covered with gardens. To the rear of the house are moderate to steep lawns and gardens with a steep east plunging drainage channel passing down through the rear of the property, near the north boundary, to the crest of the sea cliffs. There were no signs of instability or movement in the existing house and no signs of recent or significant erosion or slope instability within the rear drainage gully.

Photograph: 8 – showing drainage gully within rear of neighbouring property to north.

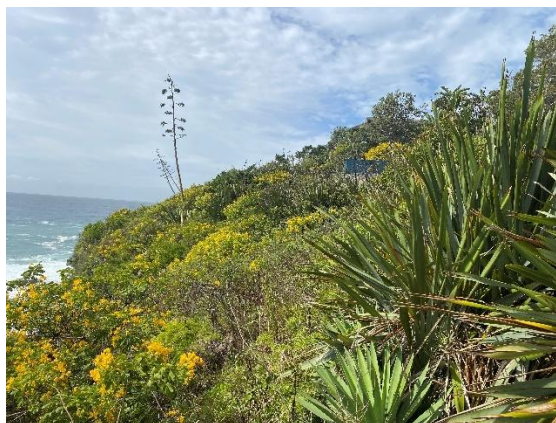
Photograph: 9 - showing dense vegetation at rear edge of site adjacent crest of sea cliffs

The coastal engineering assessment does not indicate any cliff regression conditions that may impact the site or proposed structures over the design life and a review of the photography provided within that report, along with previous CGC inspections, did not identify any significant overhangs or causes for future cliff line collapse (rock fall, topple) or larger scale instability.

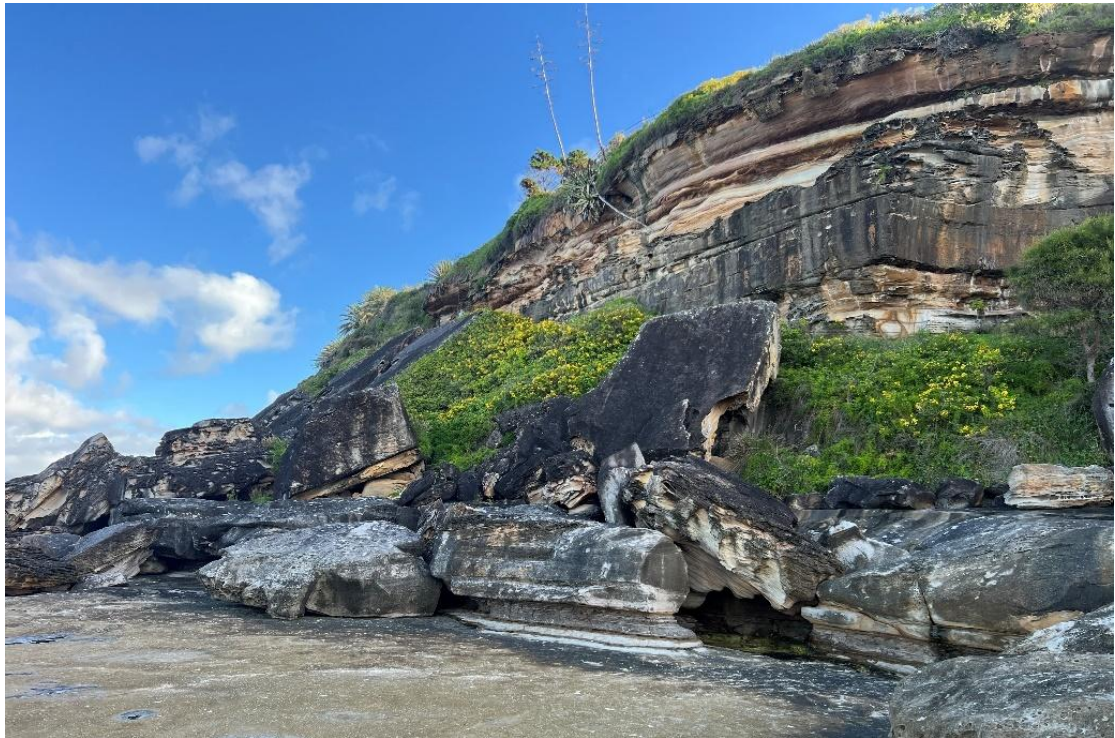
**Figure 4-2 Cliff face**

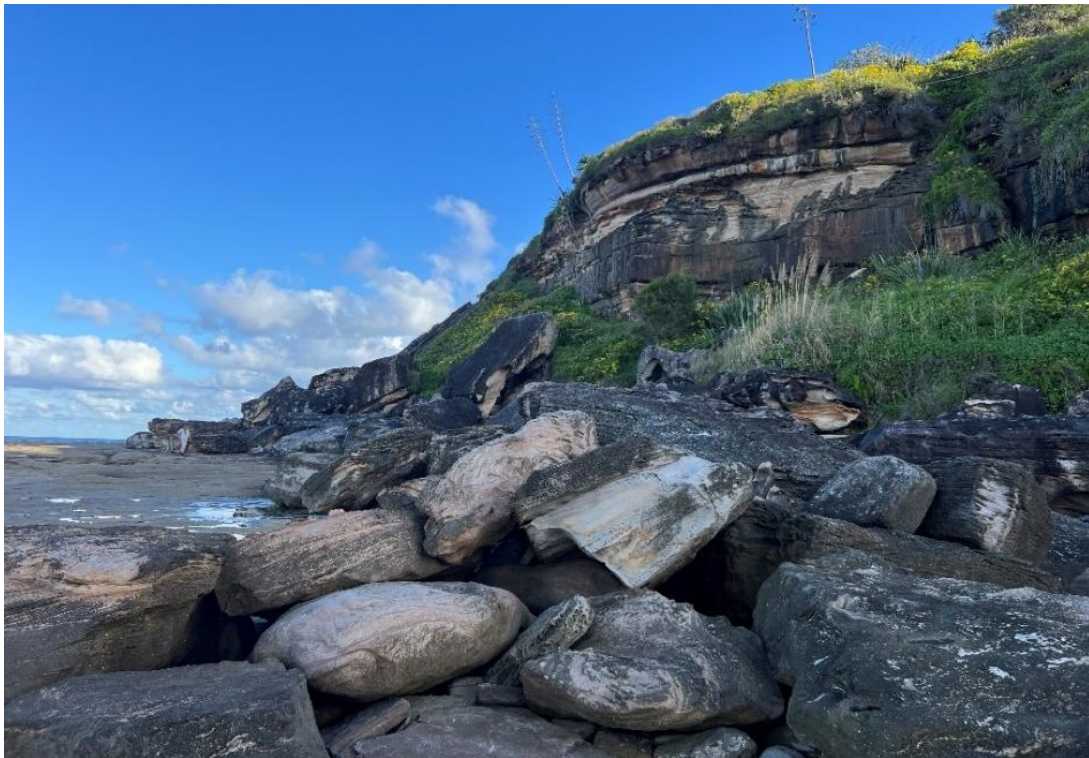
**Figure 4-3 Boulder armour at the cliff toe**

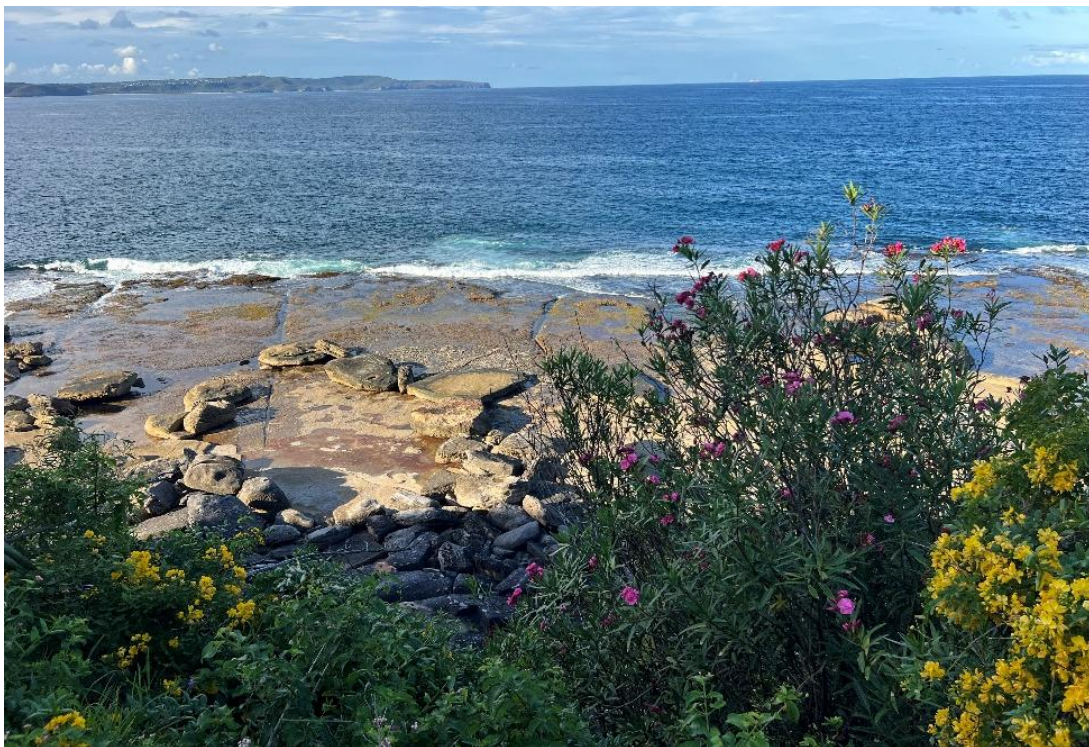
**Figure 4-4 Rock platform**
