Report Title: Geotechnical Report 53 Samuel Street, Mona Vale
Report Date: 25/11/20
Author: BEN WHITE
Author's Company/Organisation: WHITE GEOTECHNICAL GROUP PTY LTD

GEOTECHNICAL INVESTIGATION:

Alterations and Additions at 53 Samuel Street, Mona Vale

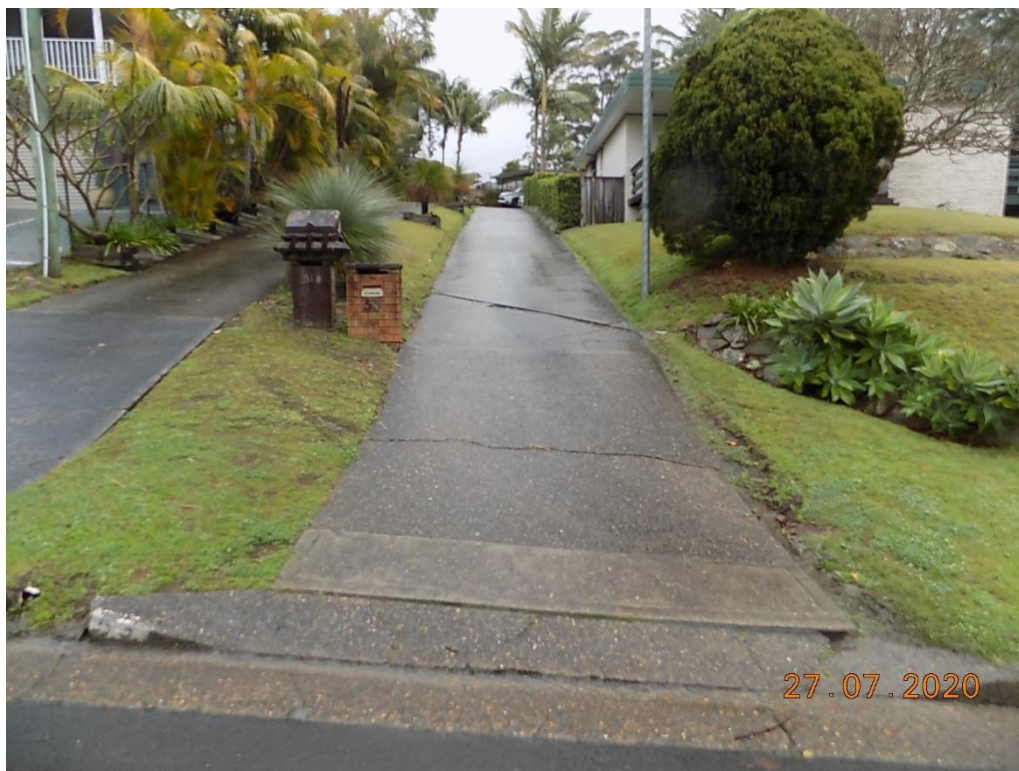
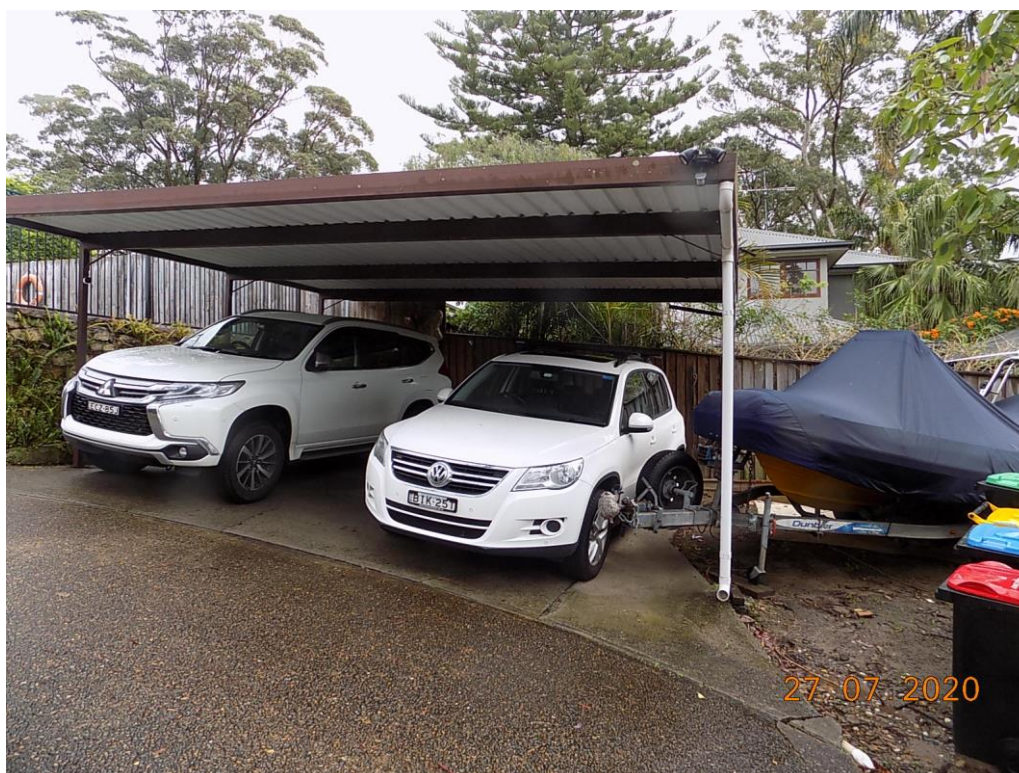
2.3 At the road frontage, a concrete driveway runs up the slope to a carport on the downhill side of the property and to a parking area on the downhill side of the house (Photos 1 to 3). The carport will be demolished as part of the proposed works. A pool has been cut into the slope between the carport and the house (Photo 4). The pool will also be demolished as part of the proposed works. The area around the pool has been filled. The fill is supported by a stack rock retaining wall that will be demolished as part of the proposed works (Photo 5). Between the pool and the house is a gently sloping lawn. The part two-storey house is supported on brick walls and brick piers (Photo 6). No significant signs of movement were observed in the supporting walls and the supporting piers stand vertical. A gently sloping lawn and tile-paved patio area extends off the uphill side of the house to the upper common boundary (Photo 7).

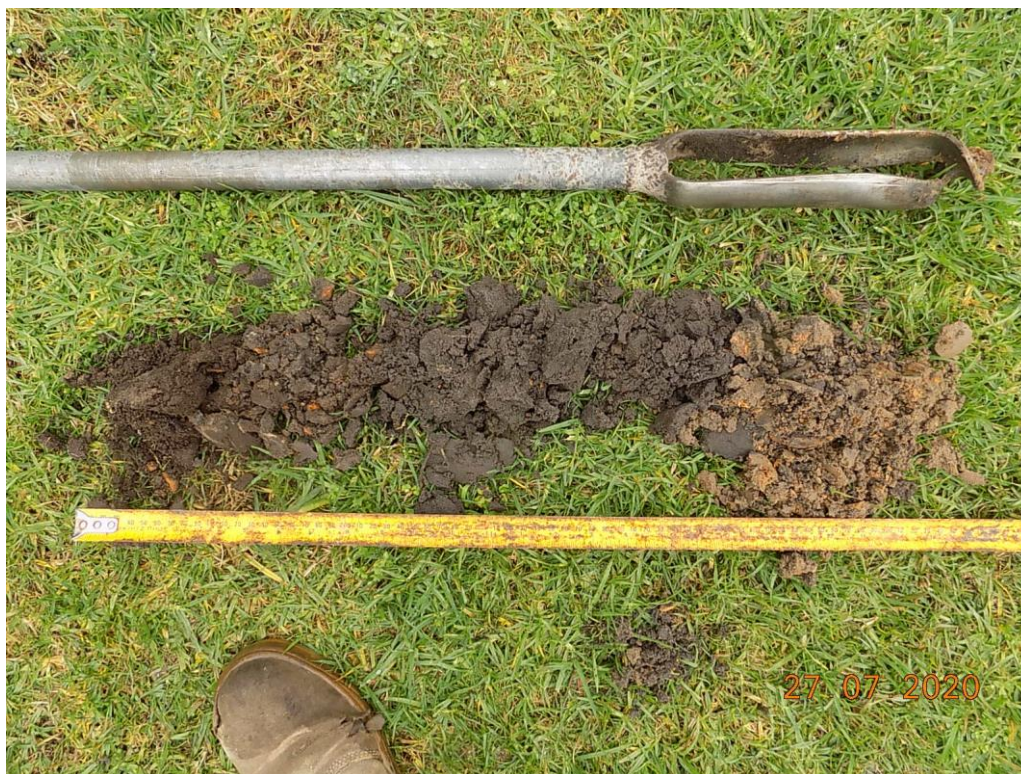
AUGER HOLE 1 (~RL21.3) – AH1 (Photo 8)

Depth (m)	Material Encountered
0.0 to 0.6	FILL , disturbed sandy soil, dark brown and mottled orange, very loose to loose, damp, medium to coarse grained with fine trace organic matter and rock fragments.

Refusal @ 0.6m on unknown obstruction within fill. No watertable encountered.

Photo 8: AH1 – Downhole is from left to right

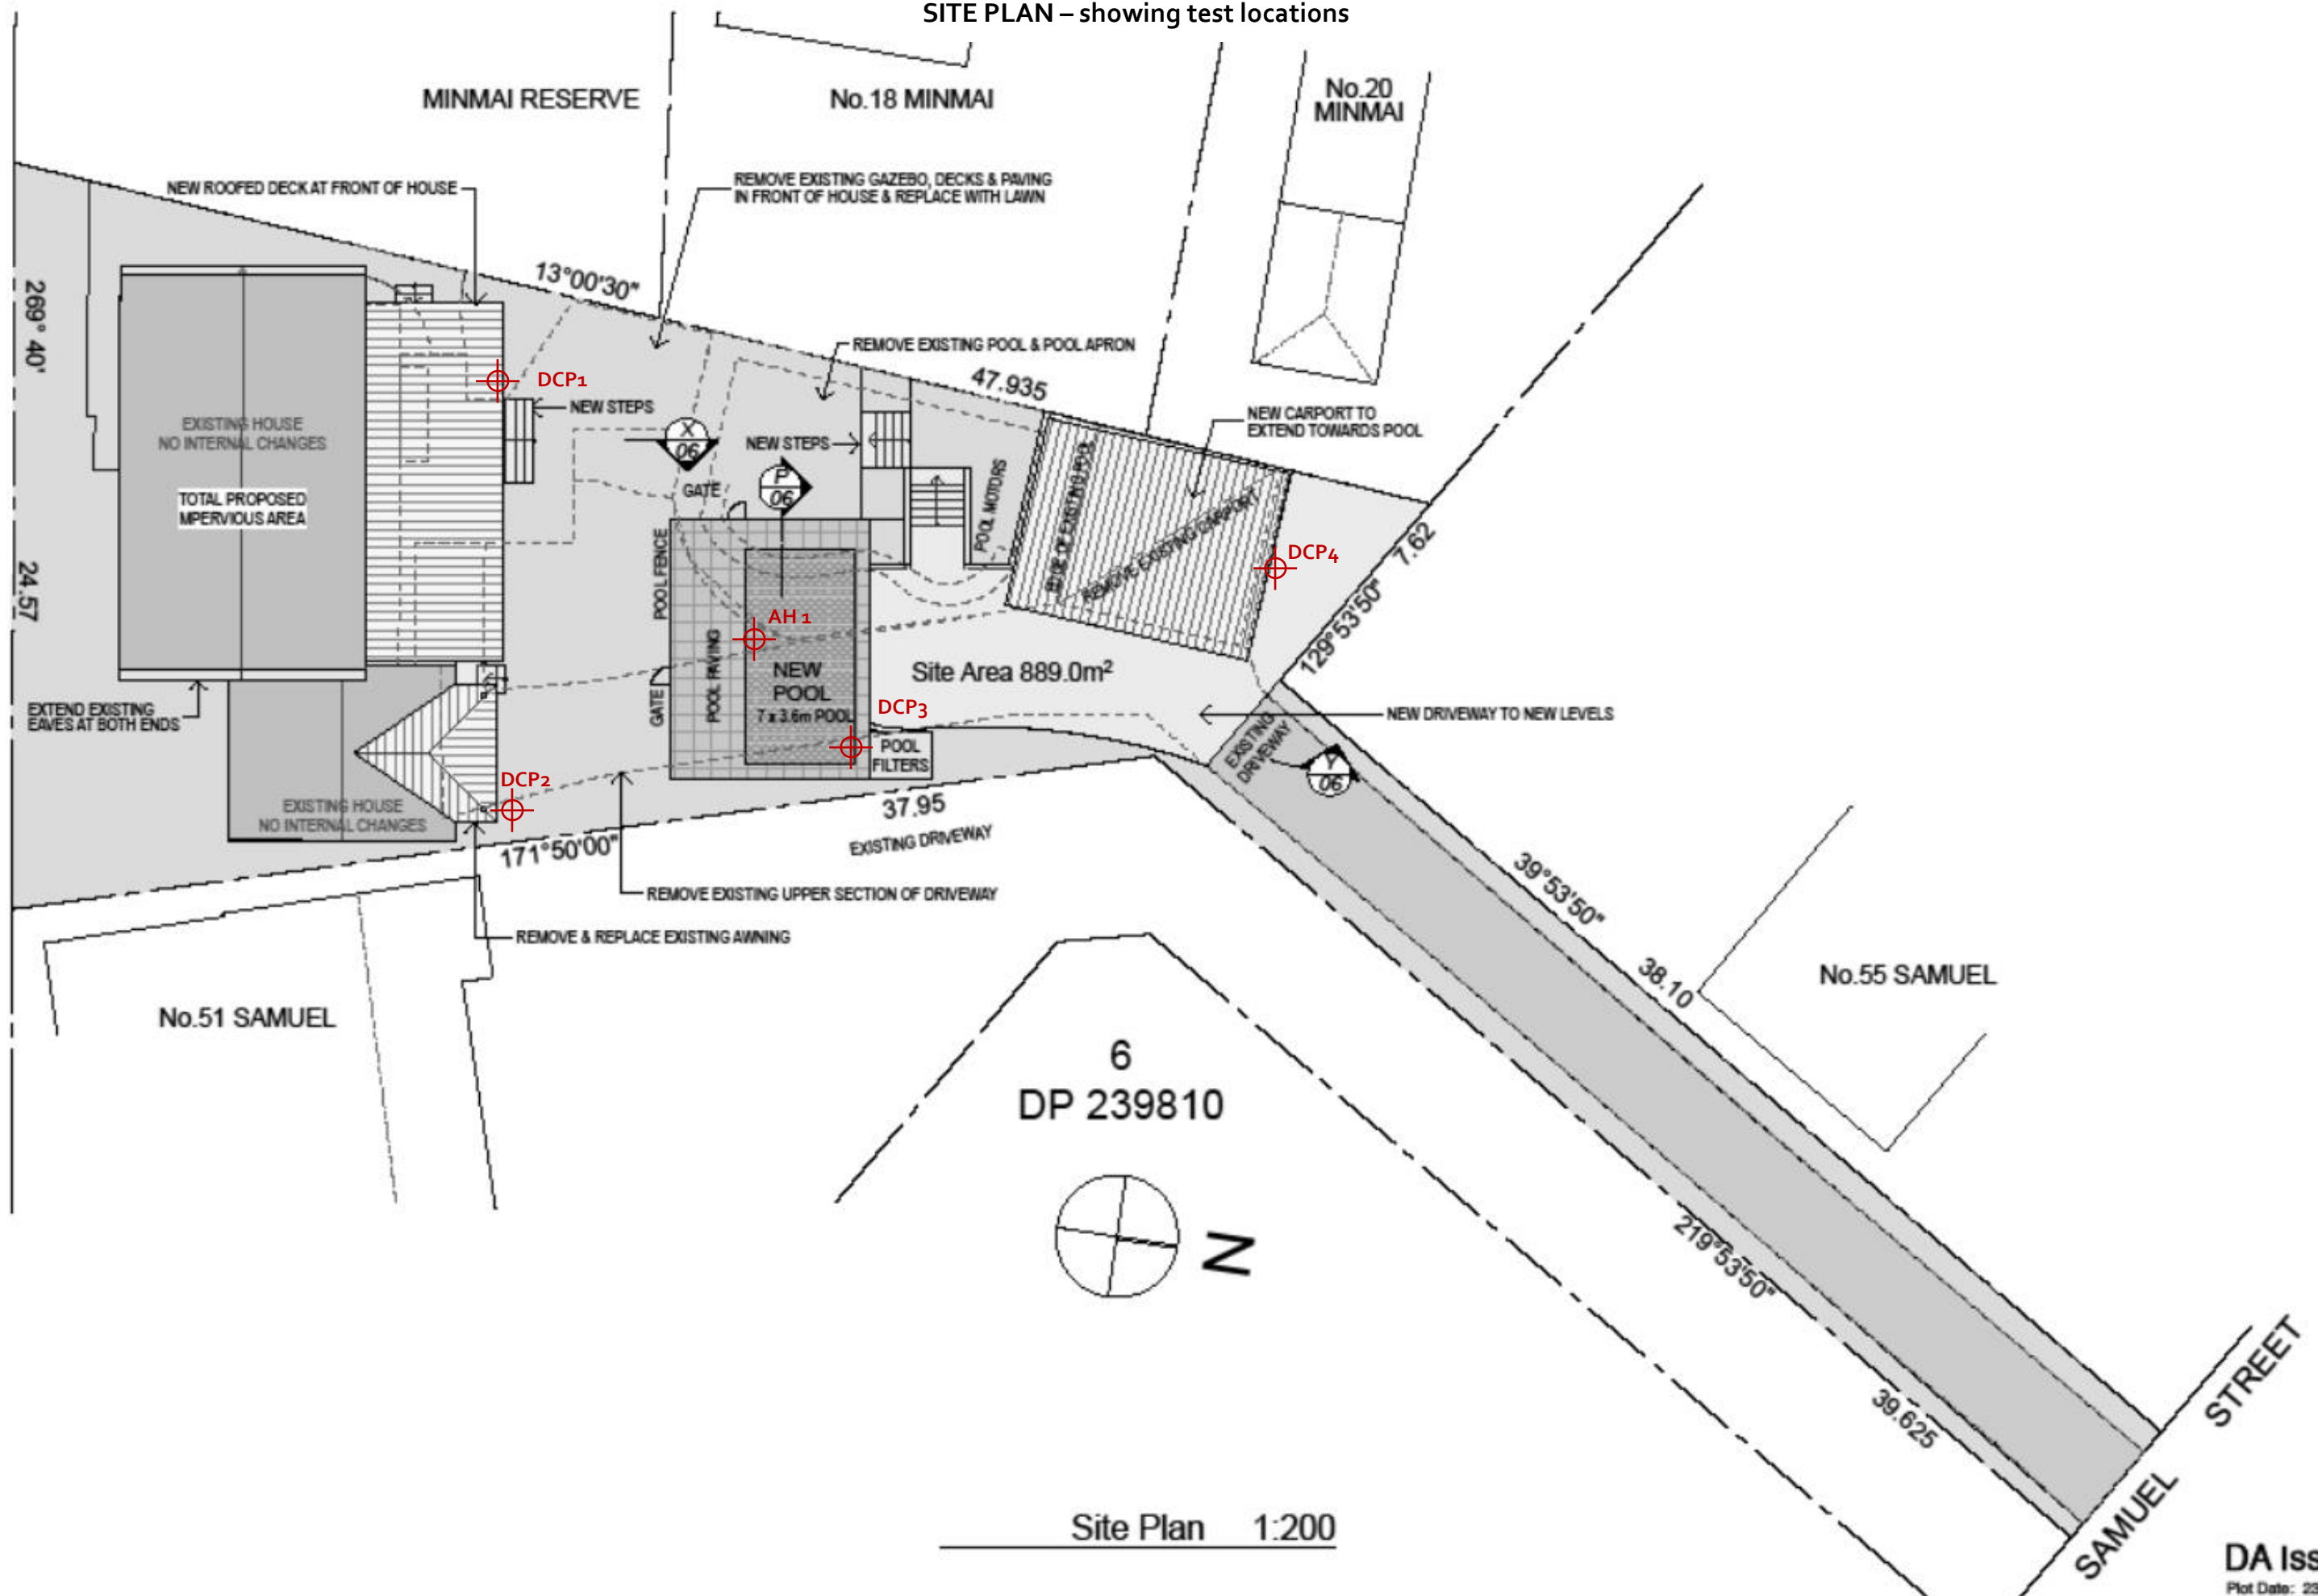
SITE PLAN – showing test locations

One auger hole was put down to identify the soil materials. Four Dynamic Cone Penetrometer (DCP) tests were put down to determine the relative density of the overlying soil and the depth to weathered rock. The locations of the tests are shown on the site plan. It should be noted that a level of caution should be applied when interpreting DCP test results. The test will not pass through hard buried objects so in some instances it can be difficult to determine whether refusal has occurred on an obstruction in the profile or on the natural rock surface. This is not expected to be an issue for the testing on this site. However, excavation and foundation budgets should always allow for the possibility that the interpreted ground conditions in this report vary from those encountered during excavations. See the appended "Important information about your report" for a more comprehensive explanation. The results are as follows:
