MT 31618 27th November, 2018 Page 1

RISK ANALYSIS & MANAGEMENT FOR PROPOSED NEW RESIDENCE AT 139 HEADLAND ROAD NORTH CURL CURL

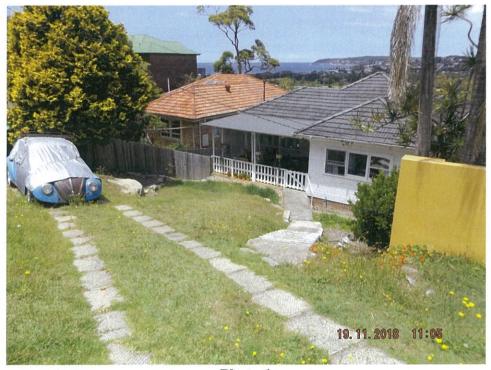
Photo 1

- 3.3 Vehicle access to the property is via a strip concrete driveway that leads to a single car space in the road reserve adjacent the front boundary, Photo 1. Pedestrian access is also via the driveway and a pathway to the main entrance. Exposed sandstone bedrock was visible at the front of the property, Photo 2. Access to the rear of the property is via a pathway on the western side of the existing residence, Photo 3. Access is also possible to the rear yard on the eastern side of the existing residence but is not a paved pathway. Sandstone bedrock was also visible at the top of the access, Photo 4 & 5. An existing rear deck area is at the lower ground level of the existing residence, Photo 6. Sandstone bedrock was visible in the upper lawn area of the rear yard, Photo 7. The rear lawn area flattens out to a gentle slope, Photo 8.
