GROUND TESTING:

5 Vista Avenue, Balgowlah Heights

The aim of this assessment is to determine the nature of the ground materials across the property and provide foundation advice.

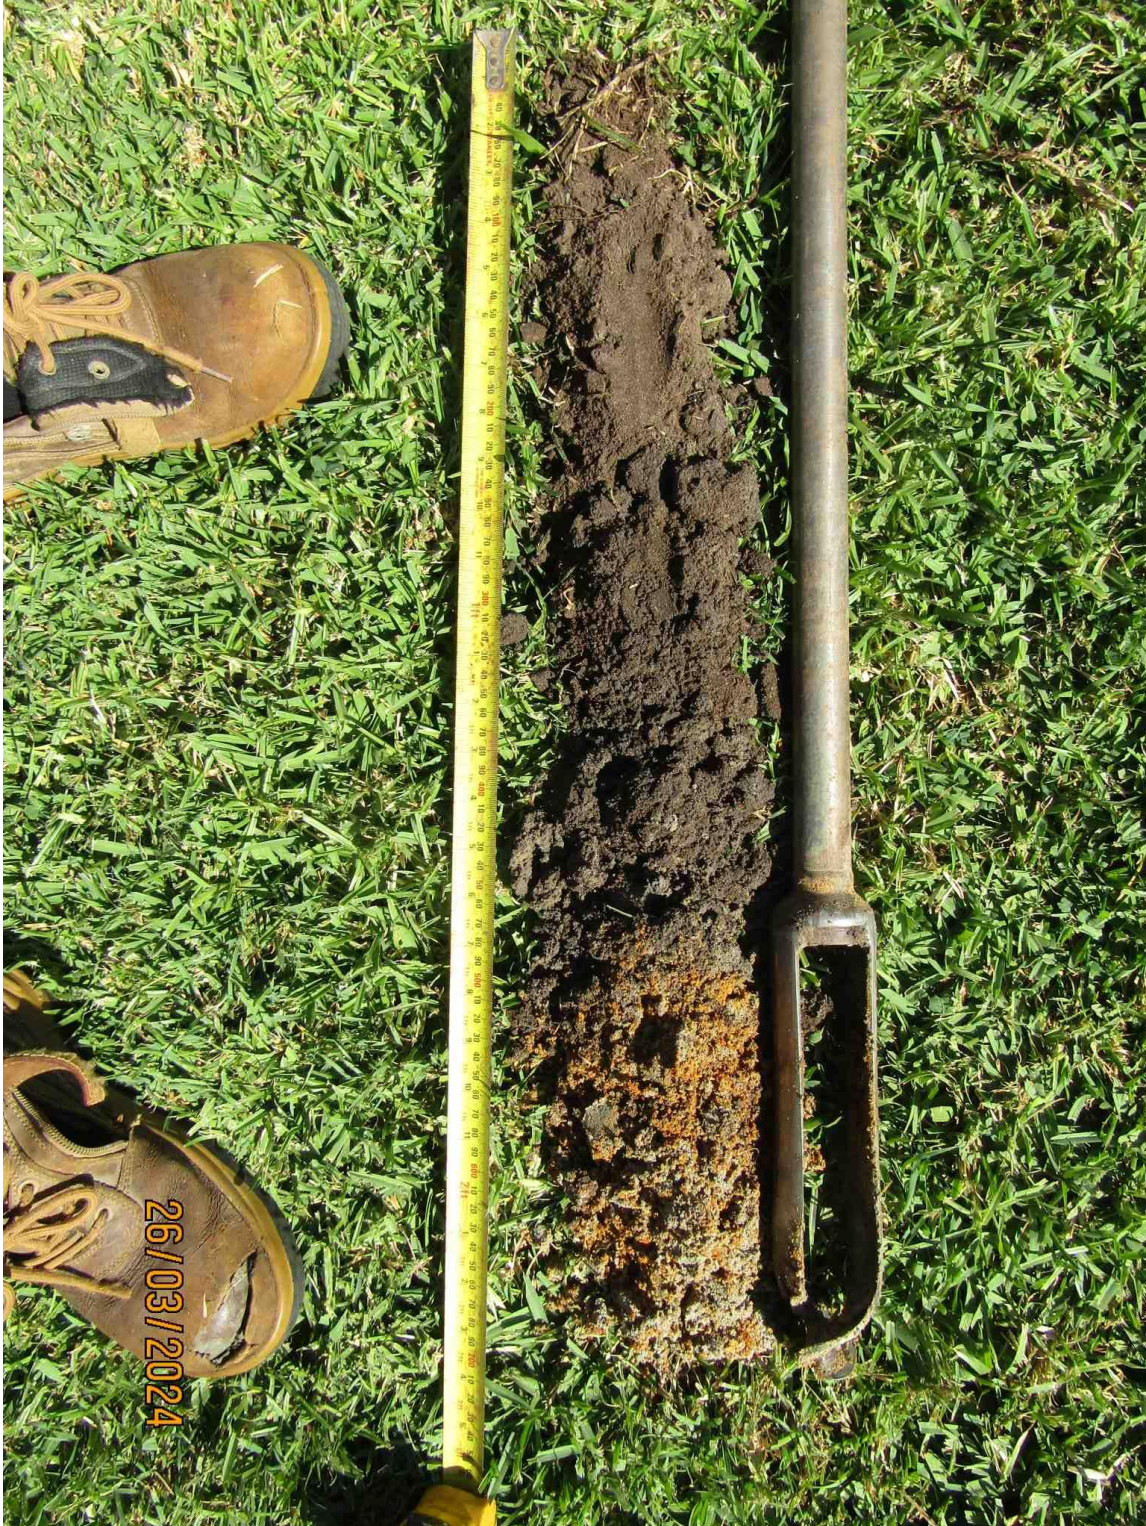
Photo 1: AH1 – Downhole is from top to bottom.

AUGER HOLE 1 (~RL70.4) – AH1 (Photo 1)

Depth (m)	Material Encountered
0.0 to 0.5	TOPSOIL , sandy soil, dark brown, Medium Dense, dry to moist, fine to medium grained.
0.5 to 0.7	SAND , grey and orange, mottled, Medium Dense, damp, fine to coarse grained, sugary texture.

Refusal @ 0.7m, auger grinding on rock. No water table encountered.

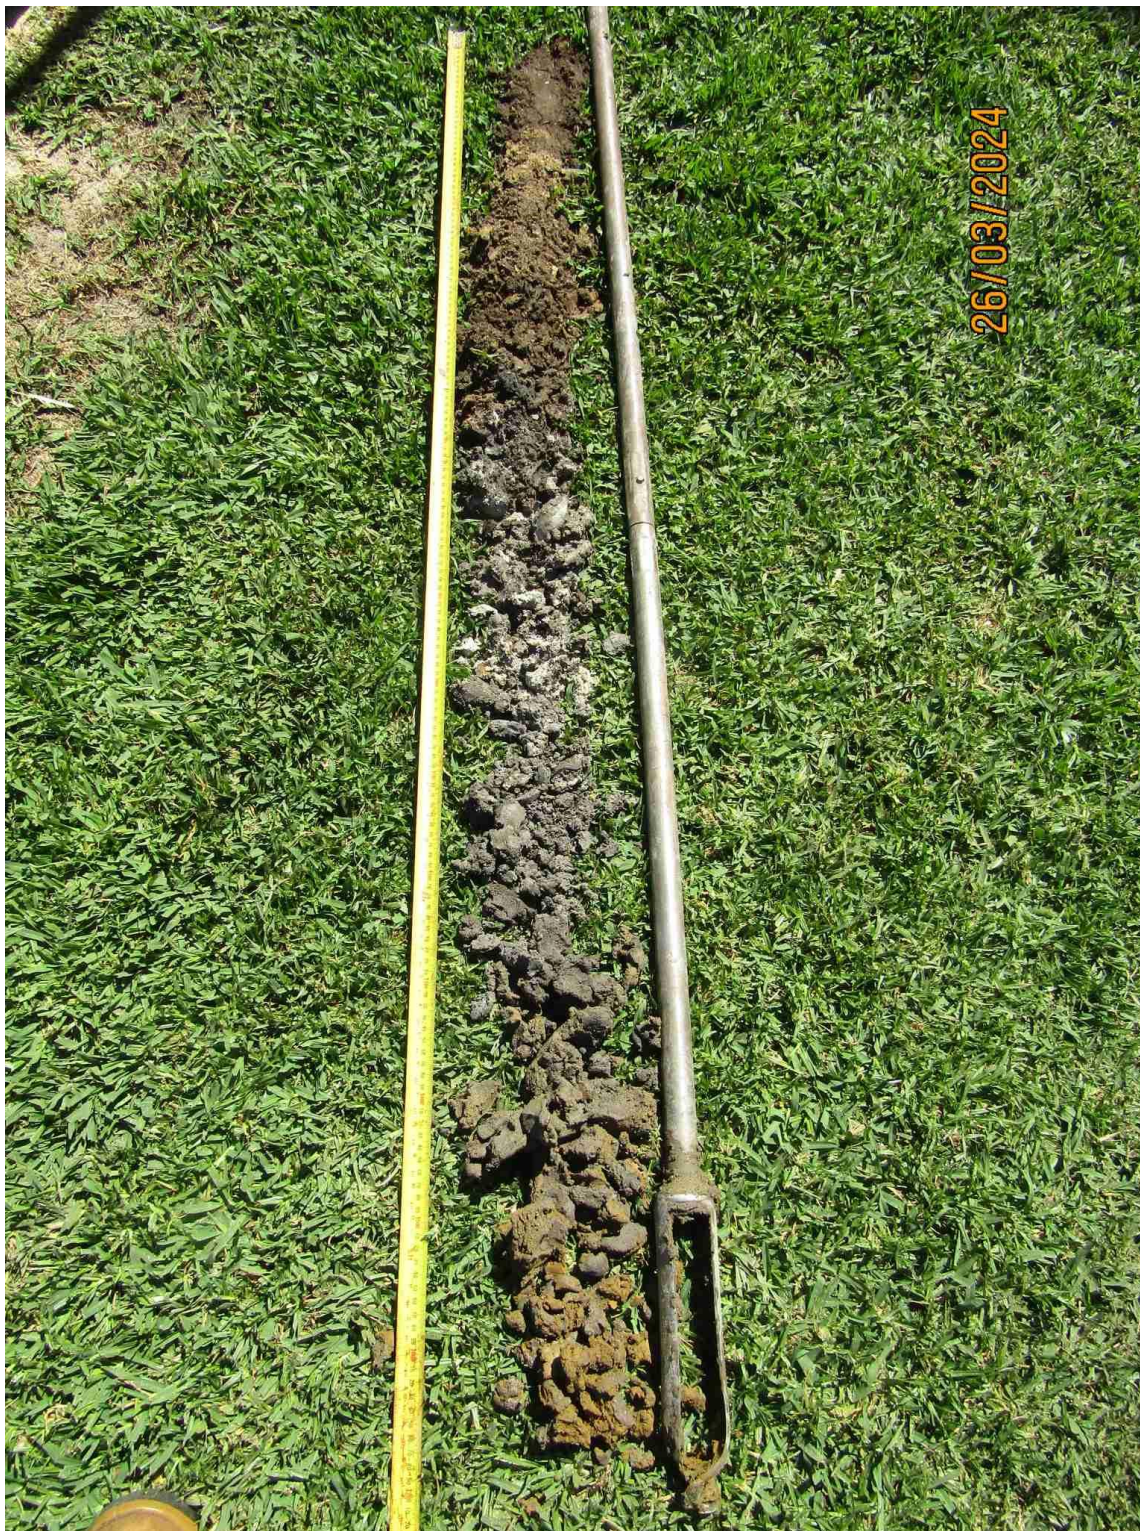
Photo 2: AH2 – Downhole is from top to bottom.

AUGER HOLE 2 (~RL67.1) – AH2 (Photo 2)

Depth (m)	Material Encountered
0.0 to 1.3	FILL , sandy soil and clay, with some rock fragments, dark brown, brown, grey, white, dry to moist, fine to coarse grained.
1.3 to 1.5	SANDY CLAY , dark grey, brown, firm, damp.
1.5 to 1.7	CLAY , brown, stiff, damp.

End of Test @ 1.7m in stiff clay. No water table encountered.
