Geotechnical Assessment

Project: Proposed Subdivision
2A West Street, Balgowlah, NSW.

REF: AG 19130
15th August, 2019

For Proposed Subdivision at
2A West Street, Balgowlah, NSW

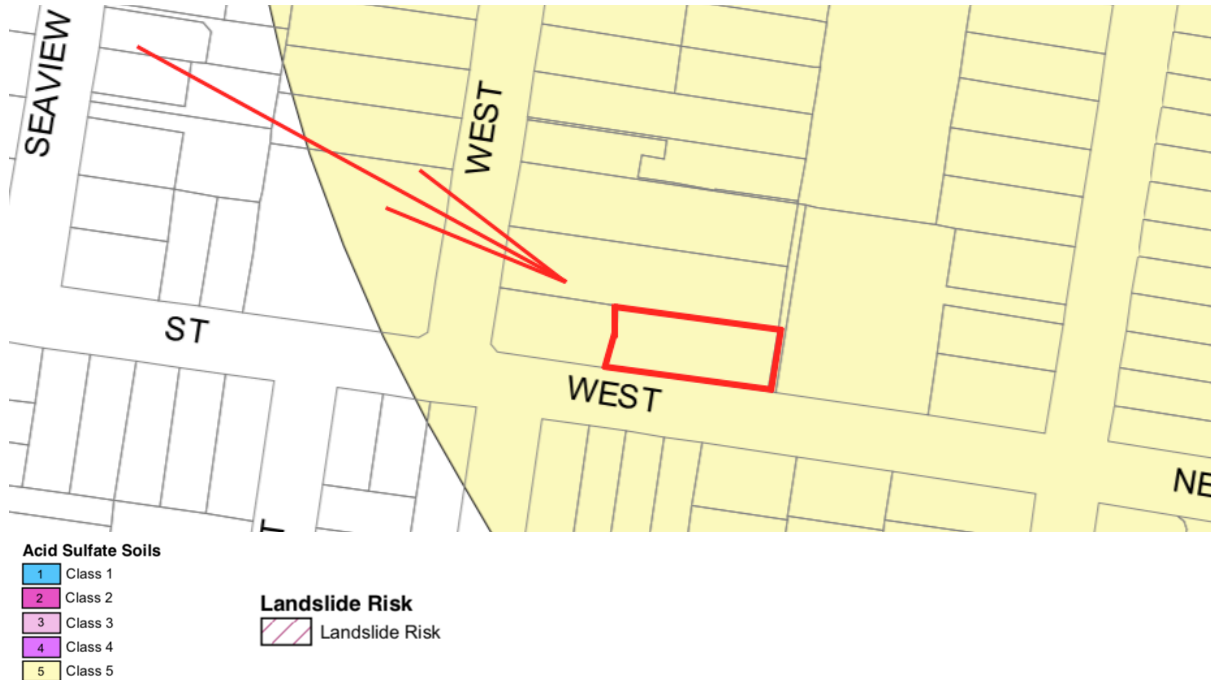
- No evidence of significant soil creep, tension cracks or other indicators of slope instability were identified at the time of our inspection.
- The existing structures displayed no evidence of significant cracking or settlement that could be attributed to slope instability.
- The property is not classified as a Landslide Risk area with reference to Northern Beaches Council MLEP Landslide Risk Map Sheet CL1_004 (MLEP Landslide Risk Map **Image 2** below).

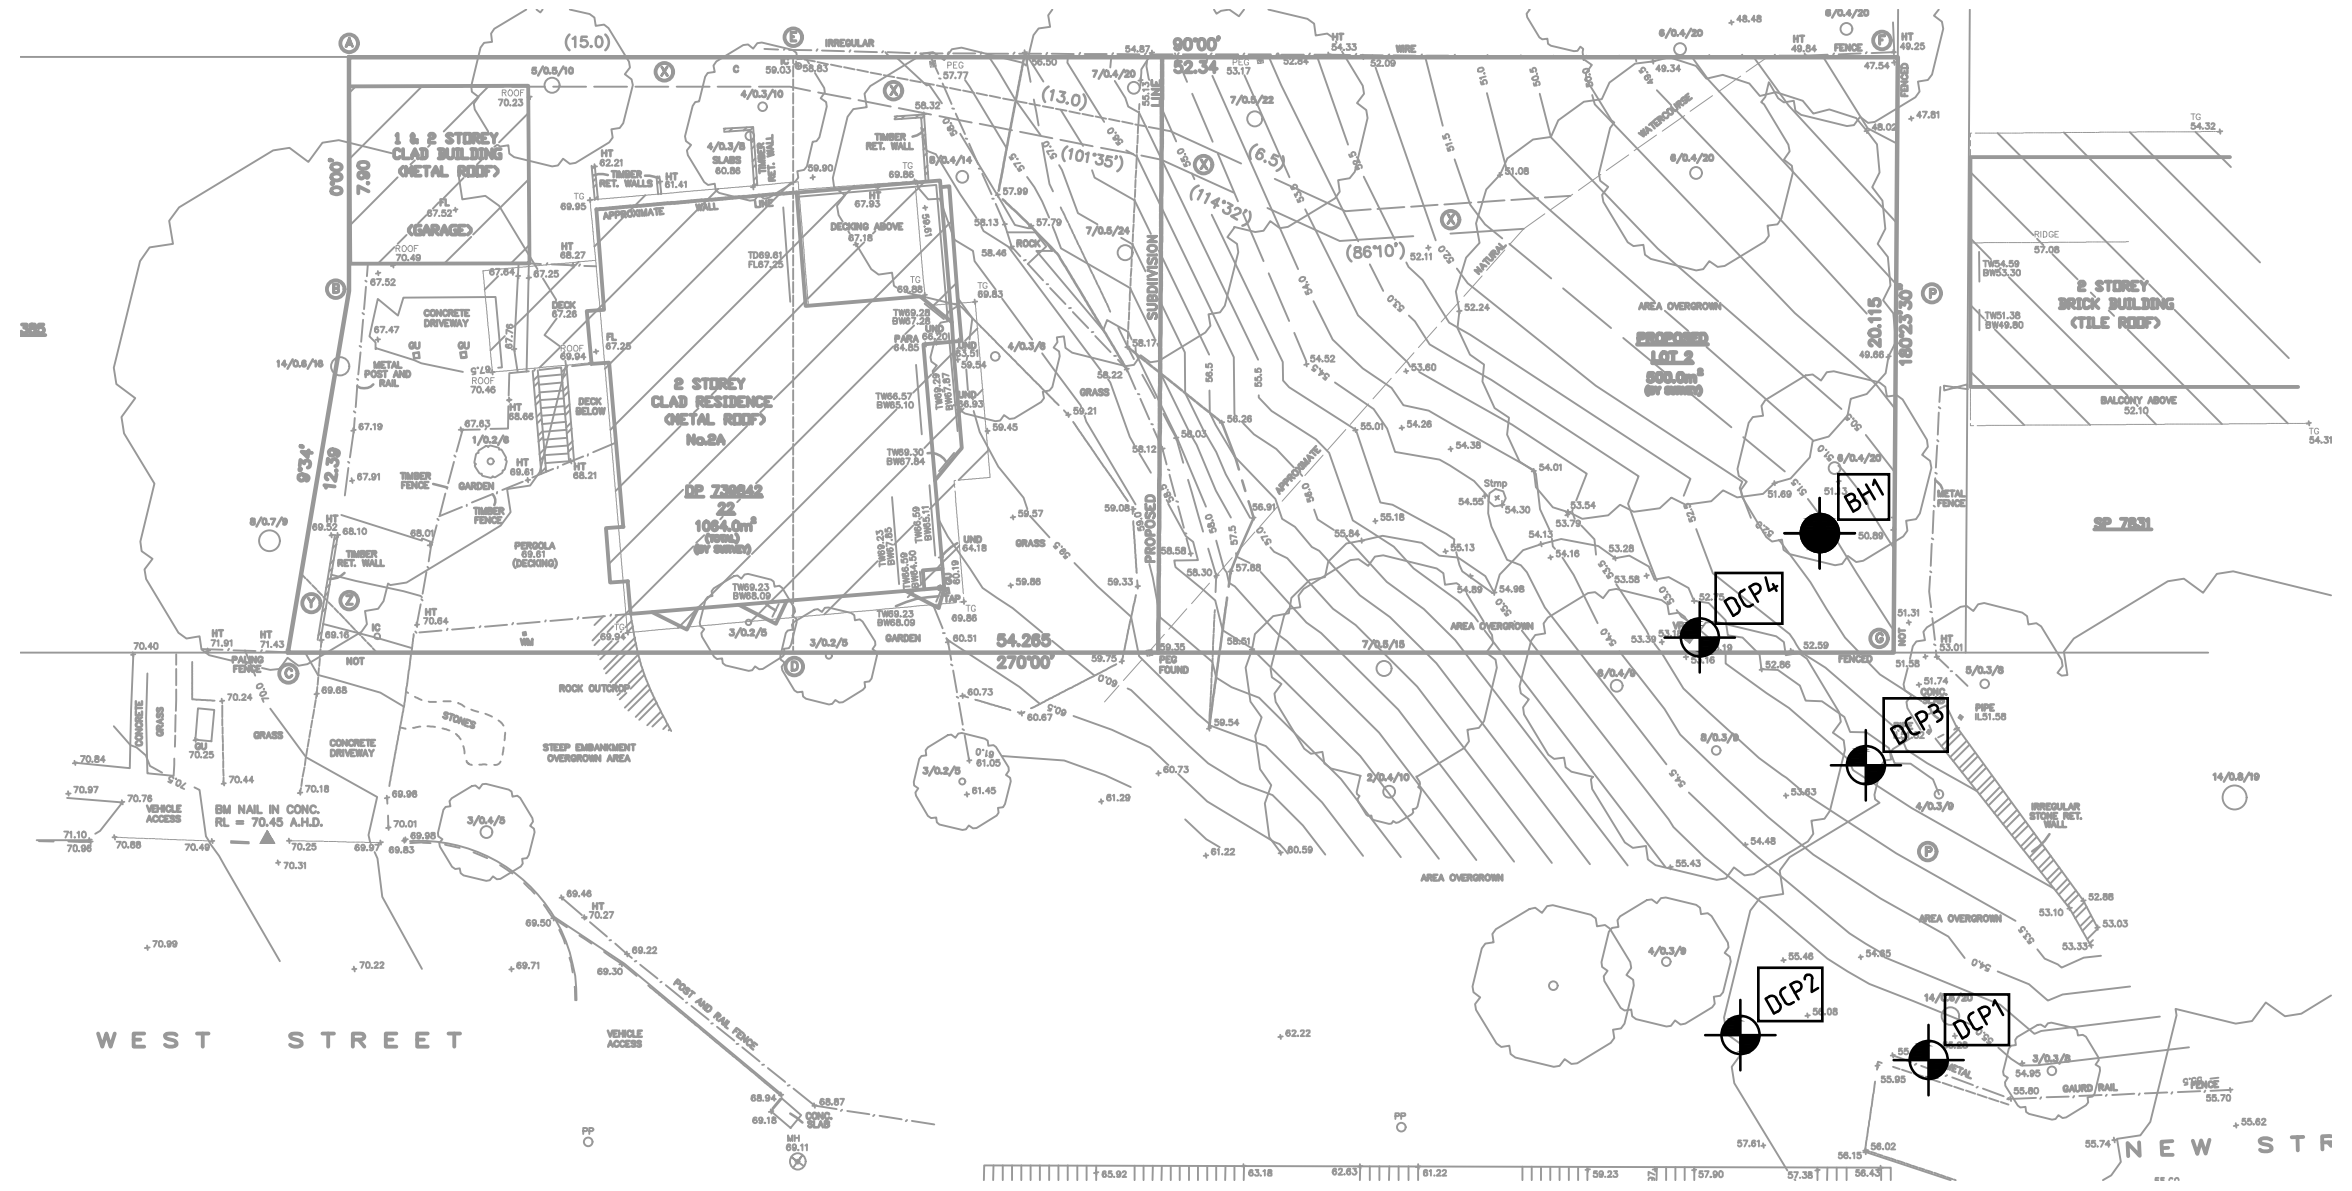
SITE PLAN/GROUND TEST LOCATIONS

BH1 - Depth	Material description
0.00 to 0.30m	SANDY SILT. Organic Top Soil. Medium grained, grey to brown, loose, dry, grass roots, indurated sandstone gravel in matrix.
	Borehole terminated at 0.30m, grinding on inferred bedrock. No standing water table encountered.
