Arboricultural Impact Assessment

28 Edinburgh Road, Forestville
NSW, 2087
21/-/DP200283
DA2025/0057 - PAN-504235
26/02/2025

Temporal Tree Management Pty Ltd.

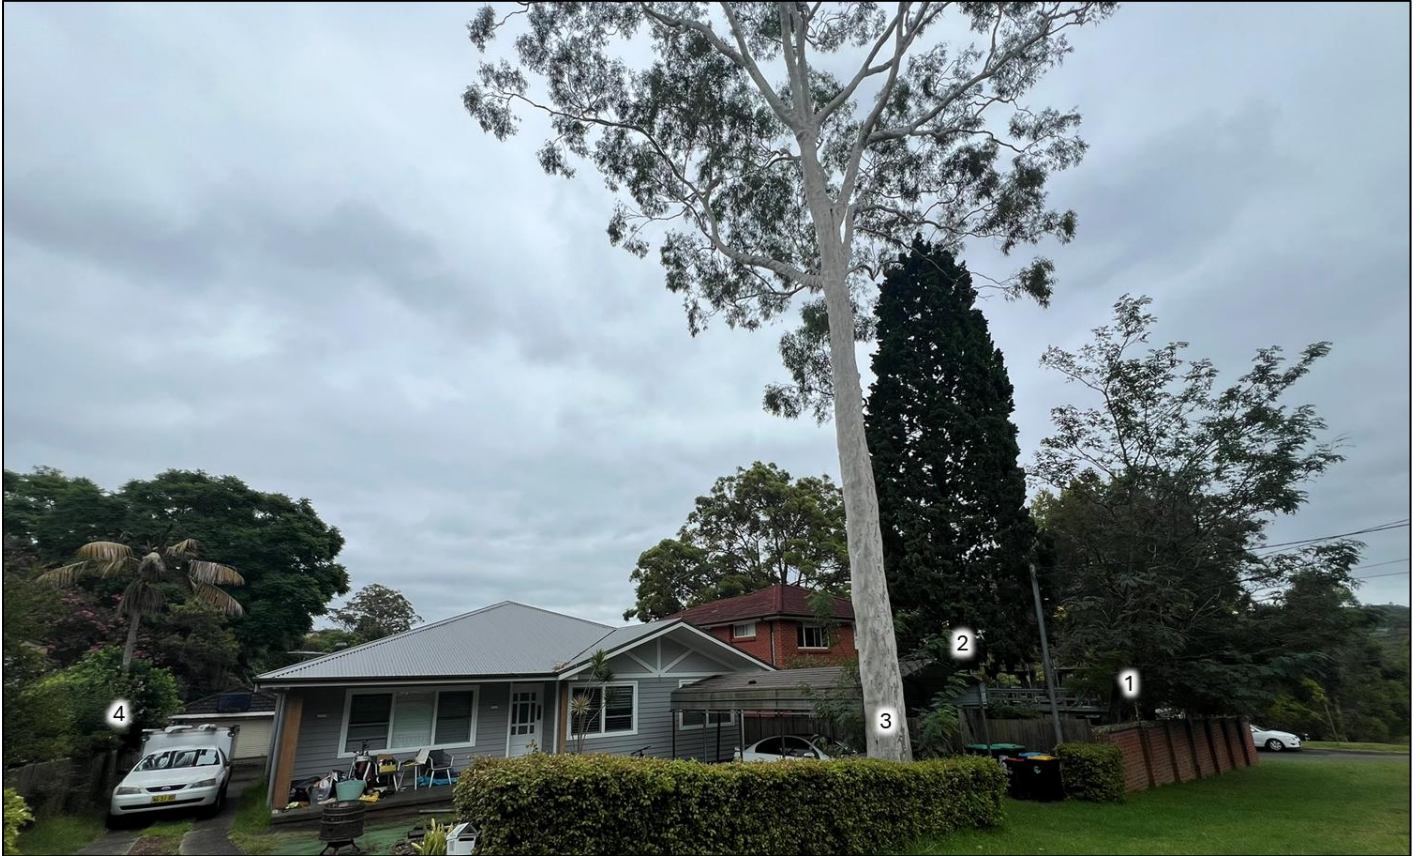
Figure 3. Trees 1-4 positioned within and adjacent to the eastern portion of the subject site.

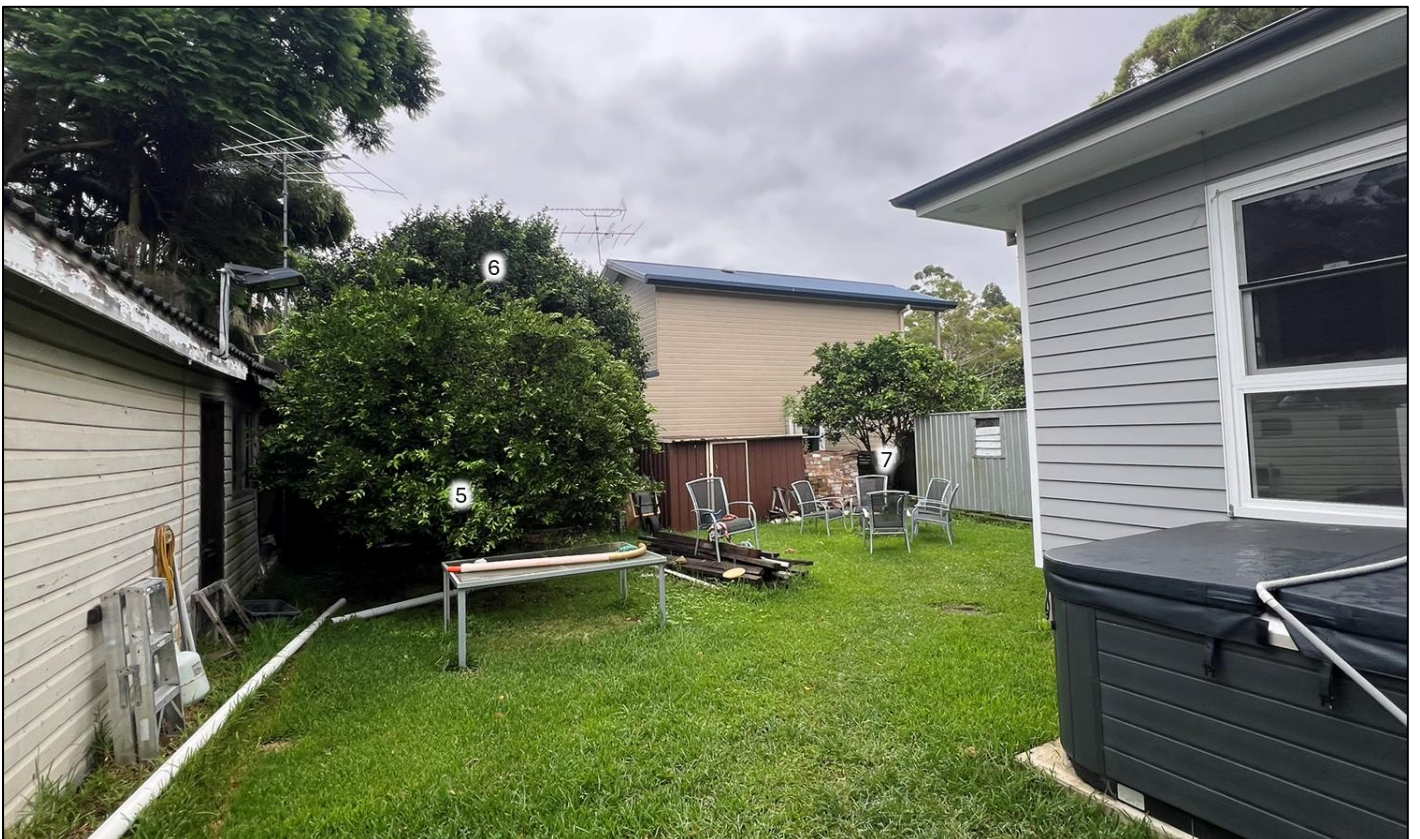
Figure 4. Trees 5-7 positioned within the western portion of the subject site.

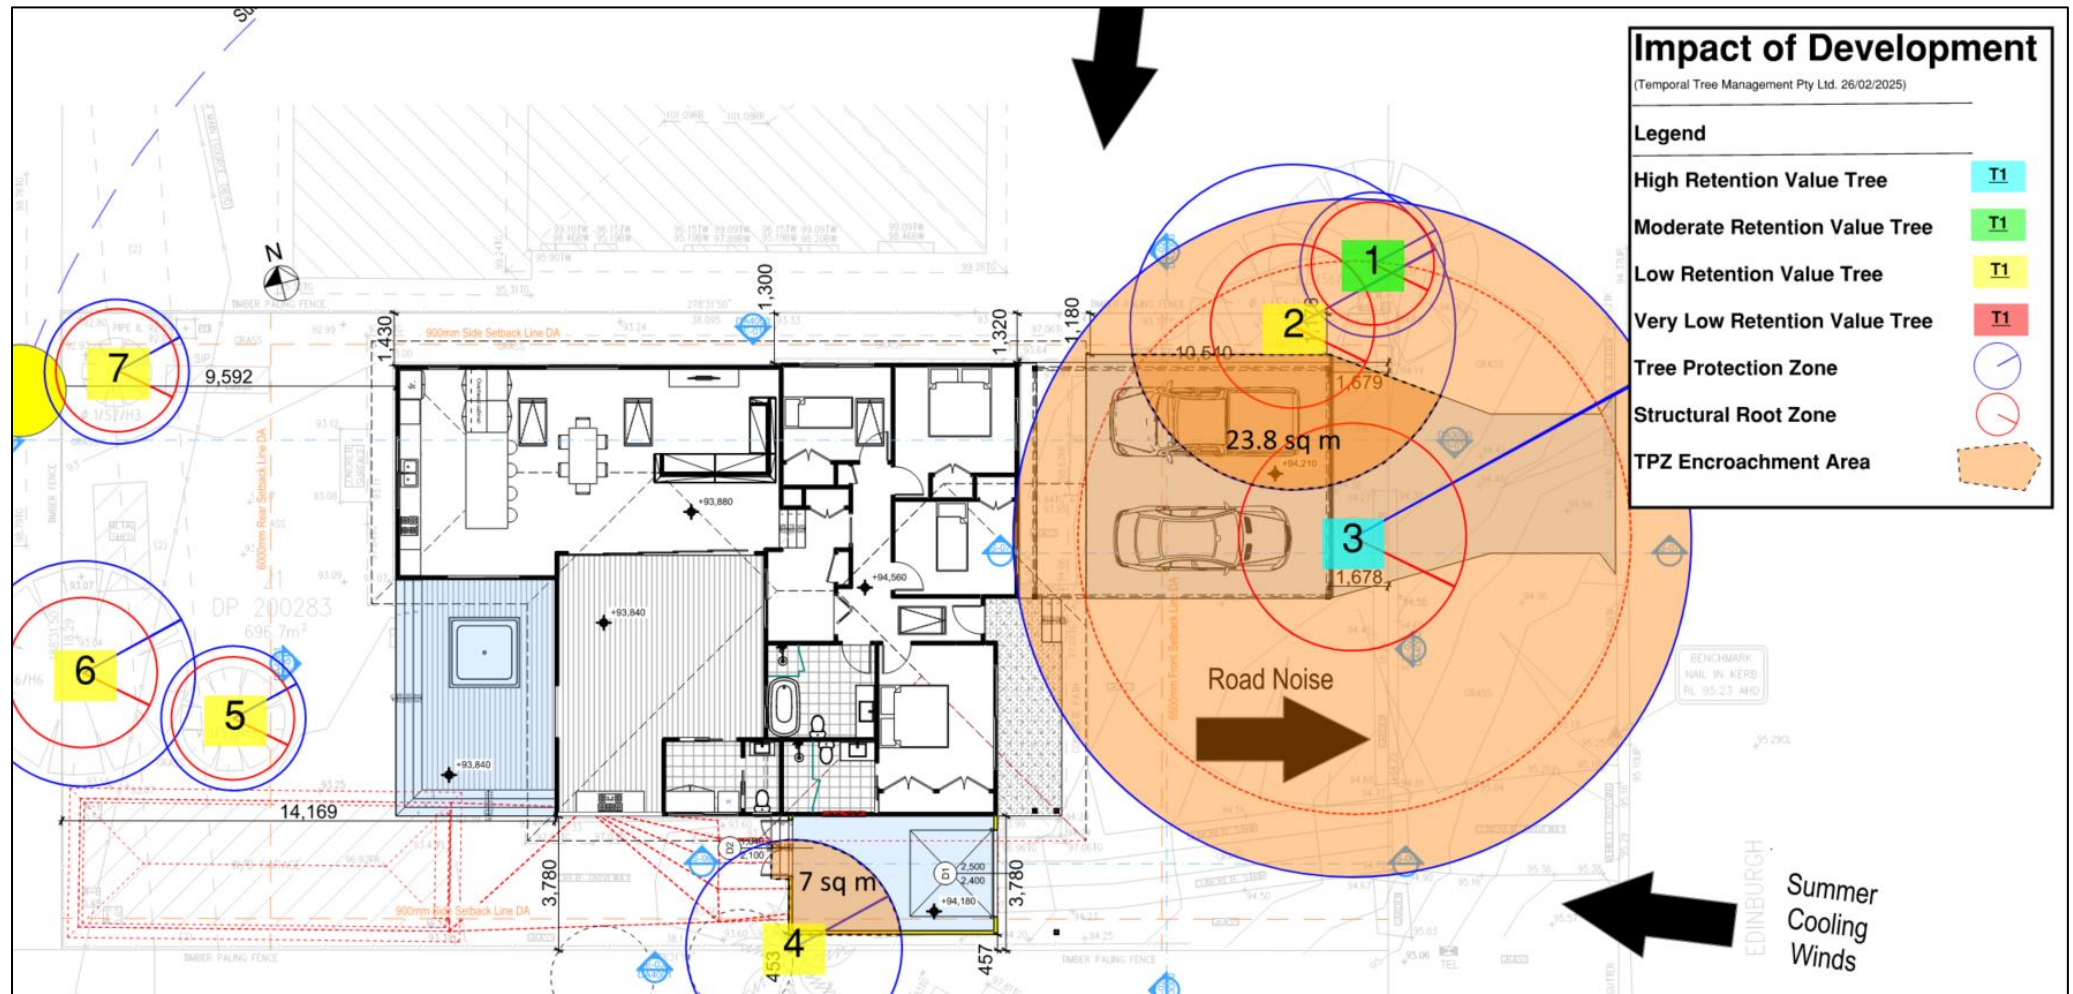
Figure 7. Retention values, TPZs, SRZs and Encroachments for seven trees positioned within the subject site. Site Plan, prepared by *Rapid Plans* (Project No: RP0919CER, Drawing No: DA1004, Revision: -, drawn 19/12/2024). Annotated by Temporal Tree Management Pty Ltd. (26/02/2025).

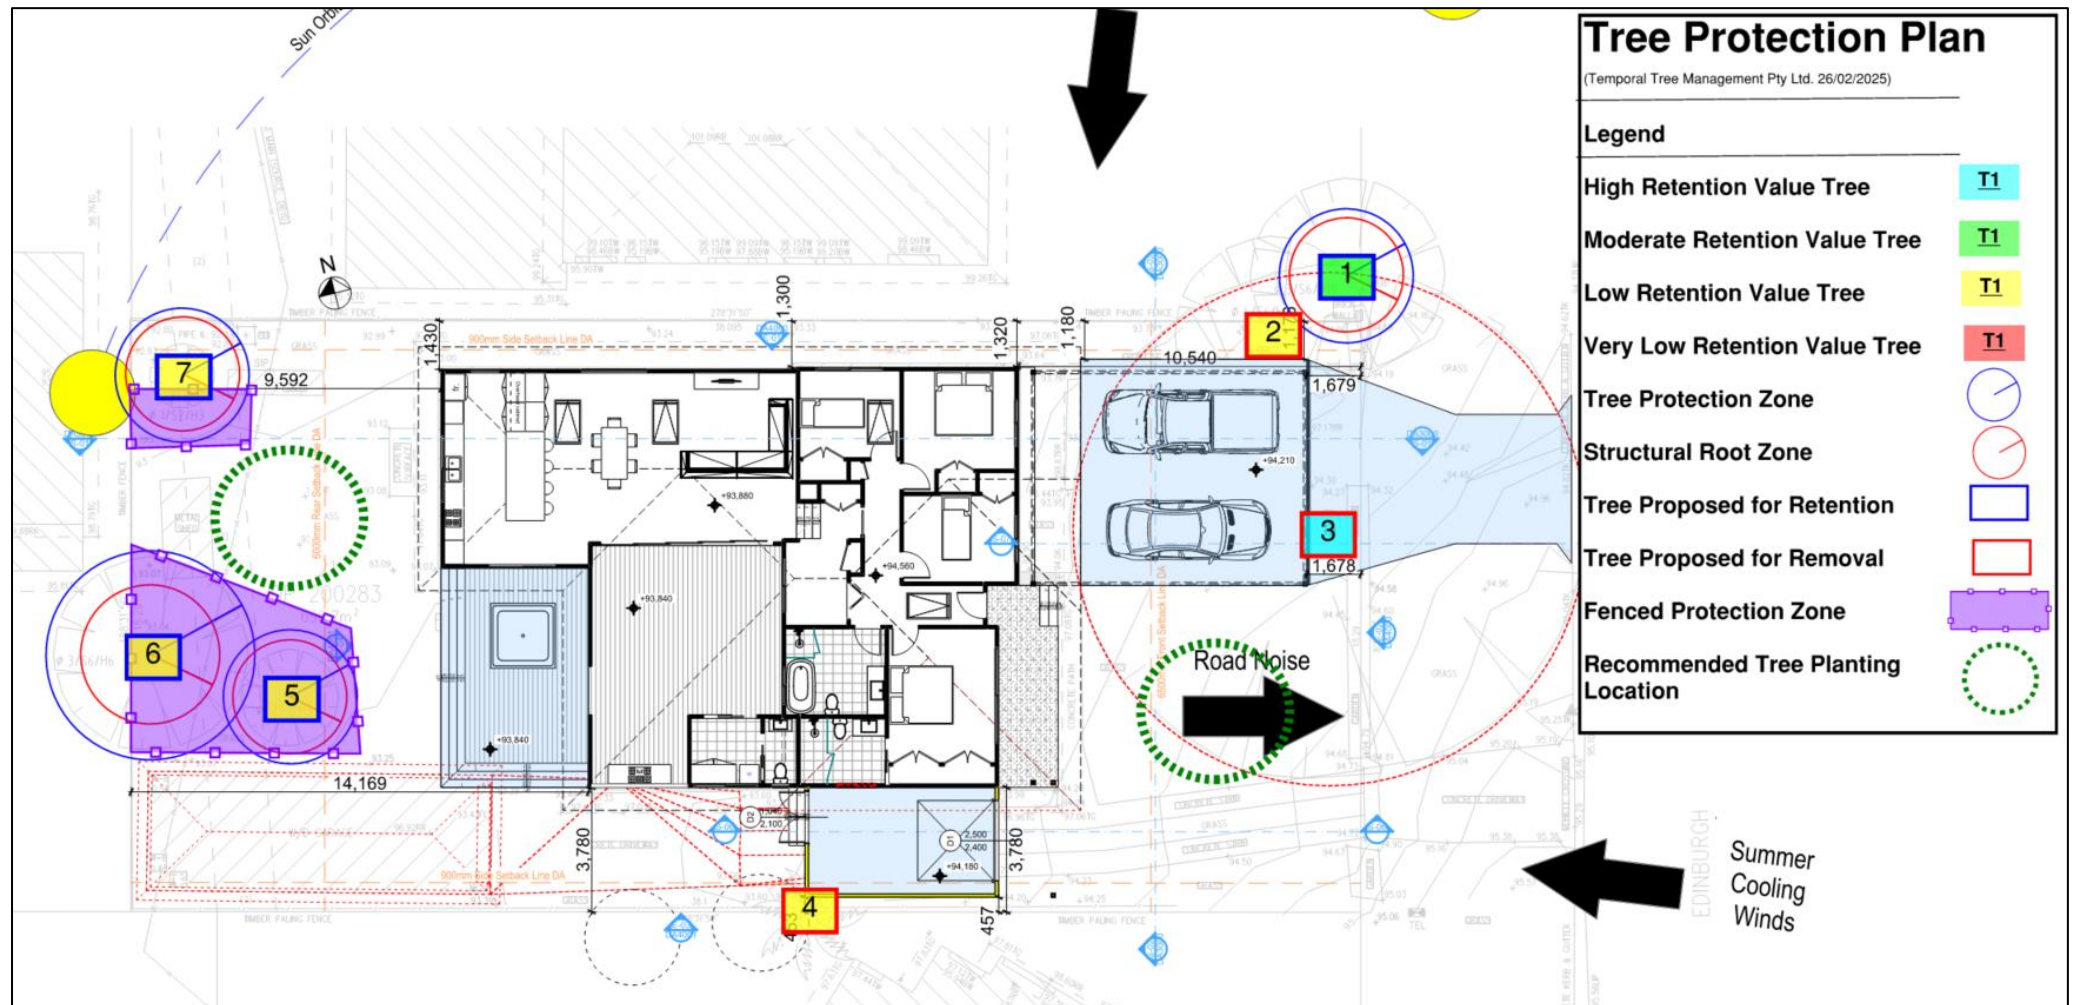
Figure 10. Tree Protection / Removal Plan for proposed development. Site Plan, prepared by *Rapid Plans* (Project No: RP0919CER, Drawing No: DA1004, Revision: -, drawn 19/12/2024). Annotated by Temporal Tree Management Pty Ltd. (26/02/2025).

- Where required, excavation for landscape planting within a retained Tree's TPZ must be undertaken using hand tools only.
- It is recommended that tree replacement specifications outlined in Section 7.1 of this report are adhered to. Tree(s) should be positioned within the western and / or south-eastern boundary of the subject site (Figure 10).

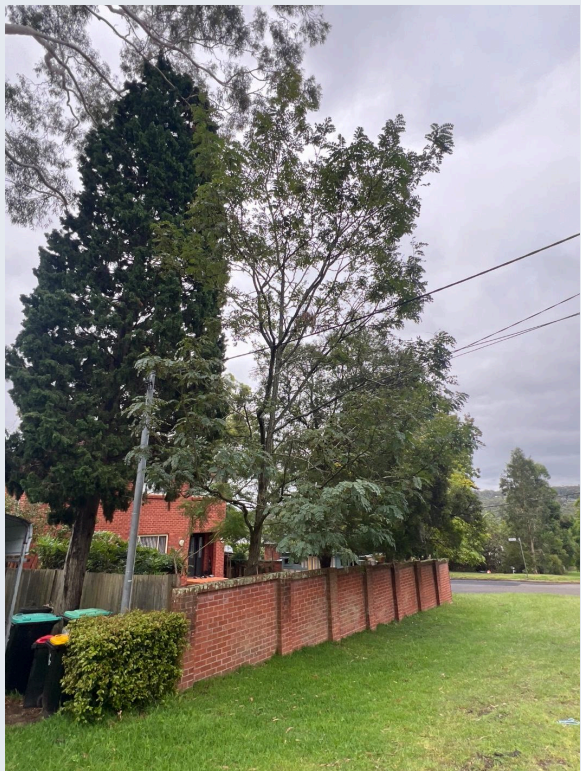
image.jpg
25/02/2025

| Tree Details | |
|---|--|
| Tree Comments: | Large tree of native species value observed to be in good condition. |
