## SITE INSPECTION REPORT - # 2

**PROJECT:** 60 Prince Alfred Parade, Newport

**DATE:** 18th May, 2023

**JOB No:** 22-229

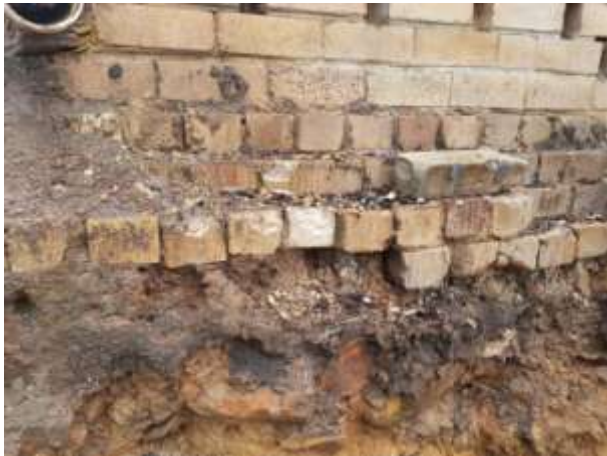
Photo 1: Poorly built masonry footing on weak foundation material.

The existing footings are not considered adequate to support the proposed alterations. As such, we would recommend removal of the existing masonry walls and shallow footings and that they be reconstructed in line with current Australian Standards (AS2870 Residential Slabs & Footings Code, AS3600 Concrete Structures Code, and AS1684 Australian Timber Framing Code) and the National Construction Code (NCC).

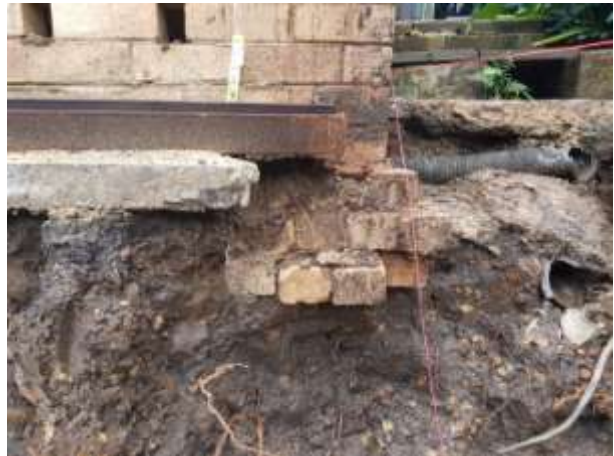
Photo 2: Poorly built masonry footing on weak foundation material.

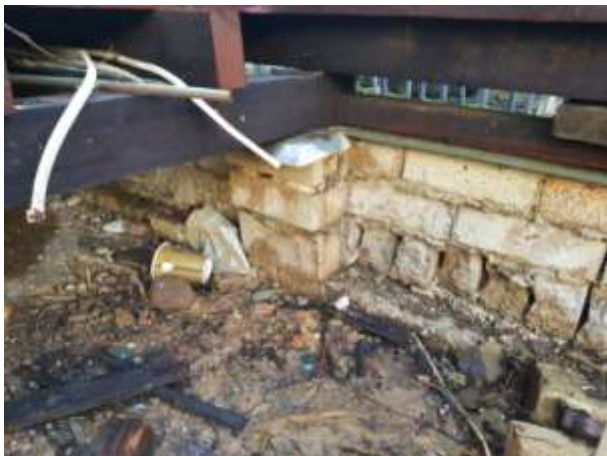
Photo 3: Masonry dwarf wall leaning over.

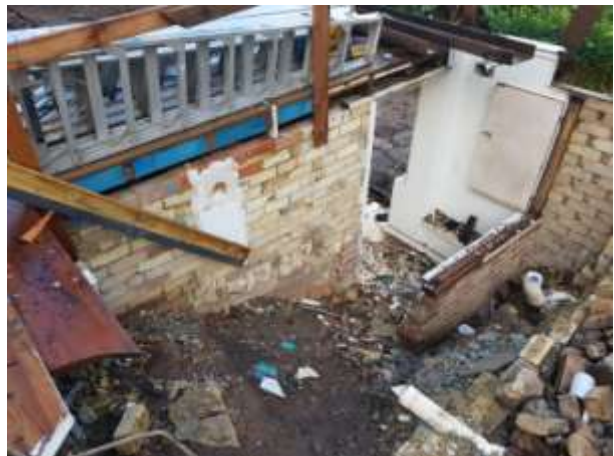
Photo 4: Poorly built subfloor masonry wall.

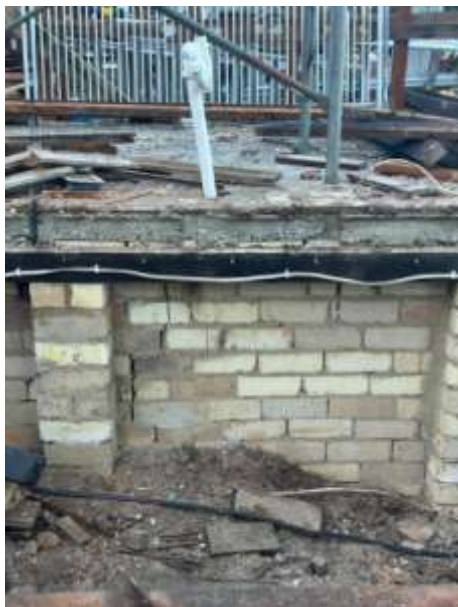
Photo 5: Major crack through masonry subfloor wall.
