J.L Geotechnical
Helping others find their footing

Geotechnical Report

51 Wyndora Avenue Freshwater 2096

Version	Date
V1	17/09/2024

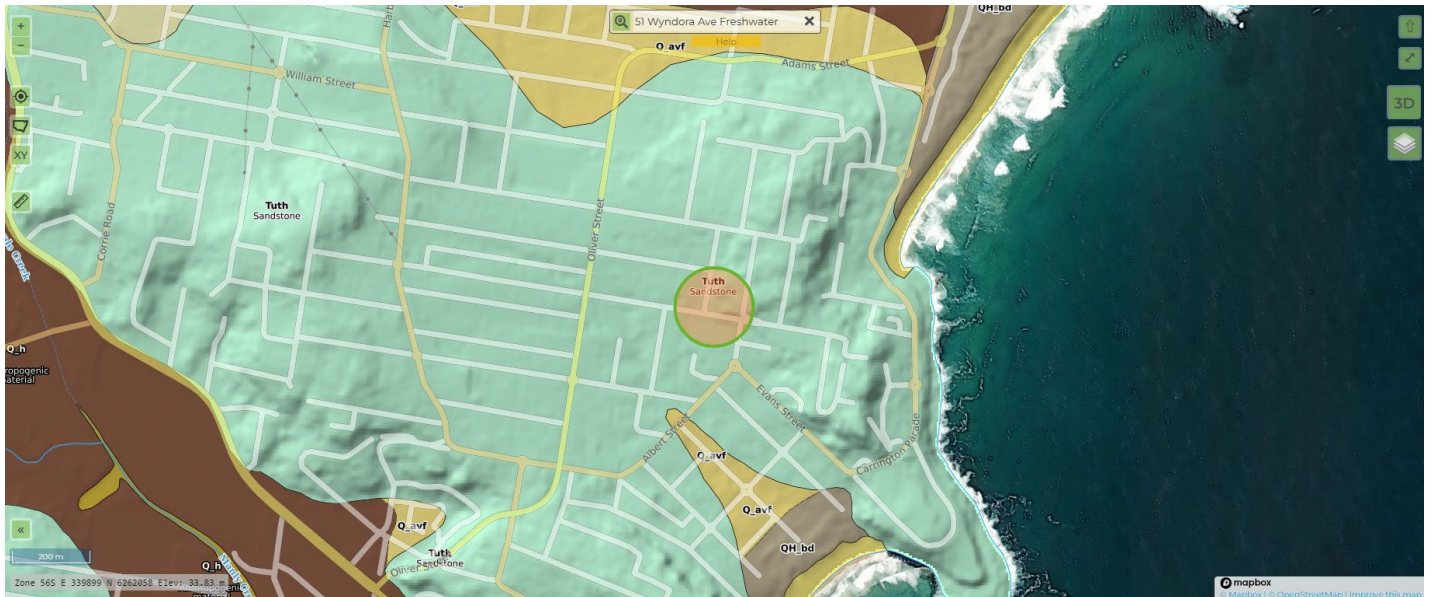
Figure 2 – Geology

The site is underlain by Triassic Period sedimentary rock - Hawkesbury Sandstone (Tuth) – Medium to coarse grained quartz sandstone with minor shale and laminite lenses. The Geological mapping is shown in figure 2.

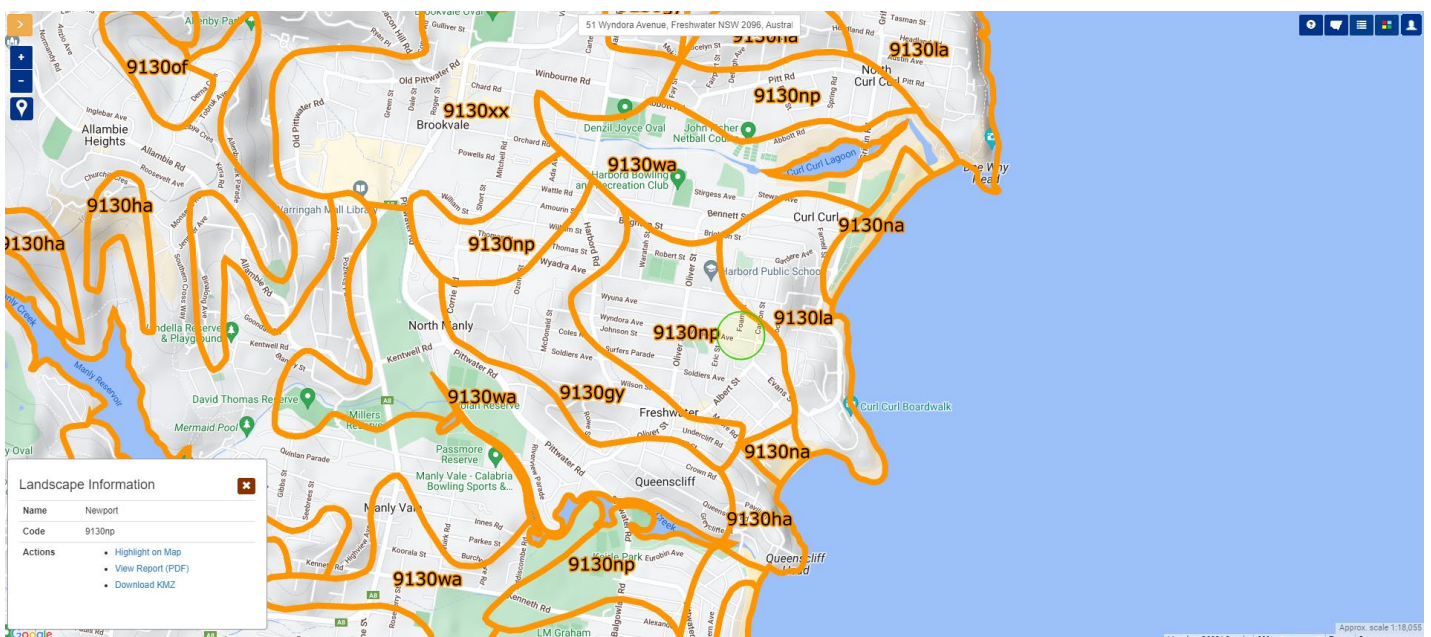
Figure 3– Soil Landscape

The site is underlain by the **Newport Aeolian soil landscape** which is described as “gently undulating plains to rolling rises of Holocene sands mantling other soil materials or bedrock. Local relief <10 m, slopes <10% on lower slopes and plateau surface and up to 35% against obstacles facing prevailing winds. Extensively cleared low eucalypt openwoodland, scrub and open-heathland.” It has soils described as “shallow (<50 cm), well sorted Siliceous Sands (Uc1.21, Uc4.24, Uc4.31) overlying moderately deep (<150 cm) buried sands including yellow Podzolic Soils (Dy5.41, Dy5.51, Dy5.62) with sandy topsoils on crests and gentle slopes; deep (>200 cm) Podzols (Uc2.32) on steep slopes, lower slopes and in depressions.” Some limitations of the soils landscape are “very high soil erosion hazard, localised steep slopes, very low soil fertility, noncohesive topsoils.” The Soil Landscape mapping is shown in figure 3.

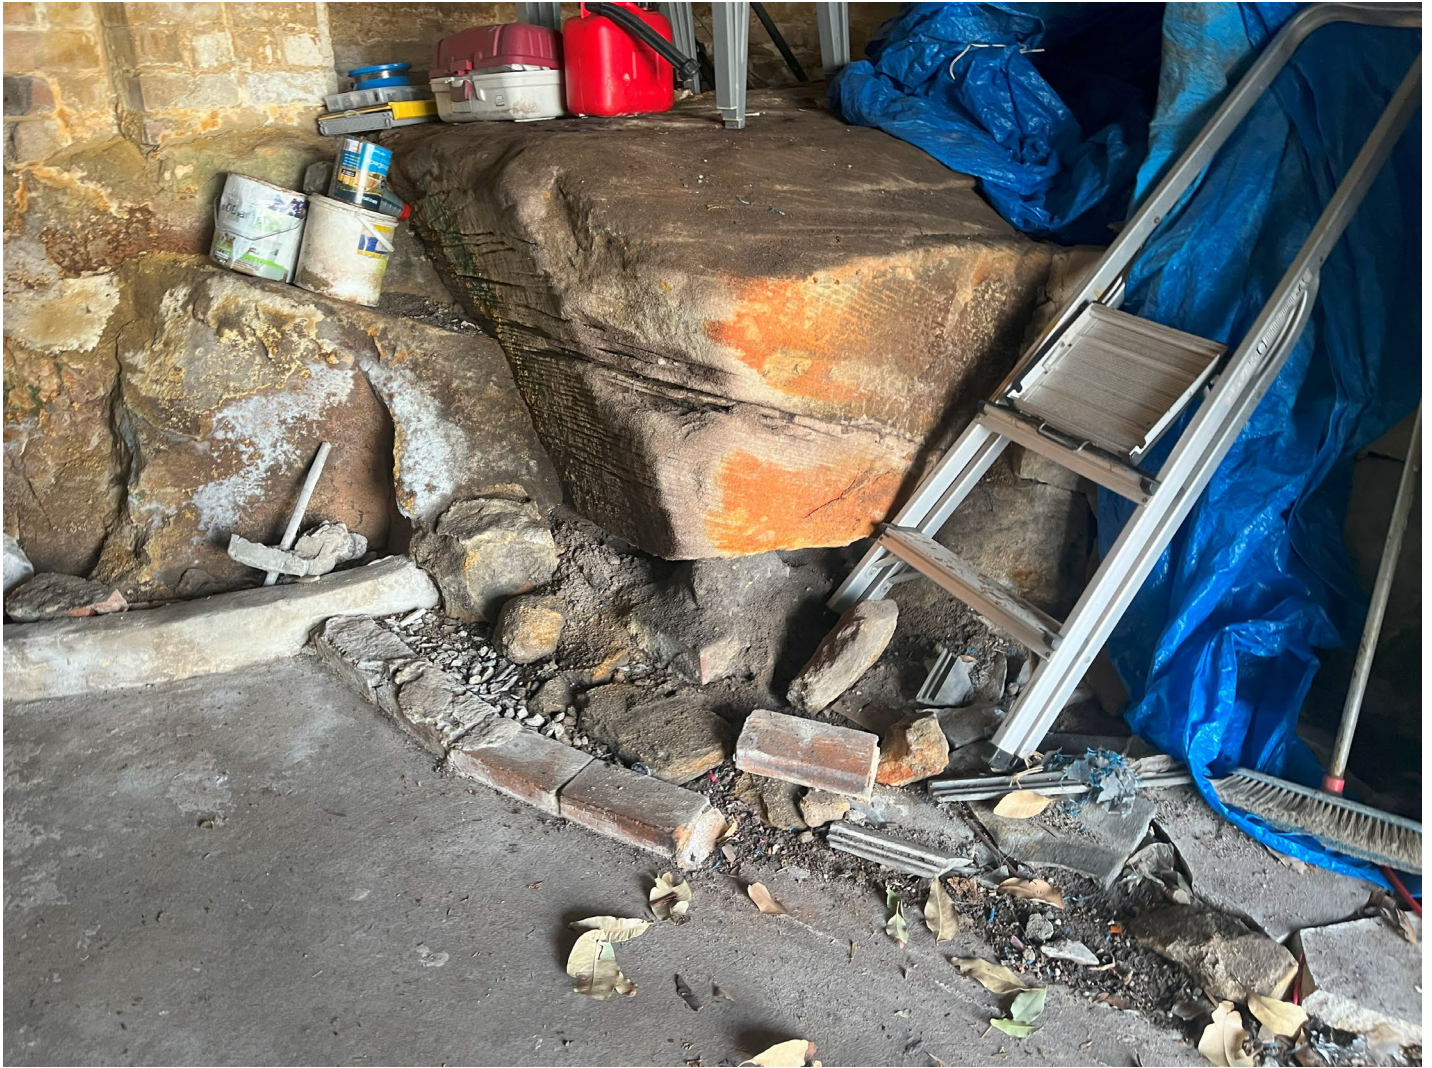
Photo 1. Rock in garage.

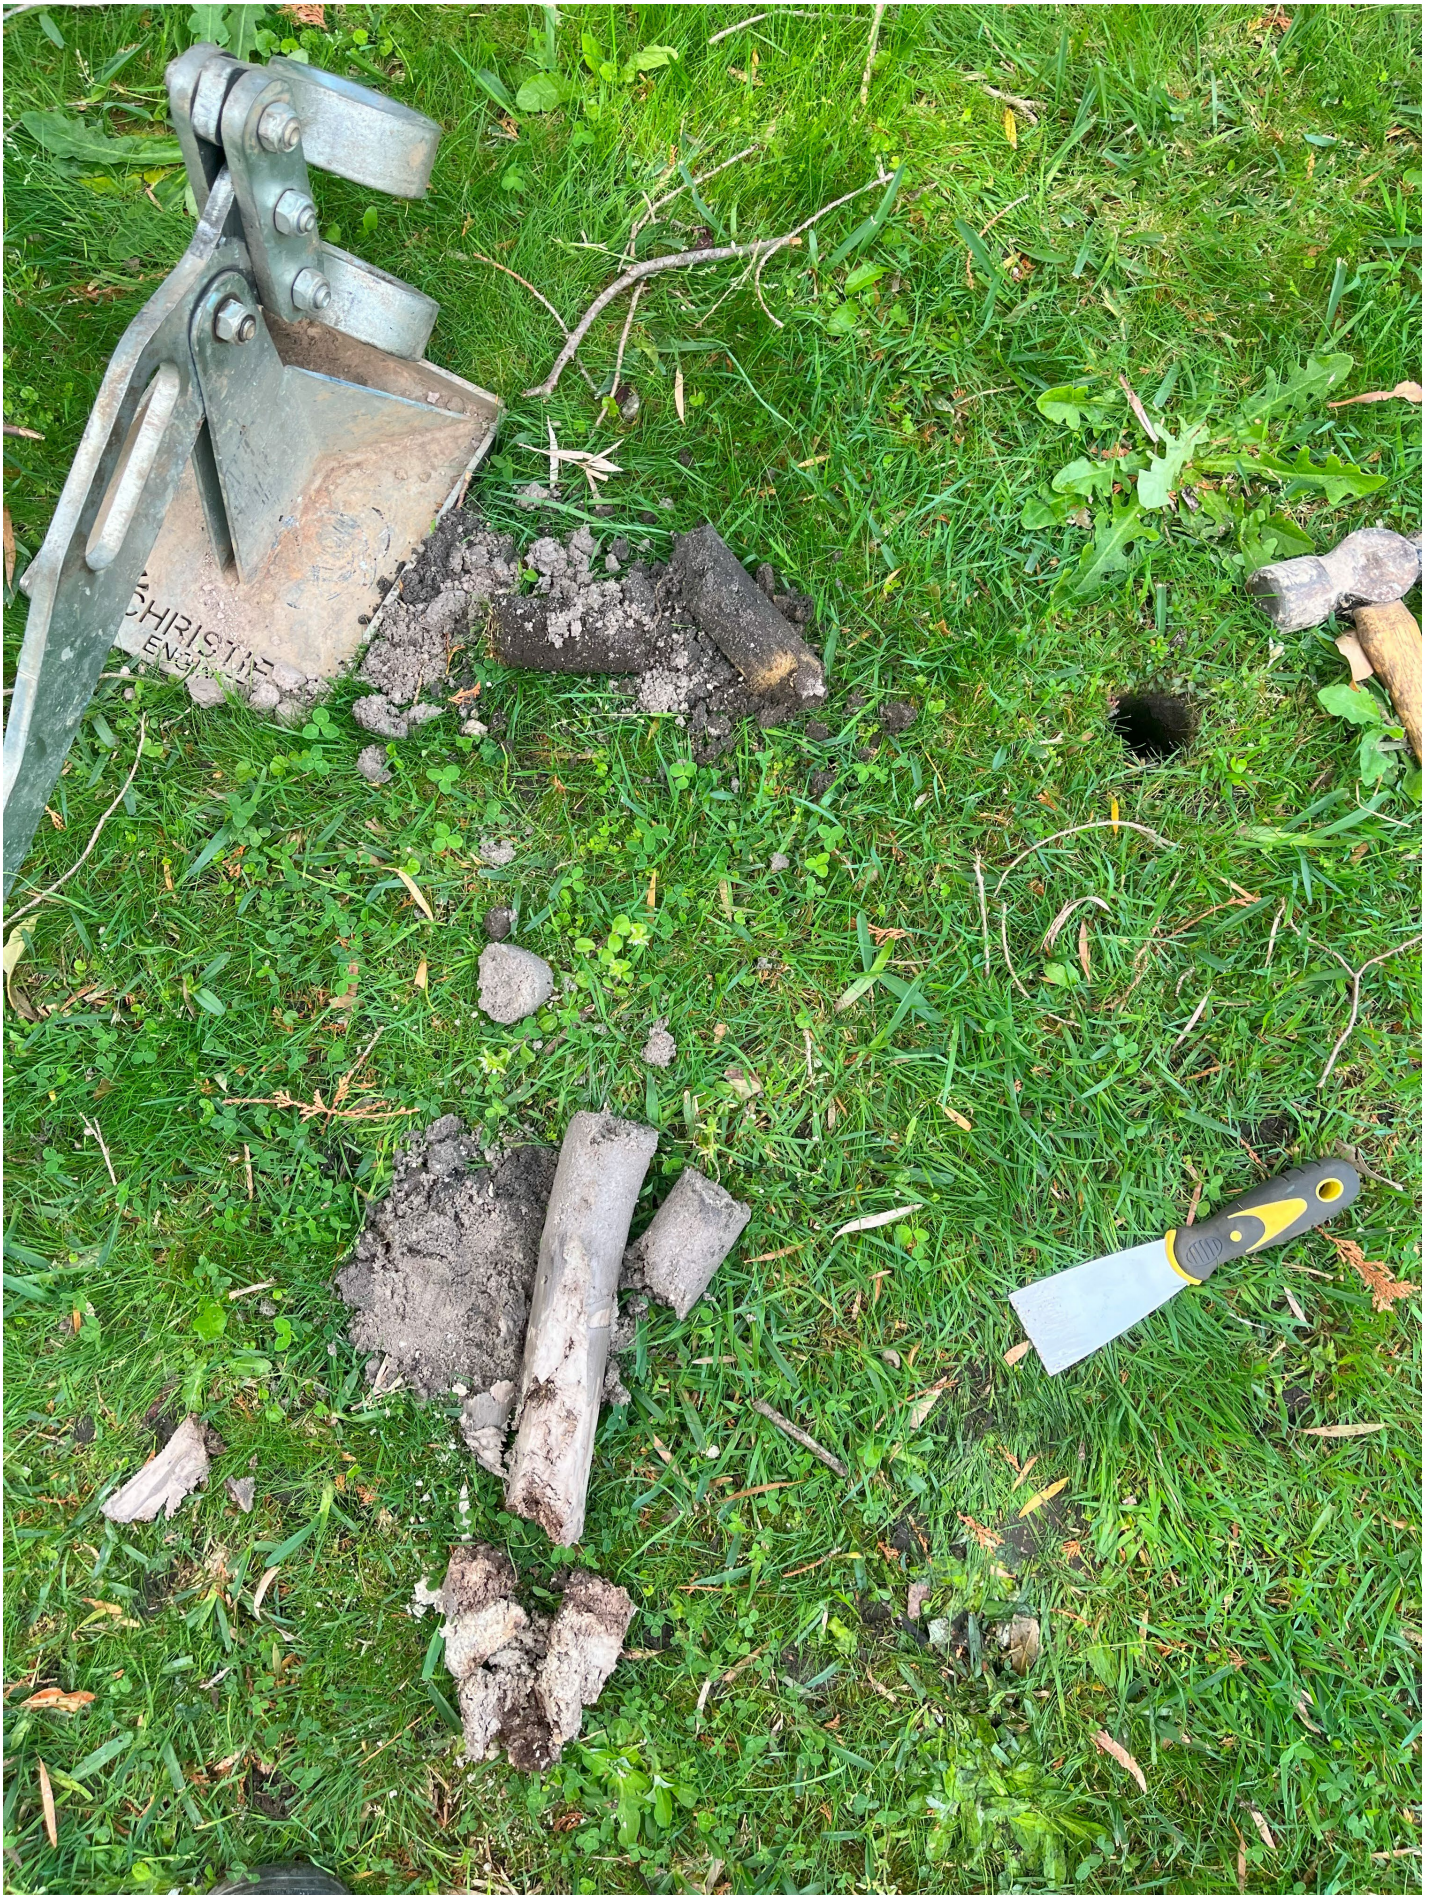
Photo 2. Soils
