# Preliminary Geotechnical Assessment

**Project:** Alterations & Additions  
33 Marlborough Avenue, Freshwater NSW

**Ref:** AG 24551  
9 December 2024

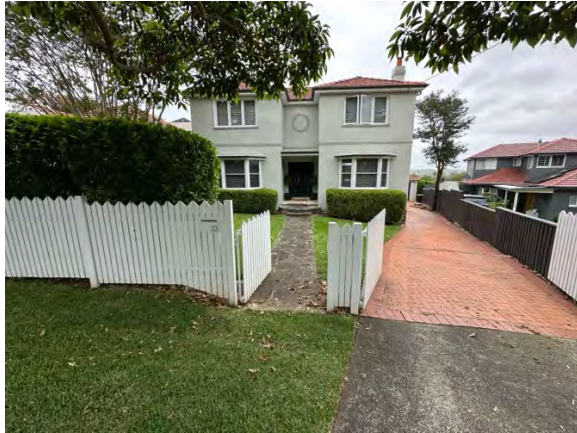
**Photo 1:** Frontage of the dwelling facing south

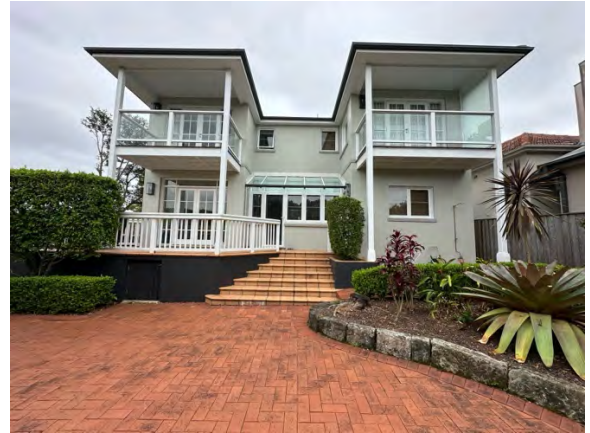
**Photo 2:** Rear of the dwelling facing north

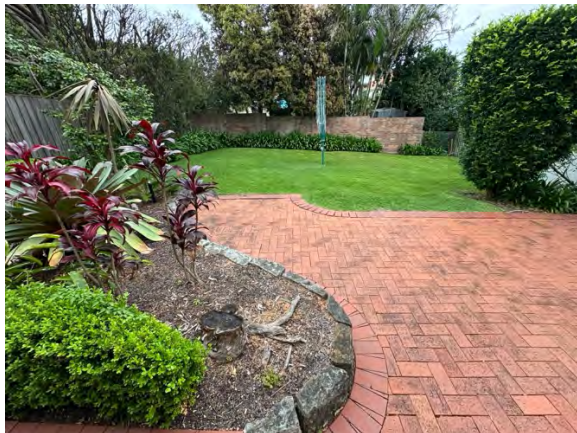
**Photo 3:** Area of proposed cabana and swimming pool facing south.

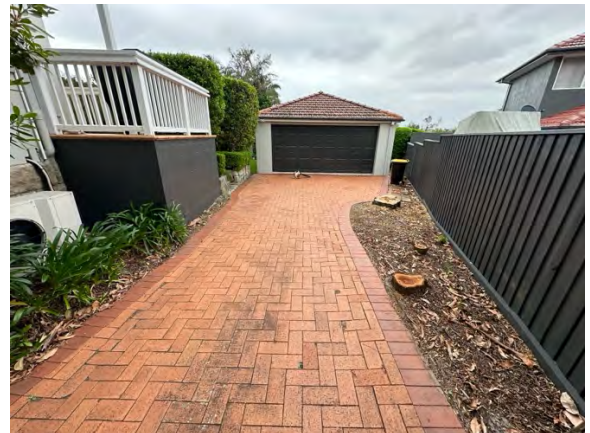
**Photo 4:** Area of proposed driveway extension facing south.
