Report Title: Geotechnical Report 4 Elwyn Close, Mona Vale
Report Date: 25/7/22

GEOTECHNICAL INVESTIGATION:

New Pool at 4 Elwyn Close, Mona Vale

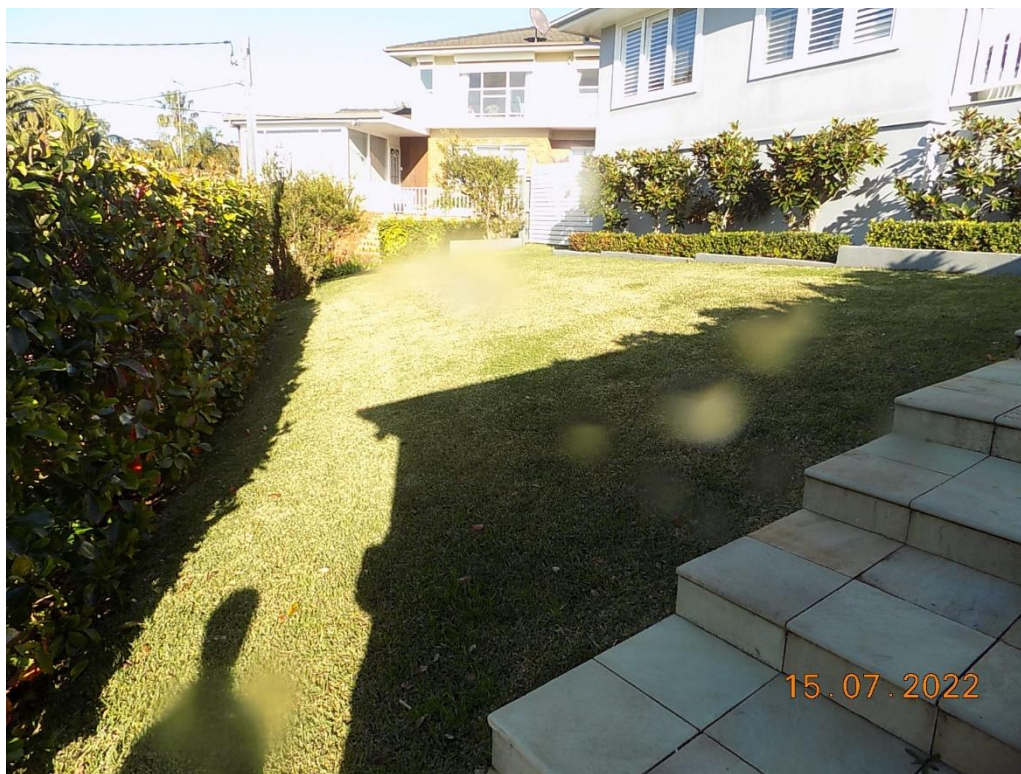
Photo 2

- 2.1** The site was inspected on the 15th July, 2022.
- 2.2** This residential property is on the high side of the road and has a SE aspect. It is located on the gentle to moderately graded upper middle reaches of a hillslope. The natural slope rises across the property at an average angle of ~9°. The land surface above and below the property continues at gradually decreasing angles.
- 2.3** At the road frontage, a concrete driveway runs to a stable rendered masonry garage (Photo 1). Between the road frontage and the house is a gently sloping lawn

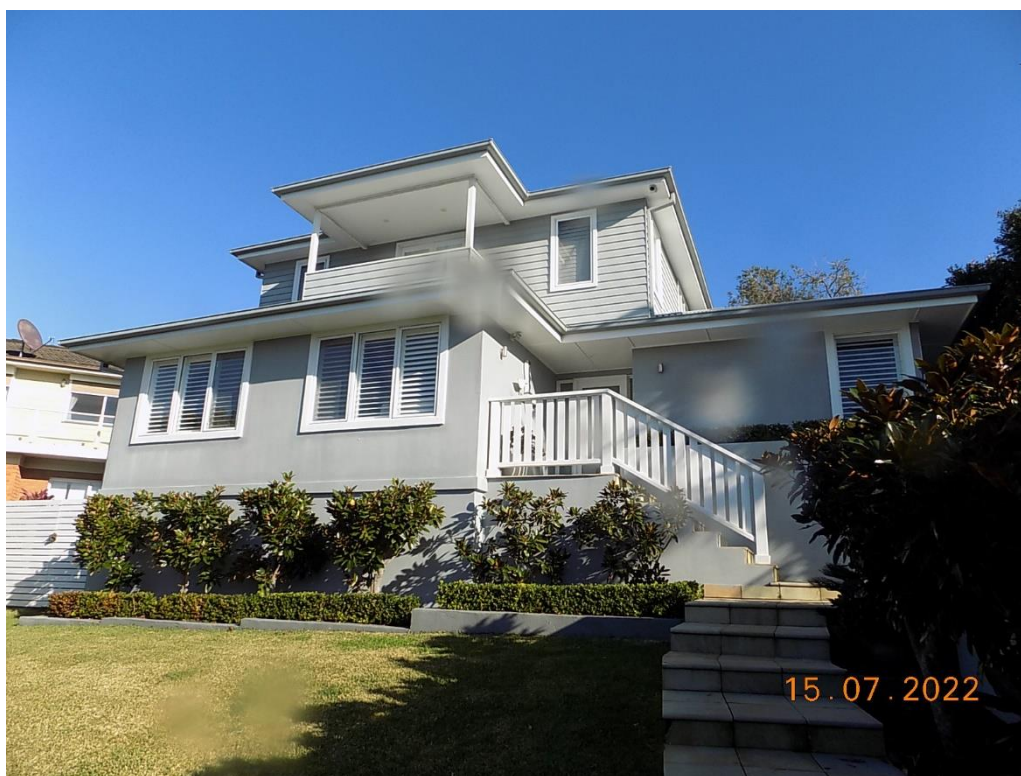
Photo 3

surrounded by garden beds (Photo 2). The part two-storey house is supported on rendered brick walls and brick piers (Photo 3). No significant signs of movement were observed in the supporting walls of the house and the visible supporting brick piers stand vertical. A timber deck extends off the uphill side of the house. The cut for the deck is supported by a rendered concrete block retaining wall ~1.0m high that will be demolished as part of the proposed works (Photo 4). The slope above the deck has been terraced with a timber retaining wall dressed in timber planks ~1.0m high that will also be demolished as part of the proposed works (Photo 5). The lawn-covered terraces extend to the upper common boundary. A fill on the upper neighbouring property is supported by a concrete block retaining wall reaching ~1.2m high (Photo 6). This wall was observed to be cracked and tilting downslope at a maximum angle of ~14°. The owner informed us that the upper neighbour is aware of the tilting wall and is gathering quotes to have it replaced. We recommend this wall be replaced within 1 year of the date of this report.

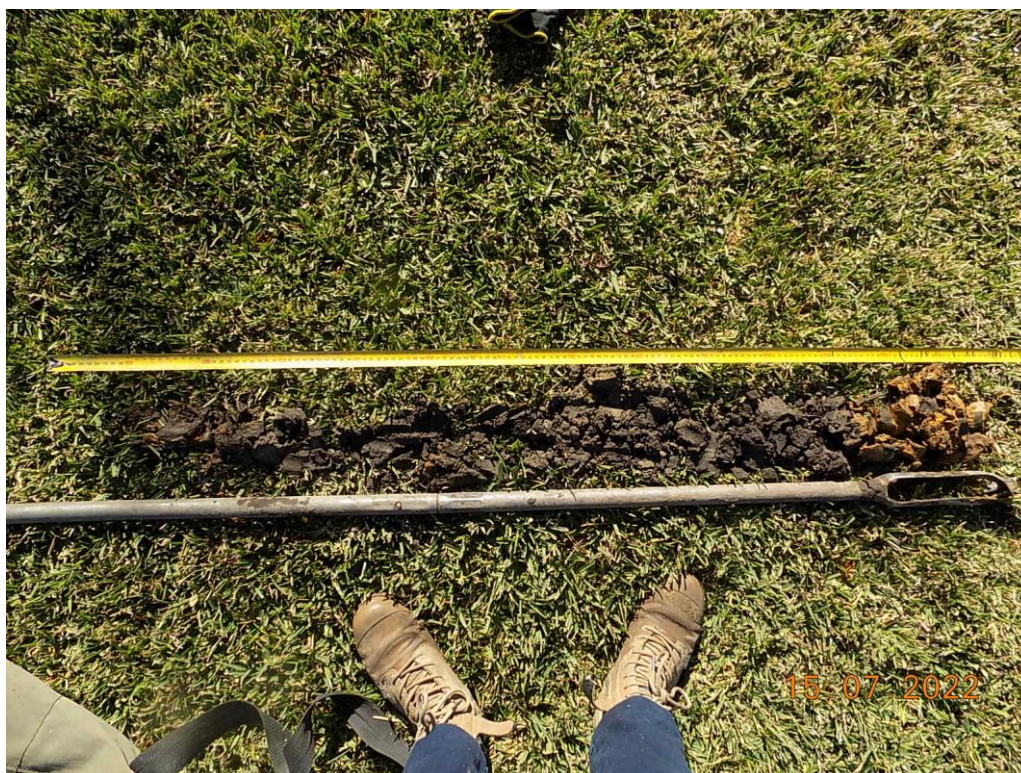
AUGER HOLE 1 (~RL37.6) – AH1 (Photo 7)

Depth (m)	Material Encountered
0.0 to 0.9	FILL , disturbed topsoil, dark brown, very loose to medium dense, damp, fine to coarse grained with fine trace organic matter and rock fragments.
0.9 to 1.1	SILTY SOIL , dark brown, medium dense, damp, fine to medium grained with fine trace organic matter.
1.1 to 1.3	CLAY , brown, stiff to very stiff, dry, fine grained.
1.3 to 1.4	CLAY , derived from weathered shale, brown and mottled maroon, very stiff, dry, fine grained.

End of hole @ 1.4m in clay derived from weathered shale. No water table encountered.

Photo 7: AH1 – Downhole is from left to right

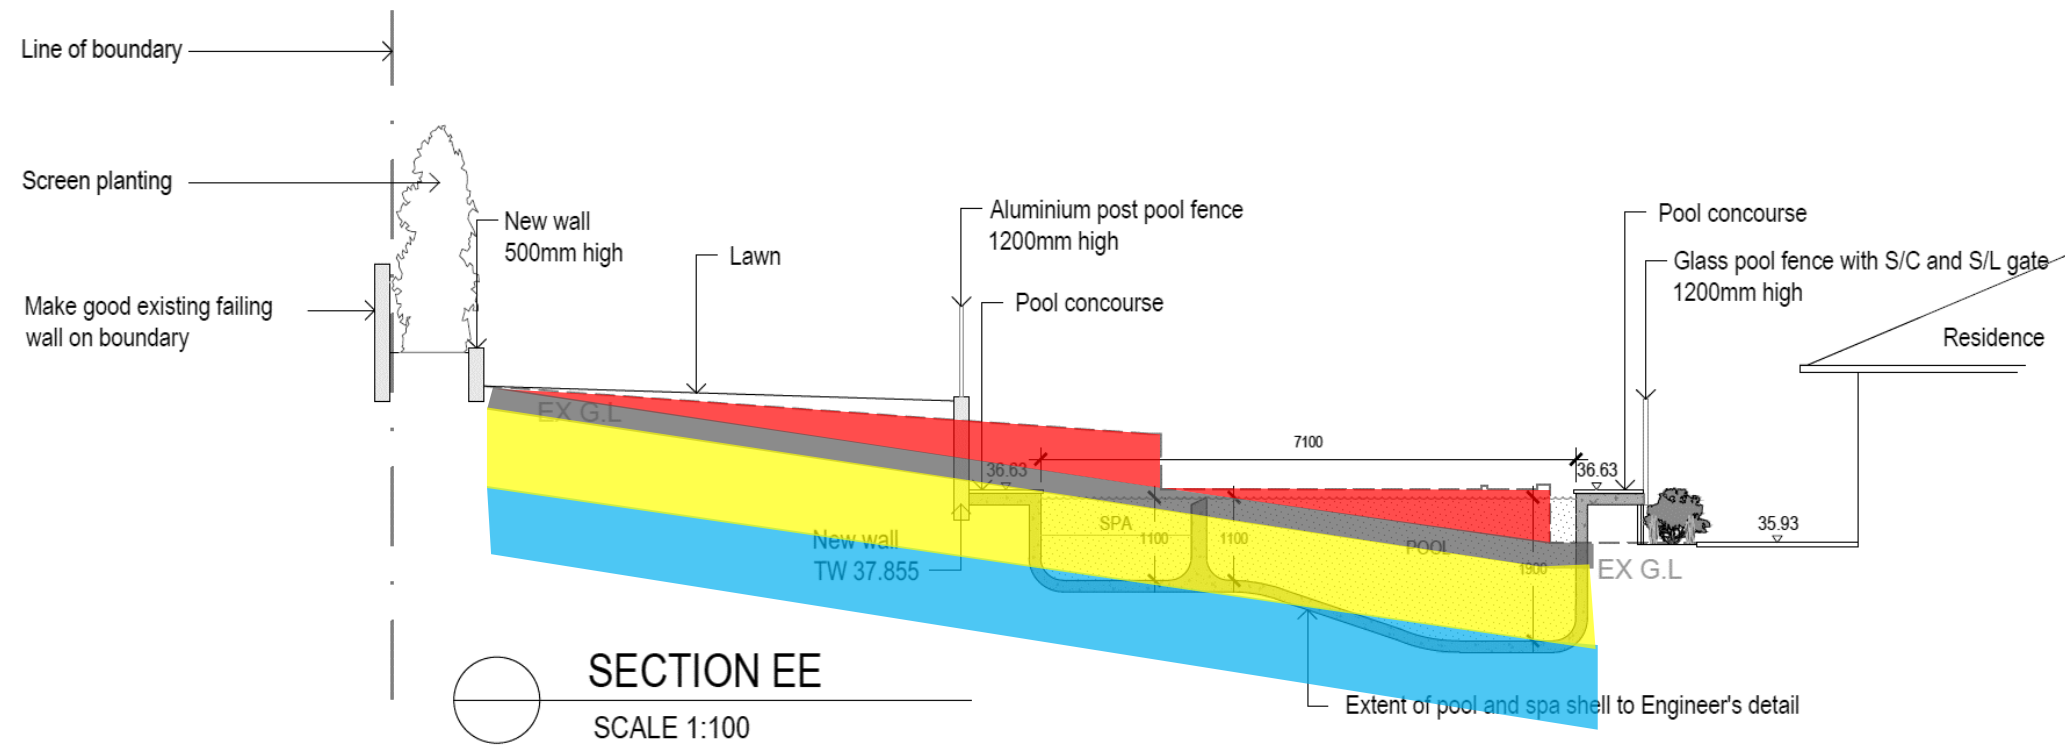
TYPE SECTION – Diagrammatical Interpretation of expected Ground Materials

The slope materials are colluvial at the near surface and residual at depth. In the test locations, the ground materials consist of silty soils over stiff to very stiff clays. Filling has been placed across the uphill side of the property for landscaping to a maximum depth of ~1.0m. The clays merge into the underlying weathered rock at depths of between 1.2 to 1.8m below the current surface, being deeper due to the presence of fill. The weathered zone is interpreted to be Extremely Low Strength Shale. See Type Section attached for a diagrammatical representation of the expected ground materials.

- Fill
- Topsoil
- Silty Clay – Stiff to Very Stiff
- Narrabeen Group Rocks – Extremely Low Strength Shale - after being cut up by excavation equipment can resemble a stiff to hard clay.
