Report Title: Geotechnical Report 12 Corniche Road, Church Point  
Report Date: 21/9/21

## **GEOTECHNICAL INVESTIGATION:**

Alterations and Additions at **12 Corniche Road, Church Point**

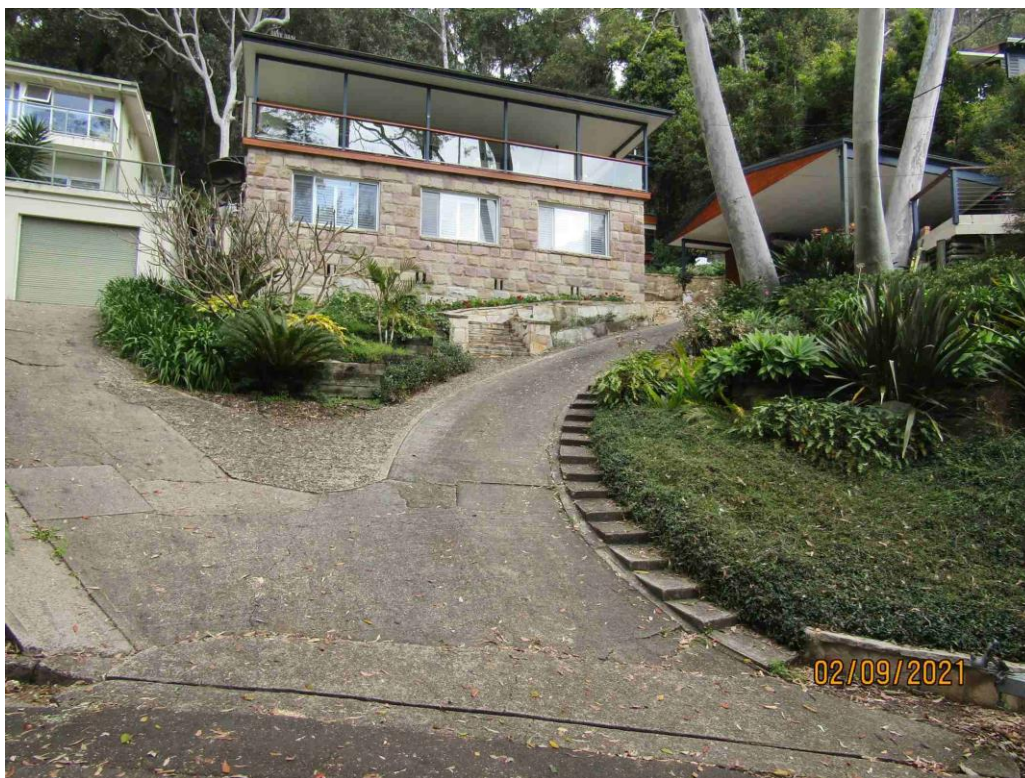
Photo 1

**2.3** At the road frontage, a concrete driveway runs up the slope to a concrete carport cut into the slope (Photos 1 & 2). Low timber retaining walls supports terraced garden areas either side of the driveway. Fill provides a level platform for the carport. The fill is supported by a stable timber retaining wall ~1.5m high (Photo 3). The sandstone block, brick and timber clad house is supported by sandstone block walls, brick walls, brick piers and steel posts (Photos 1 & 4). The supporting walls, piers and posts stand vertical and show no significant signs of movement (Photo 5). A stable sandstone block retaining wall up to ~2.5m high supports the cut for the lower ground floor of the house (Photo 6). Stable rendered masonry and sandstone block retaining walls up to ~1.8m high support the cut for the carport and fill upslope (Photos 2 & 6). A timber retaining wall ~1.3m high supports another fill further upslope (Photo 7). The wall is bulging and is tilting downslope slightly, but will be demolished as part of the proposed works. A suspended timber clad studio with deck is located at the W side of the house (Photo 15). The steel posts and concrete pier supporting the studio and upper deck stand vertical.

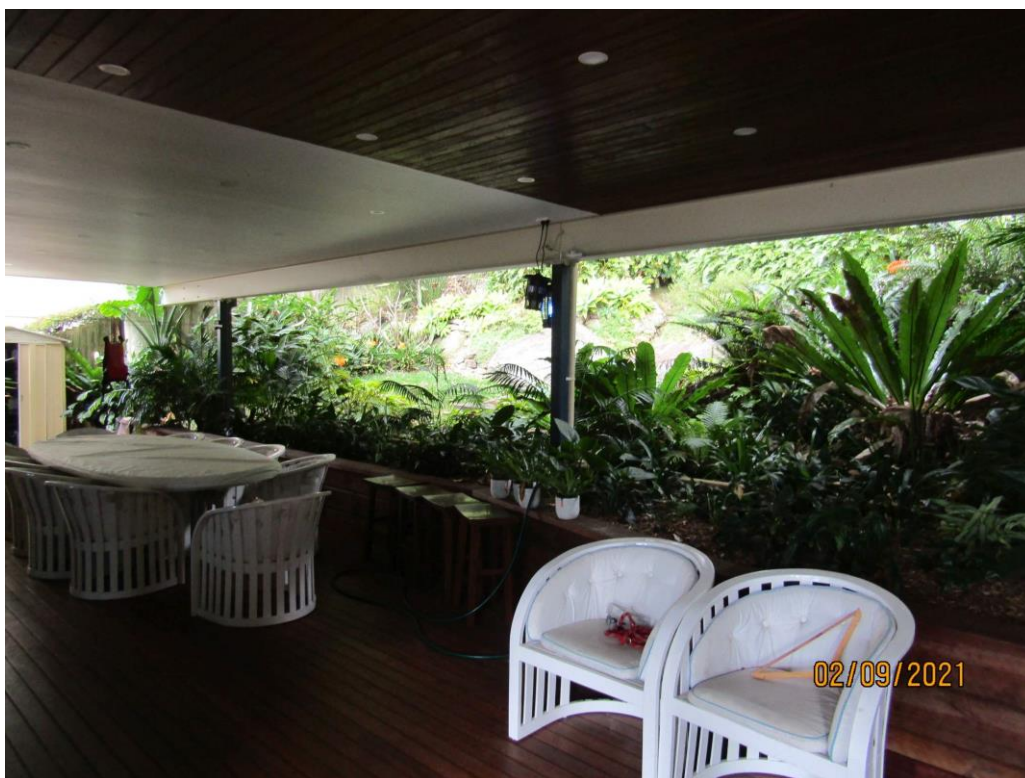
Photo 8

A timber deck extends off the uphill side of the house (Photo 8). The cut for the deck is supported by terraced low timber retaining walls (Photo 9). A steep bank is located above the cut (Photo 10). An intermittent watercourse runs down the property near the SE common boundary (Photo 11). The creek has been lined with rocks on the uphill side of the property. The creek runs under the SE side of the house. A concrete-lined channel runs under the house where this occurs (Photo 12). Sandstone joint blocks are embedded in stable positions in the slope on the uphill side of the house (Photo 13). The steep slope near the uphill property boundary is thickly vegetated

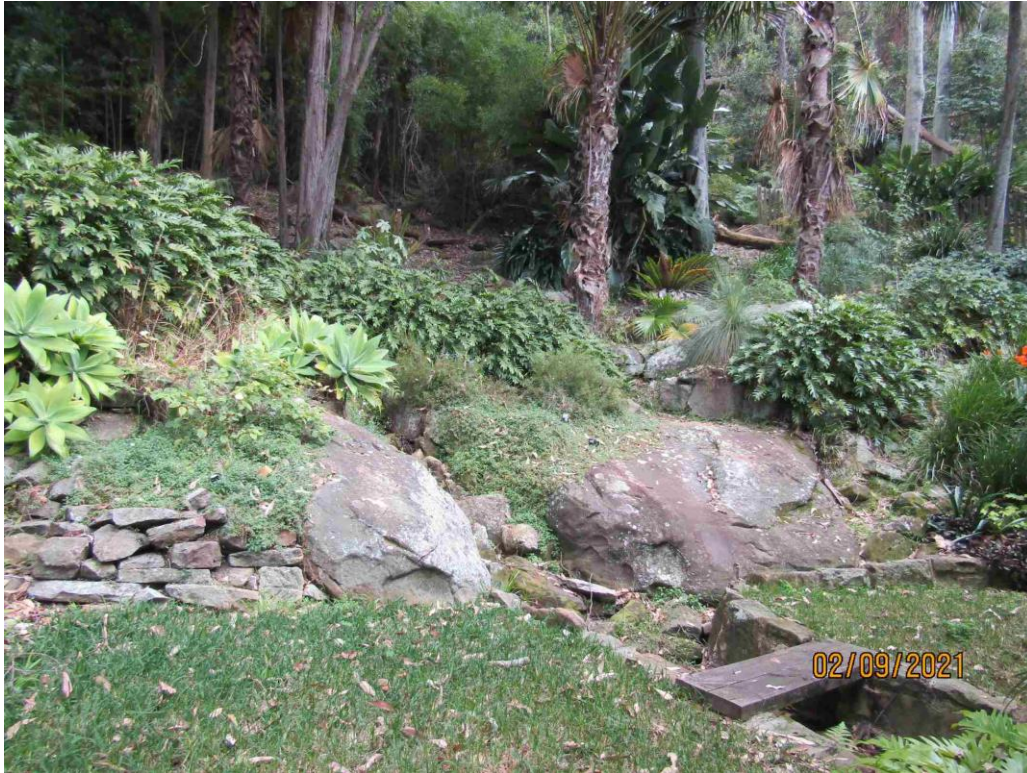
Photo 11

It is expected that sheet wash will move onto the site from above the property during heavy down pours and will flow towards the watercourse and into the concrete channel that runs underneath the house (Photos 11 & 12). Due to the steep slope above this is expected to flow at high velocities. No water was observed to be flowing in the watercourse during the time of inspection.

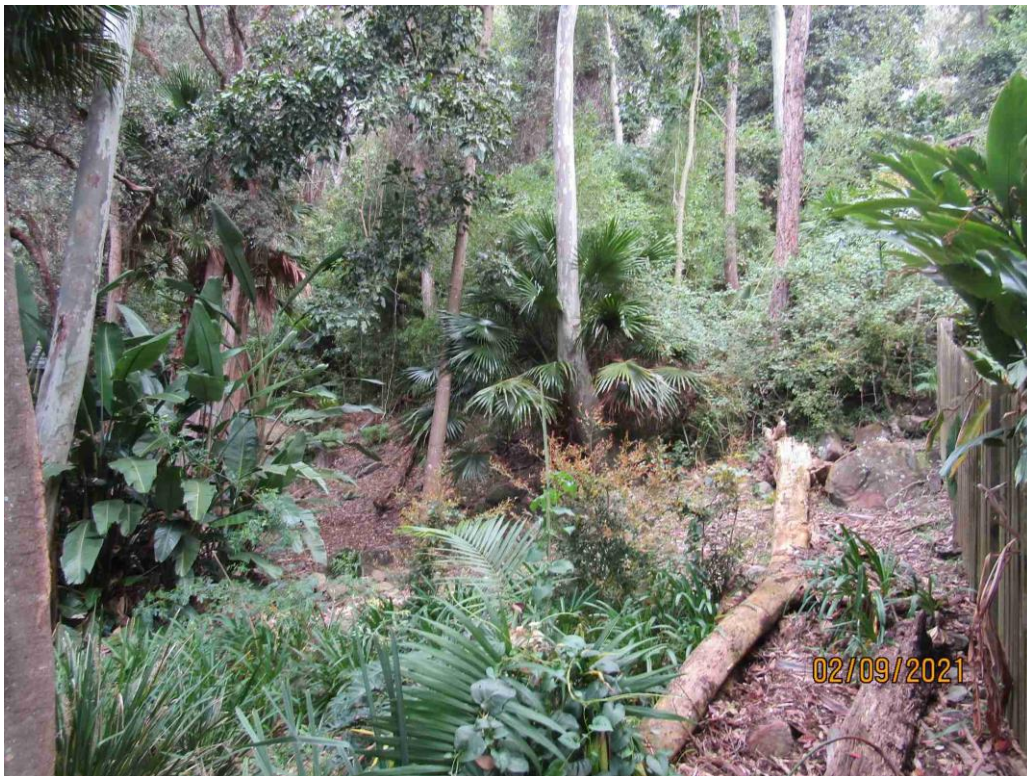
Photo 14

(Photo 14). The adjoining neighbouring properties were observed to be in good order as seen from the street and subject property.

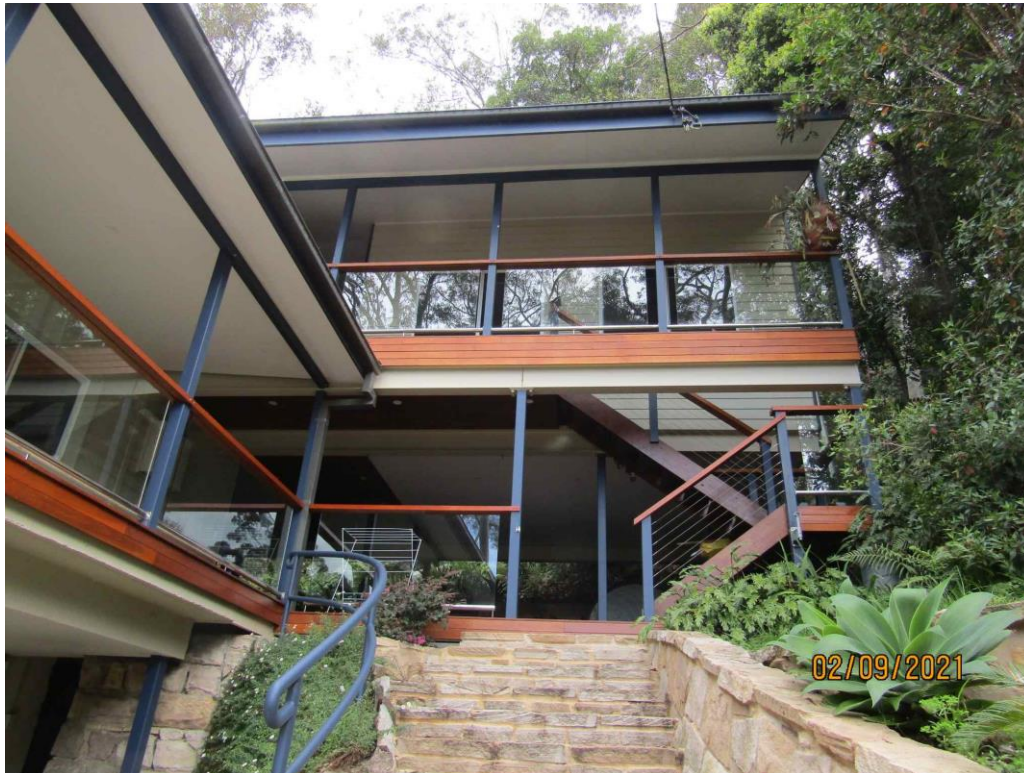
Photo 15

| HAZARDS | Hazard One | Hazard Two |
|---|---|---|
| TYPE | The steep slope that falls across the property and continues above and below failing and impacting on the property. | The proposed excavations for the garage, pool and lift collapsing onto the worksite, impacting the neighbouring properties and undercutting the subject decks and studio (Photo 15) during the excavation process. |

- The garage and pool excavation comes close to flush with the NW common boundary. The upper step comes flush with steel posts and a concrete pier supporting NW side of the existing steps, deck and studio roof (Photo 15). The middle step is set back ~0.6m from these structures.
- The lift excavation comes flush with the lower deck on the downhill side of the studio and steel posts supporting the upper deck and studio roof (Photo 15).

The NW common boundary, deck, steel posts and concrete pier will be within the zone of influence of the excavation. In this instance, the zone of influence is the area above a theoretical 30° line through fill/soil/sand and a theoretical 45° line through clay/weathered rock from the base of the excavation or the top of Medium Strength Rock, whichever comes first, towards the surrounding structures and boundaries.

Due to the depths of the excavations and the proximity to the nearby structures and NW property boundary, all sides of the excavations will require ground support installed prior to the commencement of the excavations. See the Lower Ground Floor Plan attached for the minimum extent of the required shoring shown in blue.

A spaced pile retaining wall is one of the suitable methods of support. Pier spacing is typically ~2.0m but can vary between 1.6 to 2.4m depending on the design. As the excavation is lowered in 1.5m lifts infill sprayed concrete panels or similar are added between the piers to form the wall. Drainage is installed behind the panels. To drill the pier holes for the walls, a

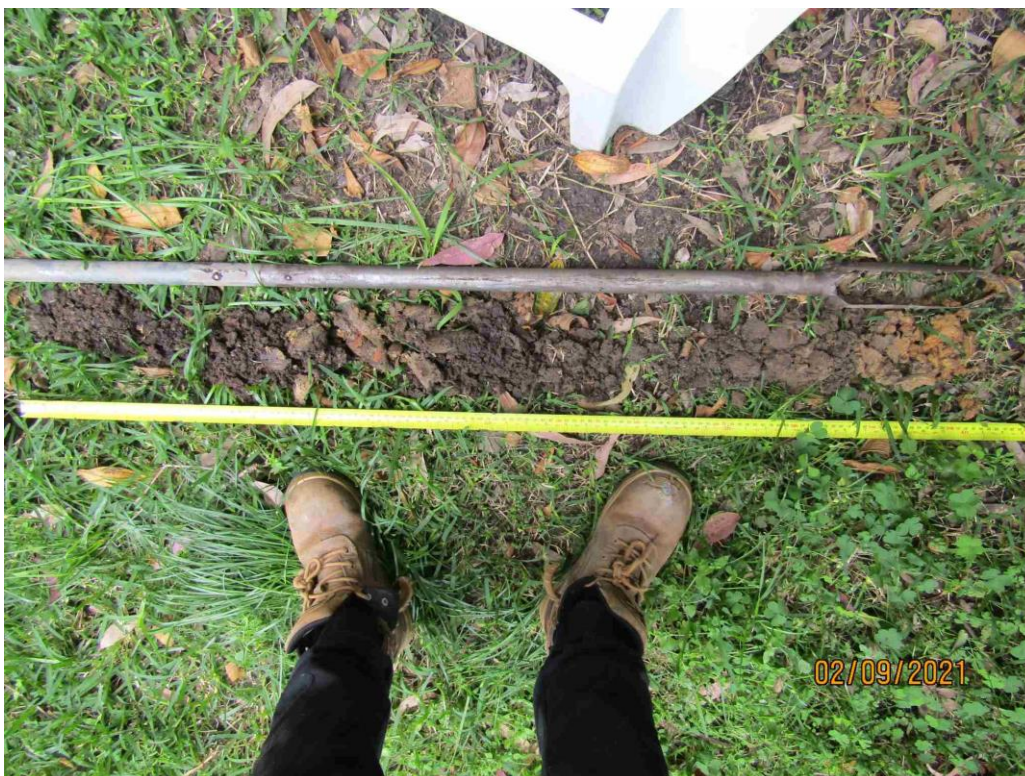
#### AUGER HOLE 1 (~RL40.8) – AH1 (photo 16)

| Depth (m) | Material Encountered |
|---|---|
| 0.0 to 0.9 | <b>FILL</b> , soil and clay, dark brown and brown orange, damp, fine to medium grained. |
| 0.9 to 1.1 | <b>SILTY SAND</b> , grey brown, damp, fine to medium grained. |
| 1.1 to 1.2 | <b>CLAY</b> , orange, firm to stiff, damp. |

End of Test @ 1.2m in firm to stiff clay. No watertable encountered.

Photo 16: AH1 – Downhole is from left to right.

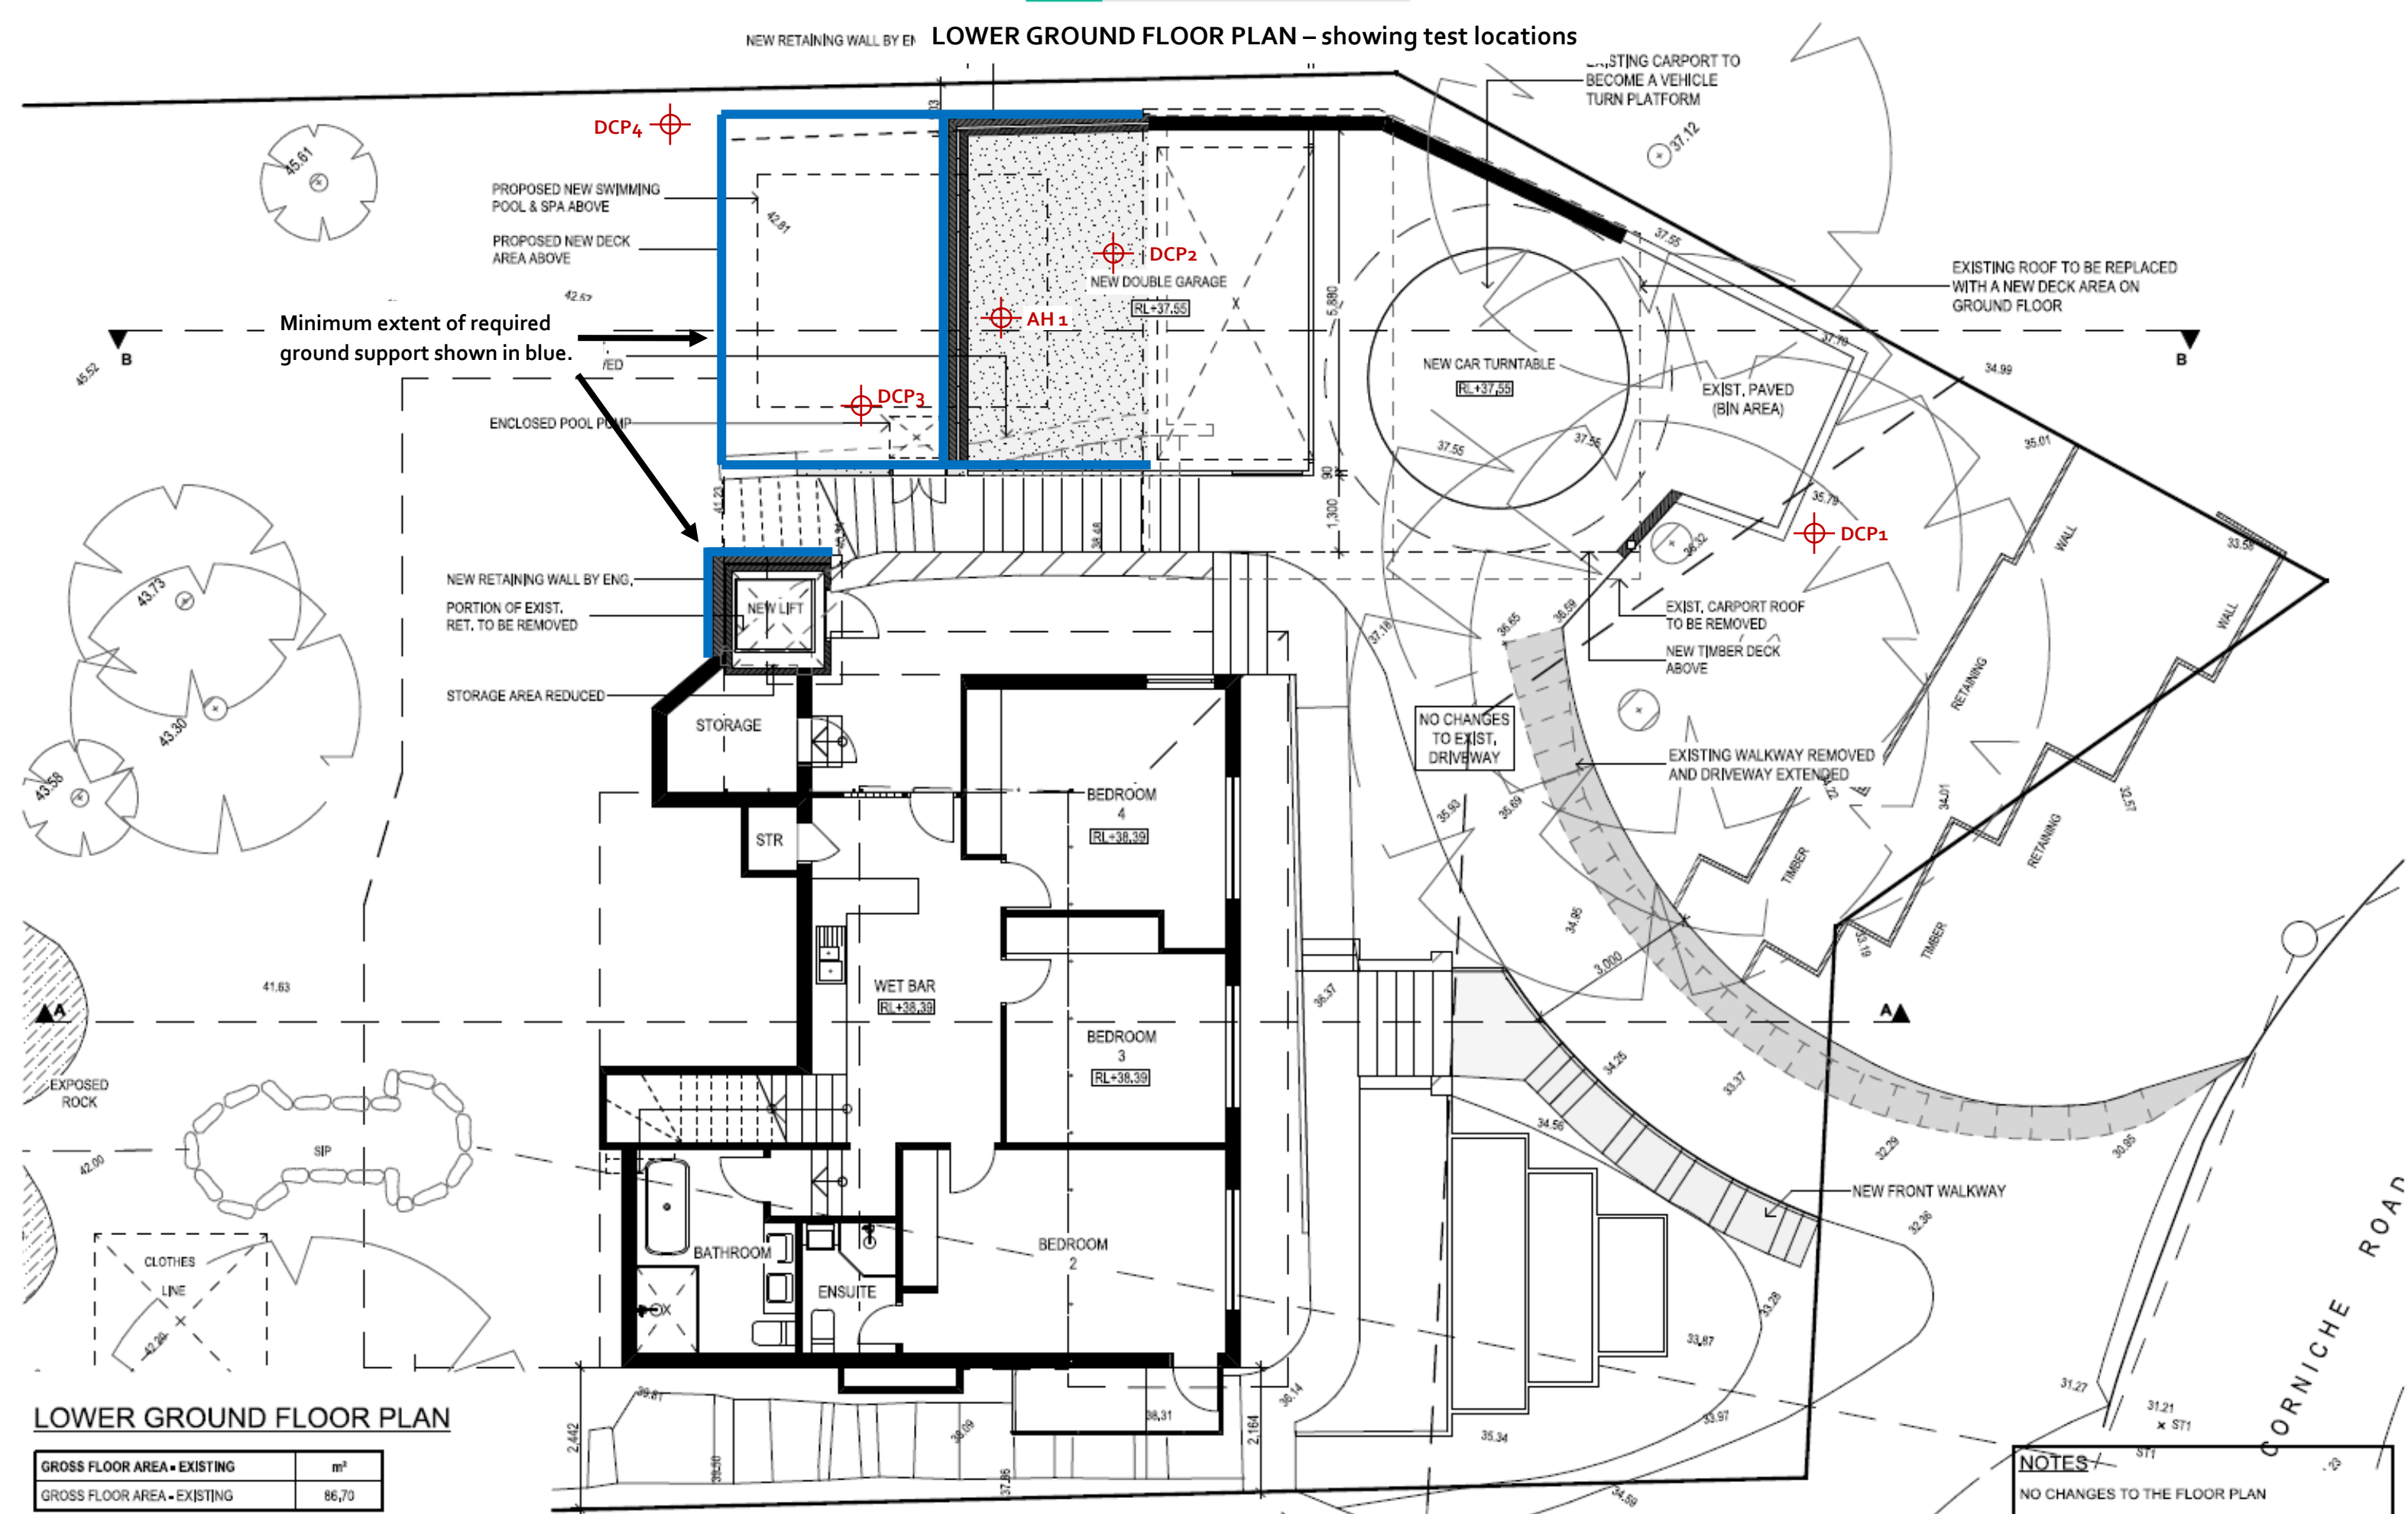
# NEW RETAINING WALL BY EN **LOWER GROUND FLOOR PLAN – showing test locations**

One hand auger hole (AH) was put down to identify the soil materials. Four Dynamic Cone Penetrometer (DCP) tests were put down to determine the relative density of the overlying soil and the depth to weathered rock. The locations of the tests are shown on the site plan. It should be noted that a level of caution should be applied when interpreting DCP test results. The test will not pass through hard buried objects so in some instances it can be difficult to determine whether refusal has occurred on an obstruction in the profile or on the natural rock surface. This may have occurred for DCP3. Due to the possibility that the actual ground conditions vary from our interpretation there should be allowances in the excavation and foundation budget to account for this. We refer to the appended "Important Information about Your Report" to further clarify. The results are as follows:

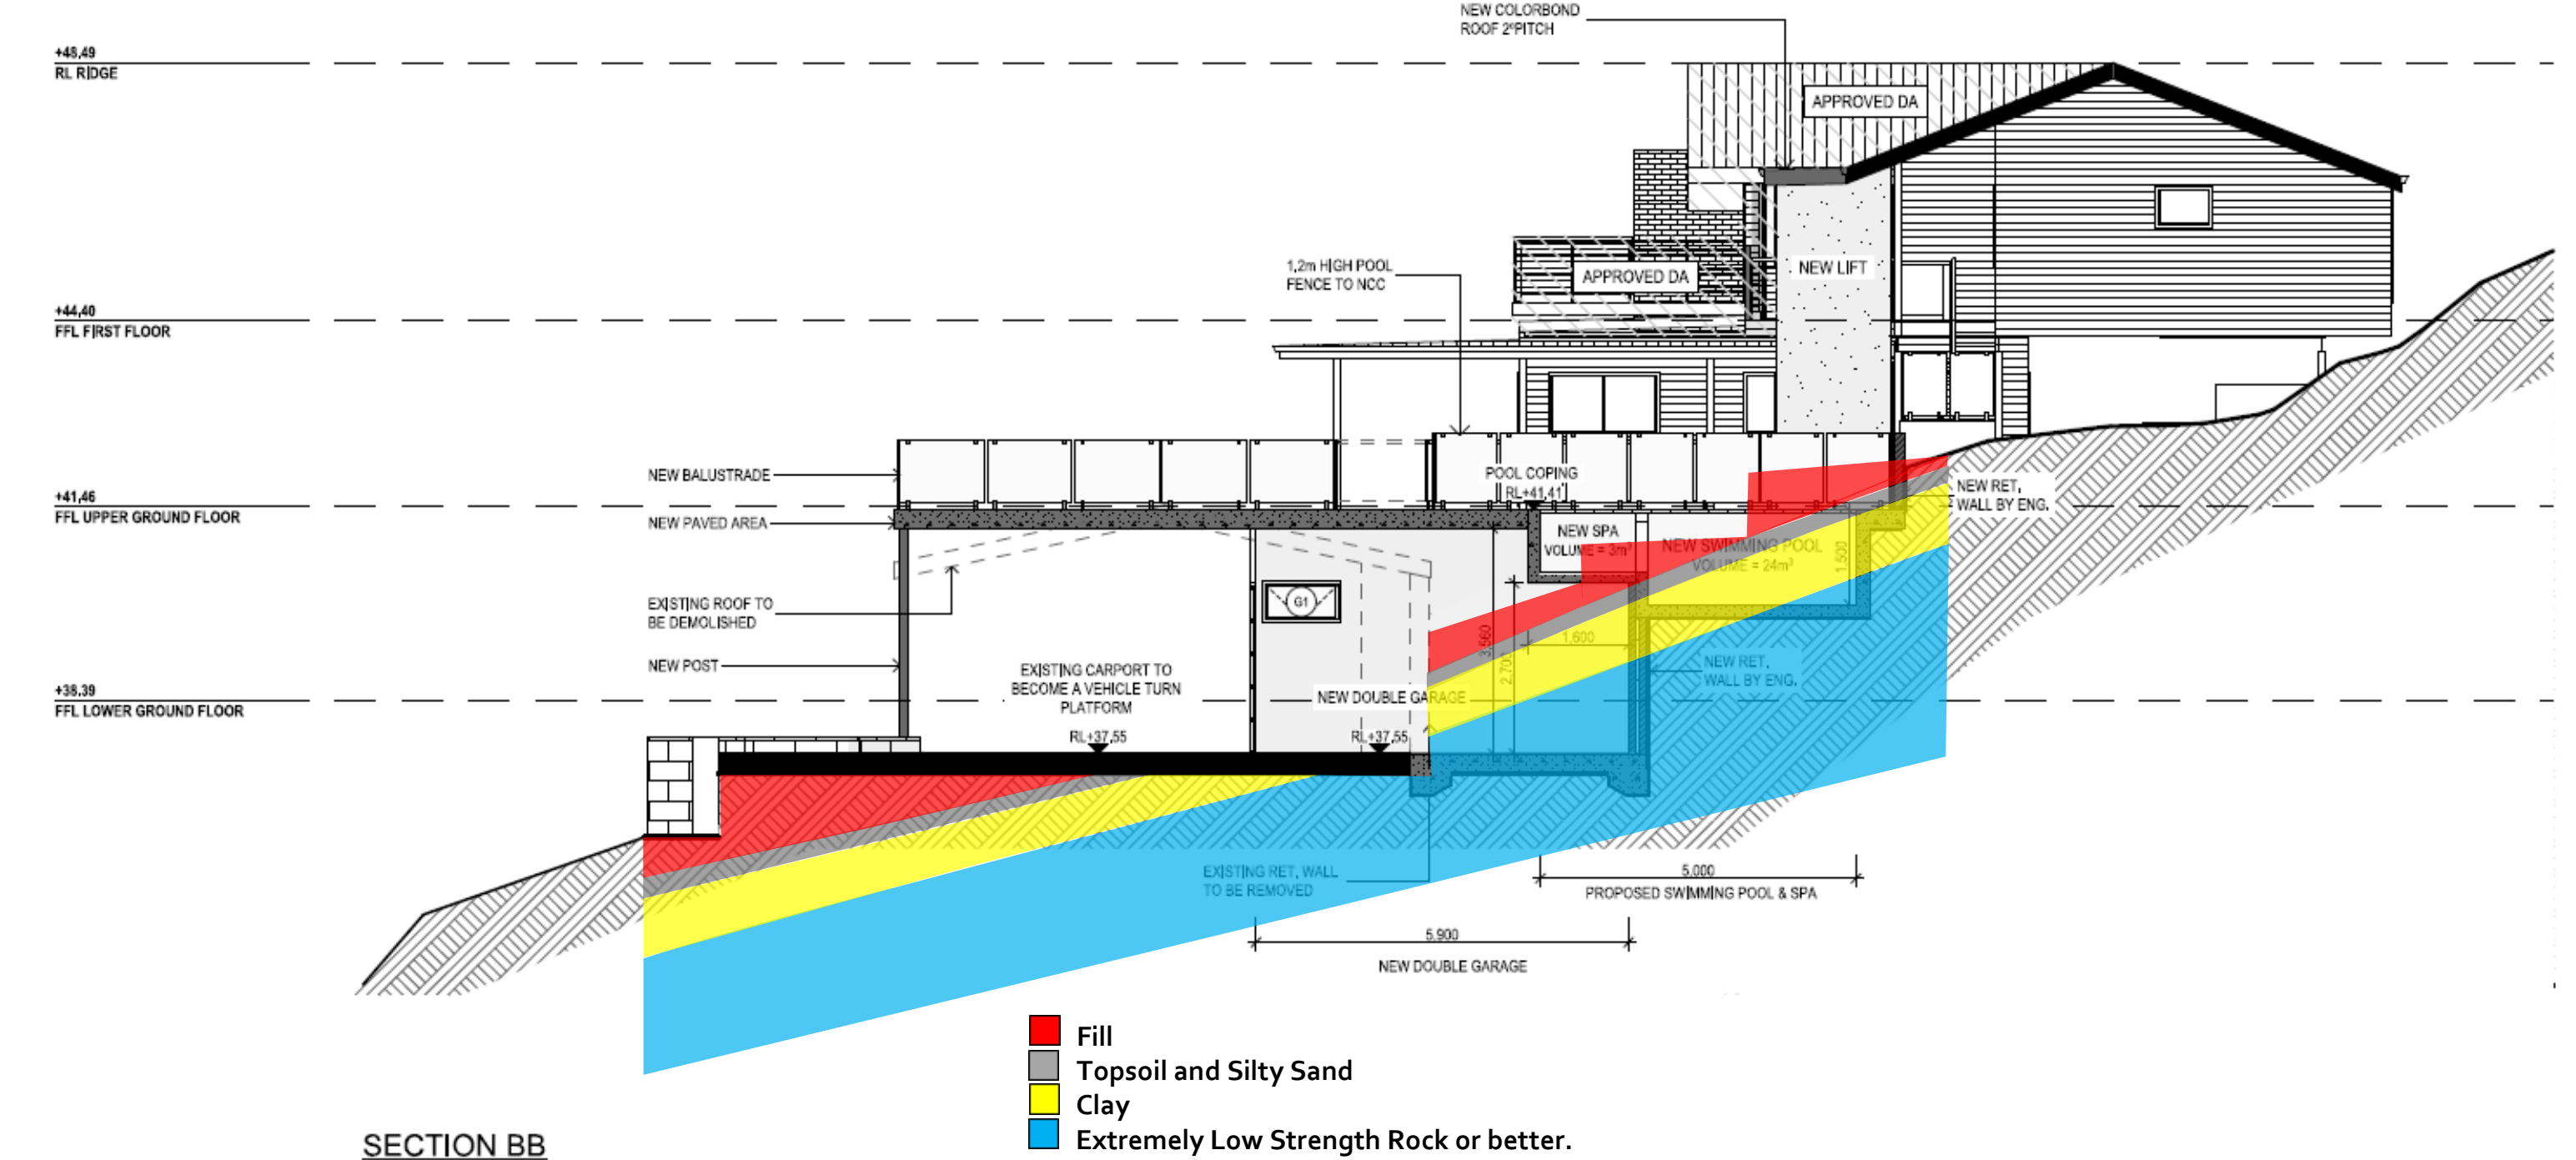
TYPE SECTION – Diagrammatical Interpretation of expected Ground Materials

to a maximum depth of ~1.5m provides level lawn and garden areas across the property. The clays merge into the weathered zone of the under lying rocks at depths from between ~1.1m to ~2.1m below the current surface. The weathered zone of the underlying rock is interpreted as Extremely Low Strength Rock or better. See Type Section attached for a diagrammatical representation of the expected ground materials.
