# Geotechnical Assessment

**Project:** Alterations & Additions  
77 Myola Road, Newport NSW

**Ref:** AG 24117  
19 April 2024

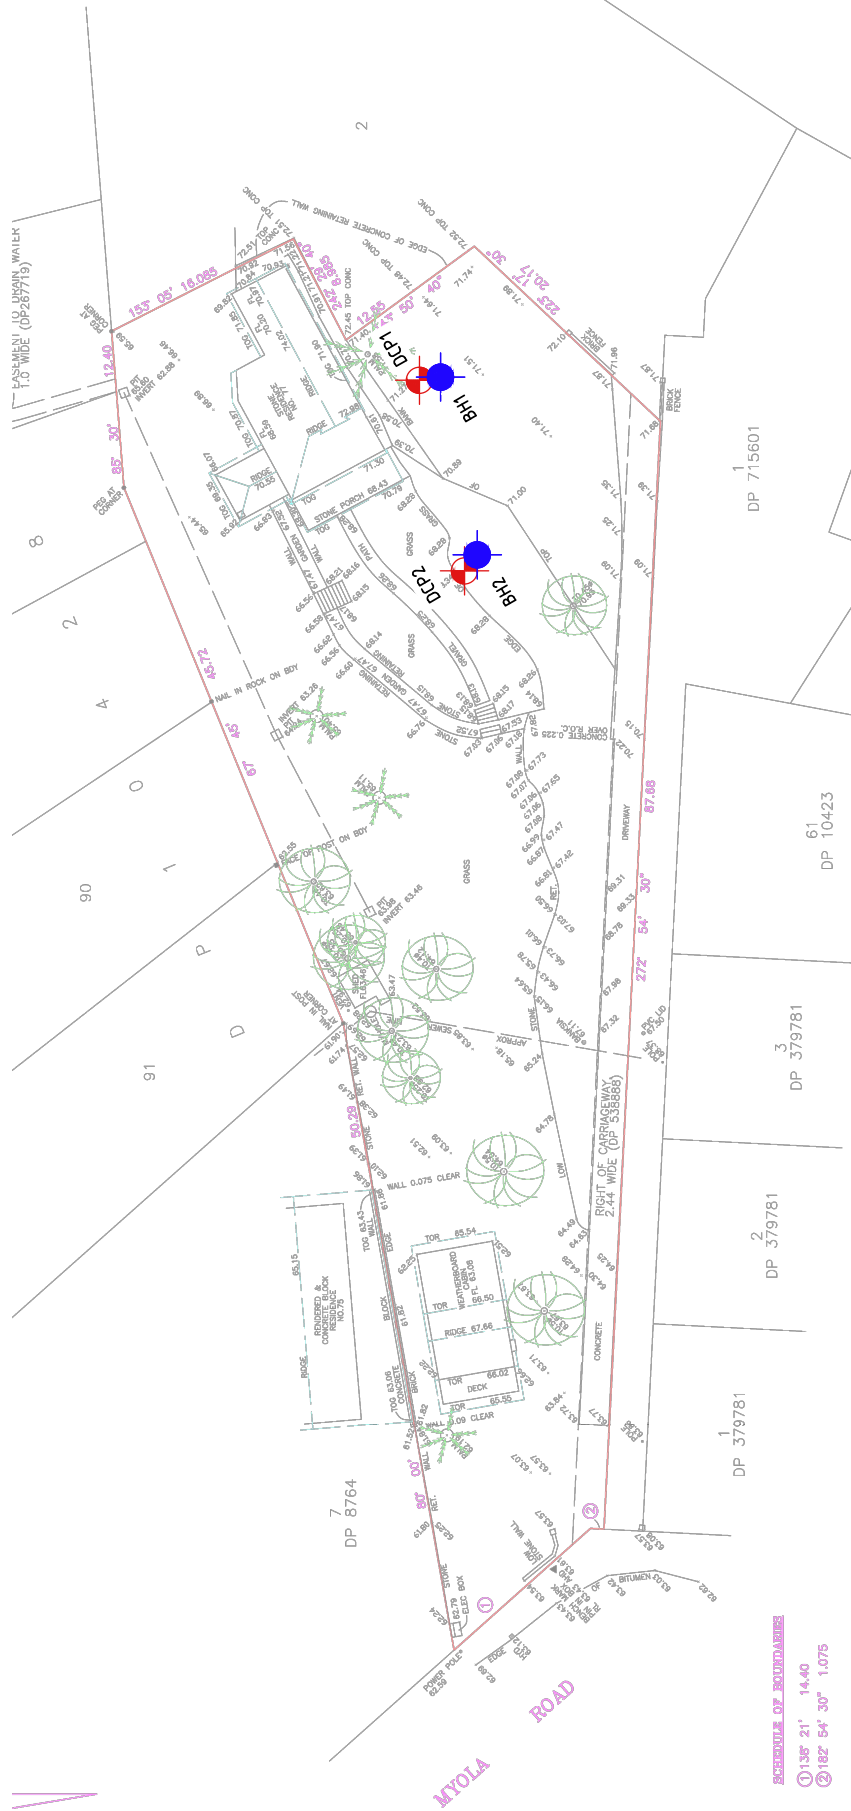
**SITE PLAN/GROUND TEST LOCATIONS**  
SCALE NTS

BOREHOLE LOCATIONS

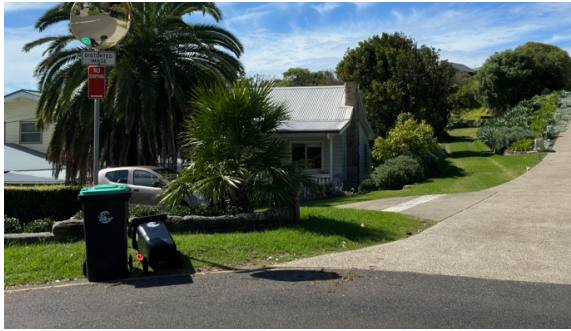
**Photo 1:** Property frontage, granny flat and lawn area, and lawn access driveway, looking east.

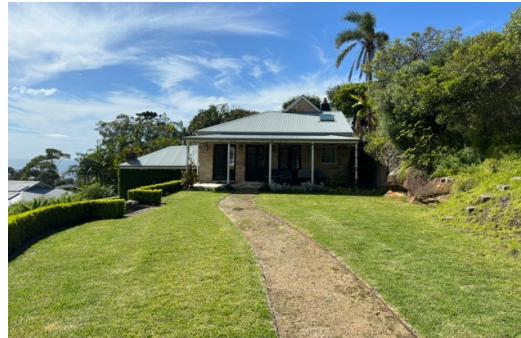
**Photo 2:** Front of existing dwelling, single storey sandstone block cottage with attached awning. Sandstone outcropping on the southern side of the dwelling, looking east.

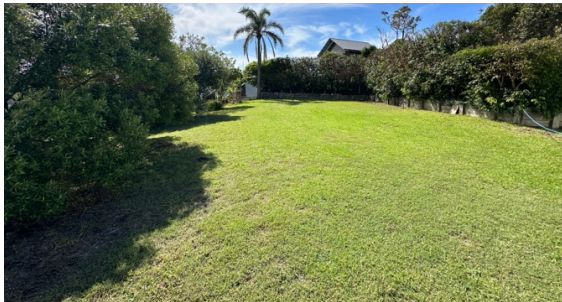
**Photo 3:** Site conditions of proposed works, lawn area with small shrubs and trees, looking east.

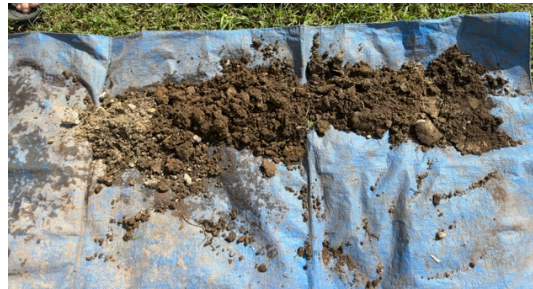
**Photo 4:** Subsurface soil profile of BH01.

Depth (m)	Water	Drilling Method	Testing	Graphic Log	Material Description	Classification Code	Consistency	Moisture	DCP graph
0.2					Fill Topsoil Silty SAND (SM) : moderately compacted, dark brown, medium grained, trace medium sized gravel, moist.	SM	MC	M	
0.4					Fill Silty SAND (SM) : brown, medium grained, with medium sized gravel, moist.	SM			
					Clayey SAND (SC) : medium dense, medium plasticity clay, brown, medium grained, with medium sized gravel, natural moist.	SC	MD		
1					<b>BH01 refusal at 0.8m (extremely weathered sandstone on auger teeth)</b>				
2
