Date 08.10.2024
 Project No 22026
 Client Jimmy and Mel Campbell
 90 Harbord Rd Freshwater 2096

Re: 90 Harbord Rd – Walls on boundary

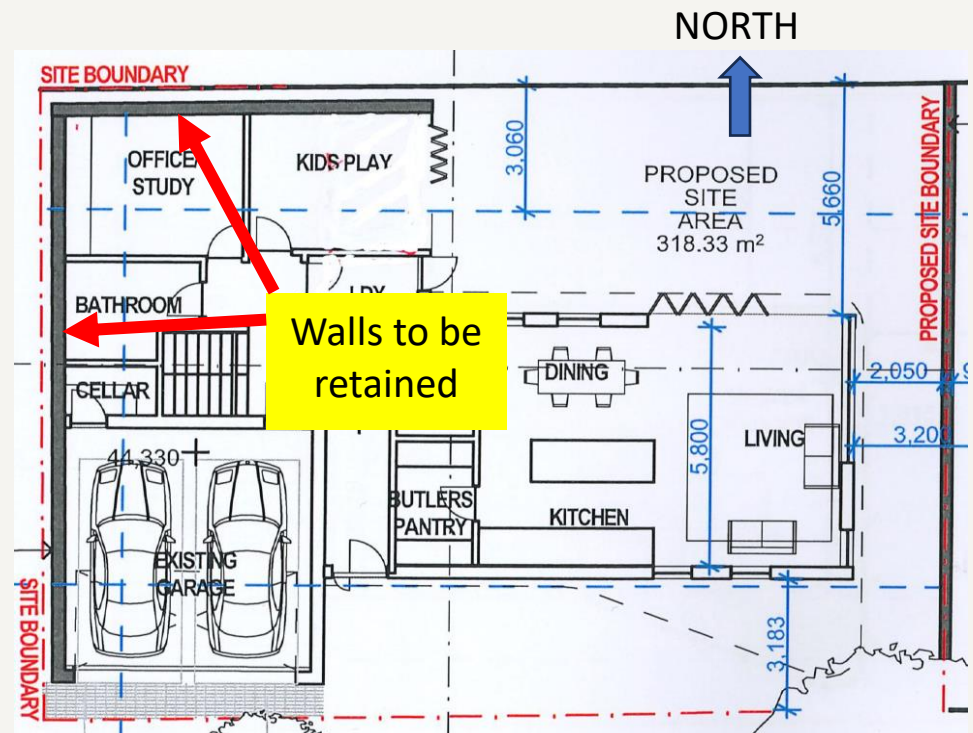
Fig.1. Ground Floor plan – Part SK100

Indicated on this plan are two walls proposed to be retained. These walls sit within a few hundred millimetres of the north and west boundaries of the property.

The DA documents show that proposed new Level 1 floors above are to be set in from the north and west boundaries by at least 1500mm.
