## **Geotechnical Assessment**

**Project:** Alterations and Additions  
65 Marine Parade, Avalon Beach NSW

**REF: AG 19229**  
23<sup>rd</sup> January, 2020

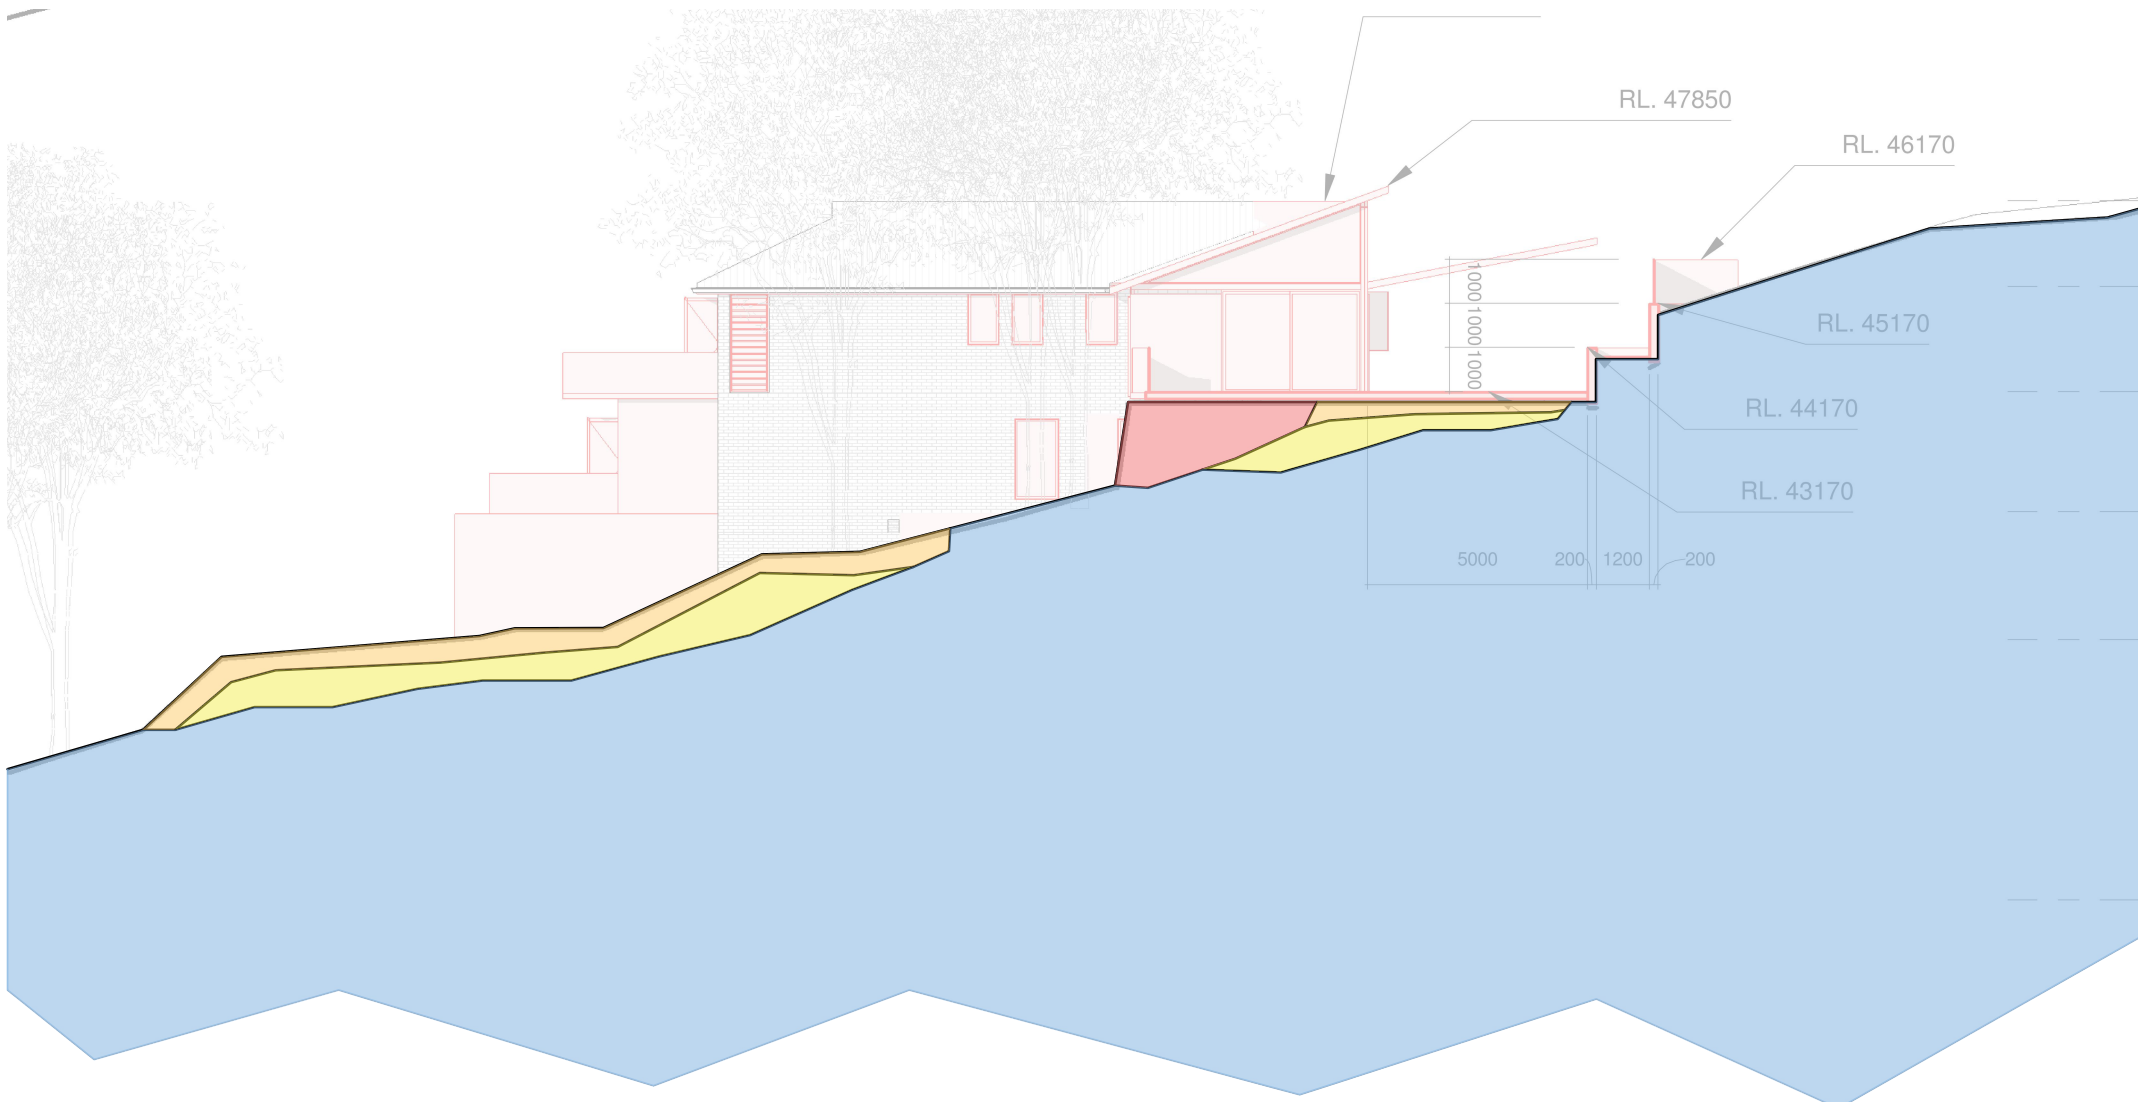
## INFERRED GEOLOGICAL SECTION

INTERPRETED SUBSURFACE SECTION ONLY.  
ACTUAL GROUND CONDITIONS MAY VARY.
