## **ARBORICULTURAL IMPACT ASSESSMENT**

39 CABBAGE TREE ROAD  
BAYVIEW

**OCTOBER 2019**

Prepared by  
Catriona Mackenzie IACA ACM2003005

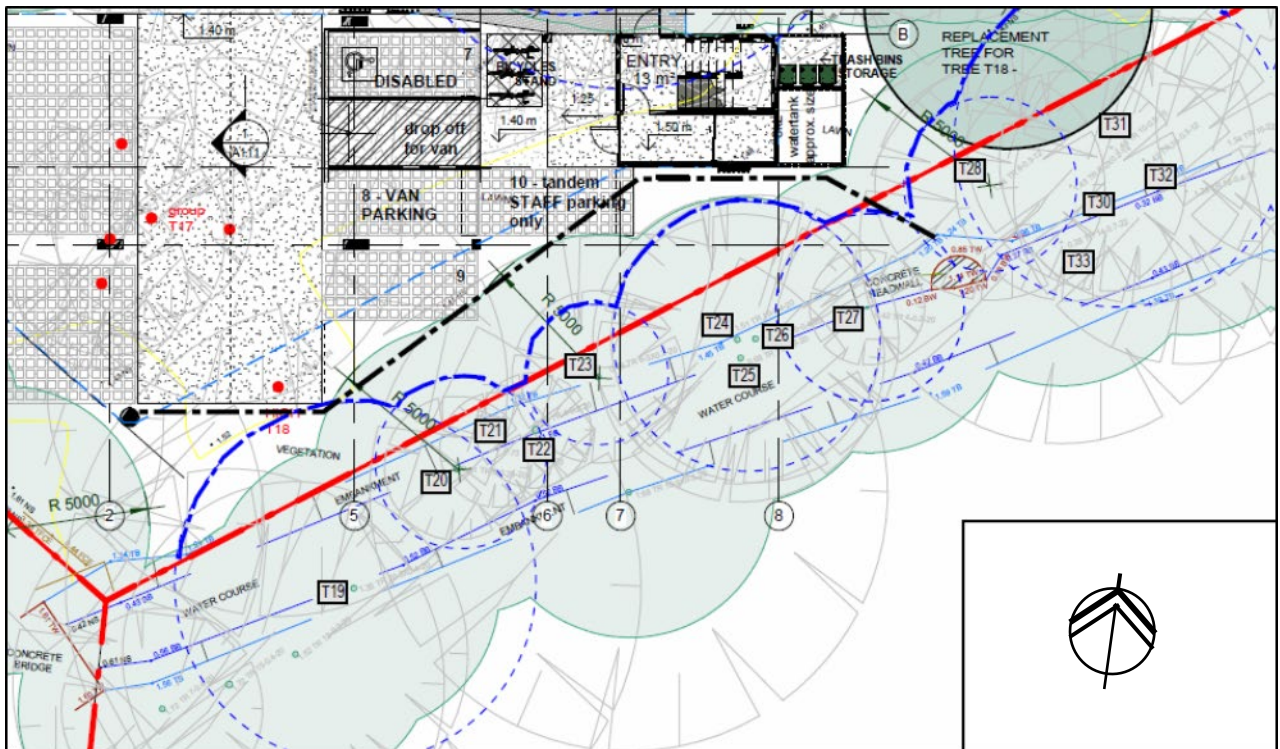
**Figure 1**

Illustrates the TPZ 's (dashed blue circles) of Trees 19 – 33 are outside the built footprint, with negligible encroachment into T19, T27 and T28 for stormwater pipe (black, dashed line) and will not be affected by the proposal, provided they are appropriately protected. Level 0 plan A103, dated 27/092019, marked up by C. Mackenzie.

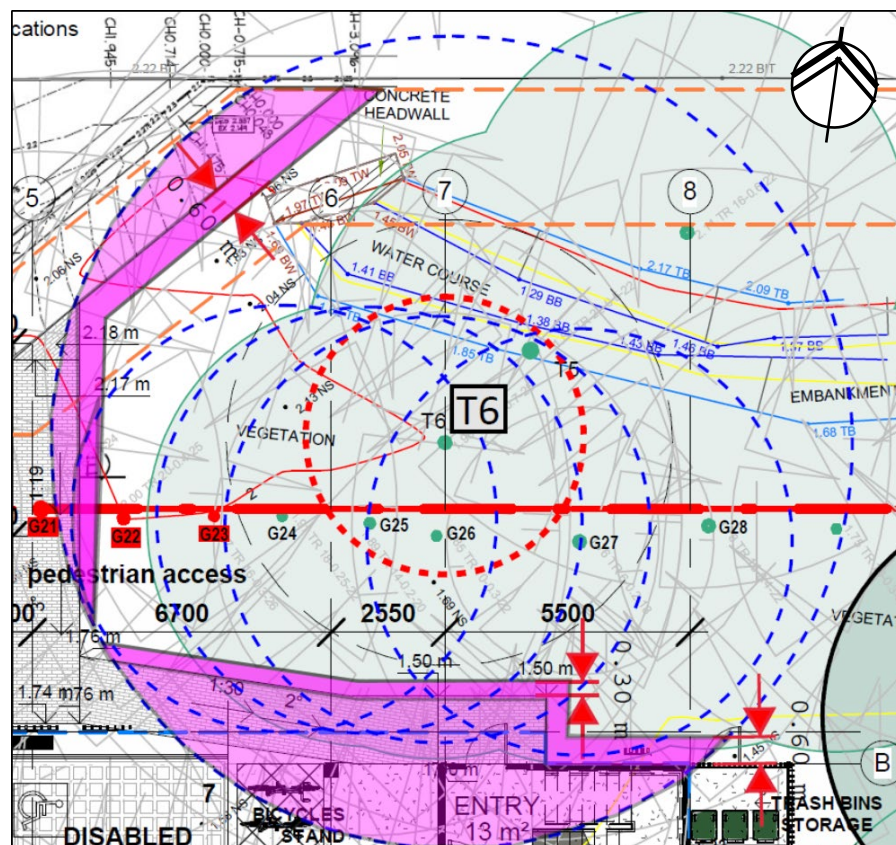
**Figure 2**

Illustrates the TPZ (outer, blue dashed circle) and SRZ (inner, red dashed circle) of T6 (Swamp Mahogany). The estimated encroachment into the notional TPZ is demonstrated by the pink shaded area, with an additional 300mm wide disturbance zone around the proposed path and low wall. (Numbers in red identify those River She-oaks proposed to be removed). Not to scale. Level 0 plan A103, dated 27/09/2019, marked up by C. Mackenzie.

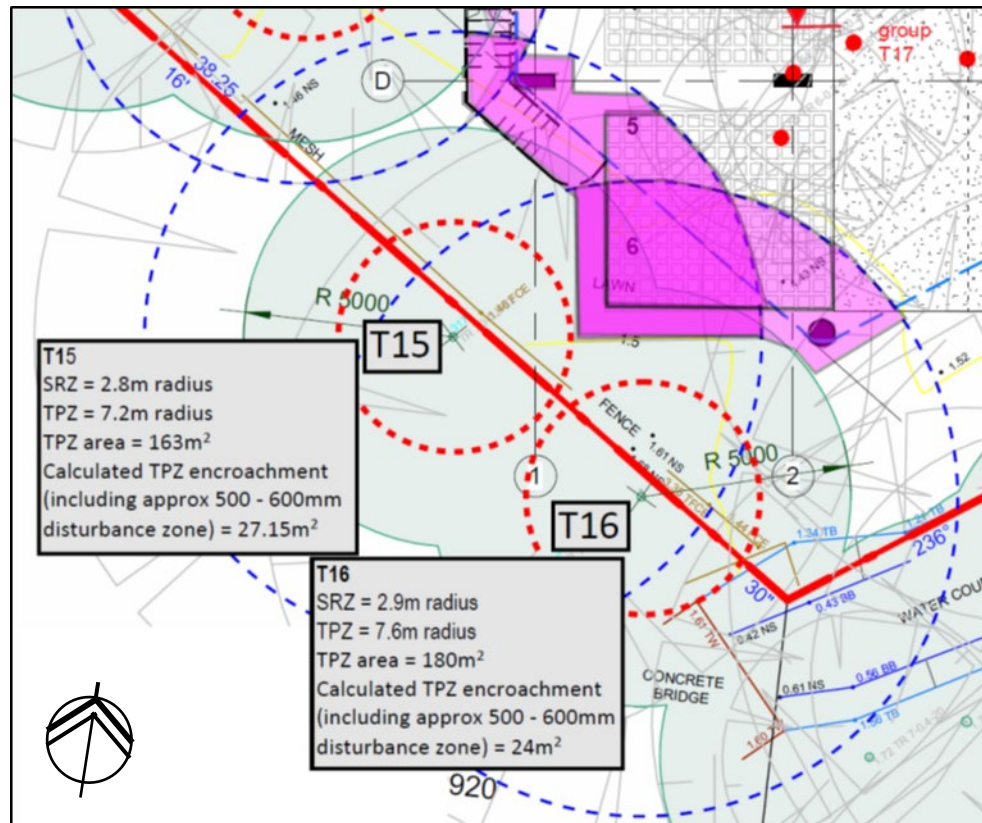
- Approximately 27.15m<sup>2</sup> (16.6%) of the notional TPZ is affected on plan (including a disturbance zone), see Figure 5.
- Broken down, this is:
  - 13.9m<sup>2</sup> (8.5%) for ground level changes for car parking area and support column within notional TPZ.
  - 13.2m<sup>2</sup> (8.1%) disturbance zone and fully elevated structure where non-woody roots can potentially occupy the disturbed/unbuilt upon soil area following construction.
- Given the above, the more realistic encroachment of the notional TPZ is likely to be in the vicinity of 14m<sup>2</sup>, equating to around 8.5%, which is in the low (minor) range of impact rating and supportable provided appropriate care is taken during construction to limit additional disturbances.

- Approximately 27m<sup>2</sup> (15%) of the notional TPZ is affected on plan (including a 300 – 500mm disturbance zone around footprint), see Figure 5.
- Broken down, this is:
  - 14.6m<sup>2</sup> (8.1%) for ground level changes for car parking area and support column within notional TPZ.
  - 9.3m<sup>2</sup> (5.2%) disturbance zone and fully elevated structure where non-woody roots can potentially occupy the disturbed/unbuilt upon soil area following construction.
- Given the above, the more realistic encroachment of the notional TPZ is likely to be in the vicinity of 15m<sup>2</sup>, equating to around 8.3%, which is in the low (minor) range of impact rating and supportable provided appropriate care is taken during construction to limit additional disturbances.

**Figure 5**  
 Illustrates the TPZ and SRZ of Trees 15 and 16 (Swamp Mahoganies)  
 The pink shaded areas identify the approximate location of fully elevated structures with shallow excavation at ground level to provide a level parking area, including a disturbance zone around a concrete pillar and parking area.  
 Not to scale. Level 0 plan A103, dated 27/09/2019, marked up by C. Mackenzie.

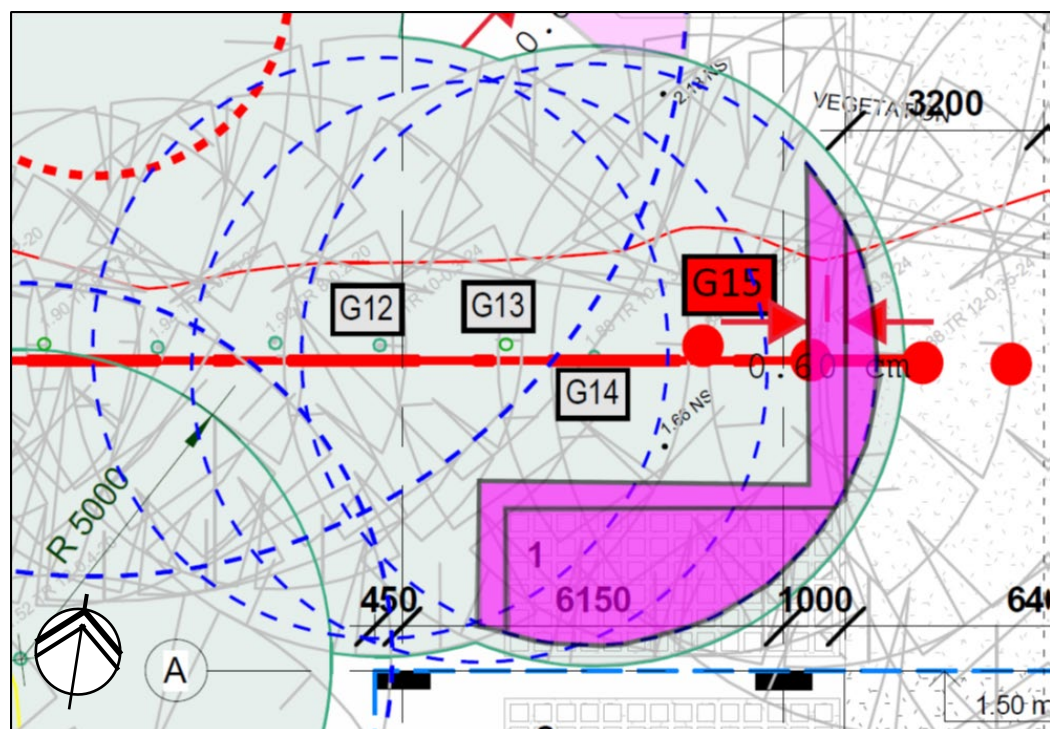
- Approximately 16.6m<sup>2</sup> (23%) of the notional TPZ is affected on plan (including a 300mm disturbance zone), see Figure 6.
- Broken down, this is:
  - 10.5m<sup>2</sup> (14.5%) for ground level changes for car parking area and driveway within notional TPZ.
  - 6.1m<sup>2</sup> (8.5%) disturbance zone and fully elevated structure where non-woody roots can potentially occupy the disturbed/unbuilt upon soil area following construction.
- Given the above, the more realistic encroachment of the notional TPZ is likely to be in the vicinity of 15m<sup>2</sup>, equating to around 15-20%, which is in the moderate range of impact rating. This encroachment is supportable provided appropriate care is taken during construction to limit additional disturbances.

**Figure 6**  
 Illustrates the TPZ's of Trees G12 – G14 (River She-oaks to be retained). The pink shaded area identifies the encroachment including up to 600mm disturbance zone for driveway and car parking works. Note trees in red are those proposed to be removed. Not to scale. Level 0 plan A103, dated 27/09/2019, marked up by C. Mackenzie.

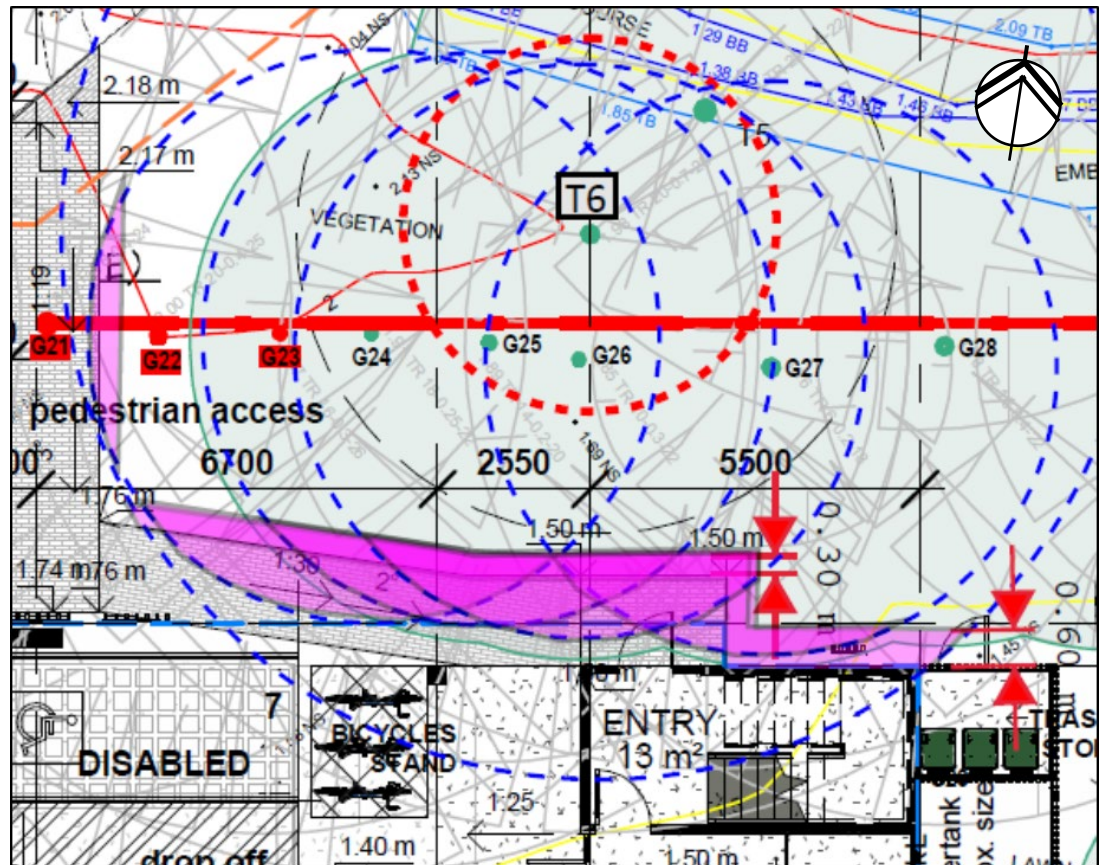
**Figure 7**

- Approximately 8.7m<sup>2</sup> (12.1%) of the notional TPZ is affected on plan (including a 300mm disturbance zone), see Figure 7.
- Broken down, this is:
  - 5.5m<sup>2</sup> (7.6%) for low retaining wall and path within notional TPZ.
  - 3.3m<sup>2</sup> (4.5%) disturbance zone where non-woody roots can potentially occupy the disturbed/unbuilt upon soil area following construction of the retaining wall.
- Given the above, the more realistic encroachment of the notional TPZ is likely to be in the vicinity of 5.5m<sup>2</sup>, equating to around 7.6%, which is in the low (minor) range of impact rating. This encroachment is supportable provided appropriate care is taken during construction to limit additional disturbances.

Illustrates the TPZ's of Trees G24 – G27 (River She-oaks). The pink shaded area identifies the encroachment including up to 300mm disturbance zone for pedestrian path works and 600mm from building alignment. (Note trees in red are those proposed to be removed.)
