J3391A. 31st January, 2022. Page 1.

GEOTECHNICAL INVESTIGATION:

Additions and Alterations at 1 Kanimbla Crescent, Bilgola Plateau

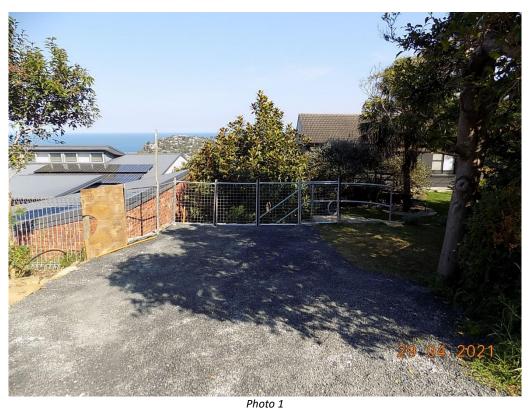
2.3 At the road frontage, a gravel driveway runs to a parking area on the uphill side of the property (Photo 1). The slope between the road frontage and the house has been terraced with a series of stable stack rock retaining walls, reaching ~1.5m high (Photo 2). One of these walls was observed to be partially supported directly onto outcropping Medium Strength Sandstone (Photo 3). The part two-storey brick house is supported on brick walls and steel posts. The supporting walls show no significant signs of movement and the supporting posts stand vertical (Photo 4). A stable stack rock wall reaching ~1.2m high and lining the E neighbouring boundary supports the cut for the neighbouring property. A moderate to steeply sloping lawn falls to the lower boundary. A large dislodged sandstone joint block was observed to be sitting in a stable position on the slope under the W side of the house (Photo 6).
