**GEOTECHNICAL RISK MANAGEMENT POLICY FOR PITTWATER
FORM NO. 1 – To be submitted with Development Application**

Report Title: Report to David Royle on Geotechnical Assessment for Proposed Subdivision at 24 Bungan Head Road and 7 Bushrangers Hill, Newport, NSW

**REPORT TO
DAVID ROYLE**

**ON
GEOTECHNICAL ASSESSMENT
(In Accordance with Pittwater Council Risk
Management Policy)**

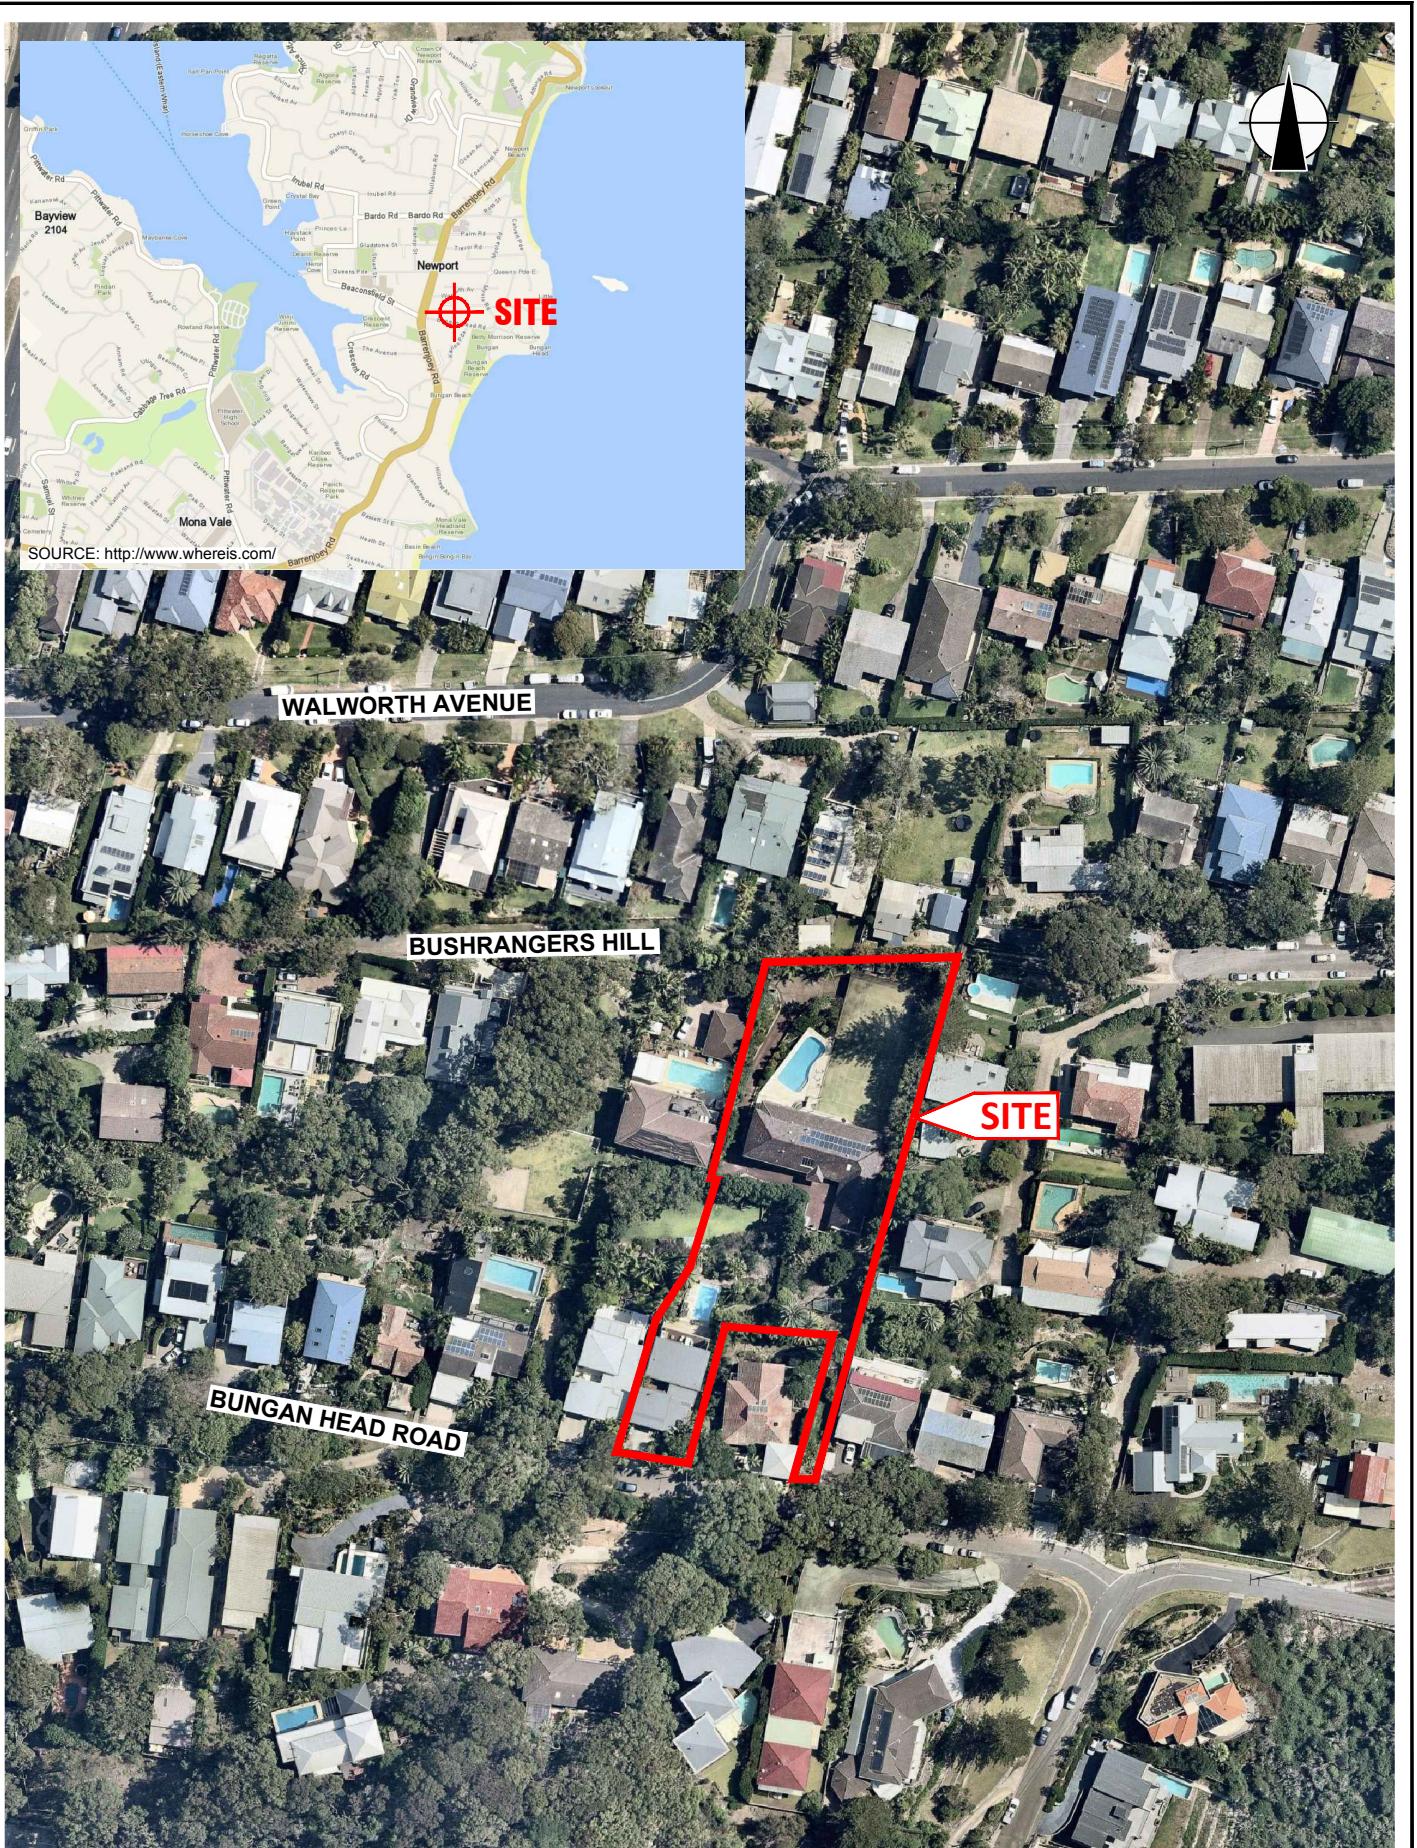
The attached Figure 2 presents a geotechnical sketch plan showing the principal geotechnical features present at the site. Figure 2 is based on the survey plan prepared by Mepstead and Associates (Dwg No. 5800-DET1, Issue A, dated 27 November 2019). Additional features on Figure 1 have been measured by hand held inclinometer and tape measure techniques and hence are only approximate. Should any of the features be critical to the proposed development, we recommend they be located more accurately using

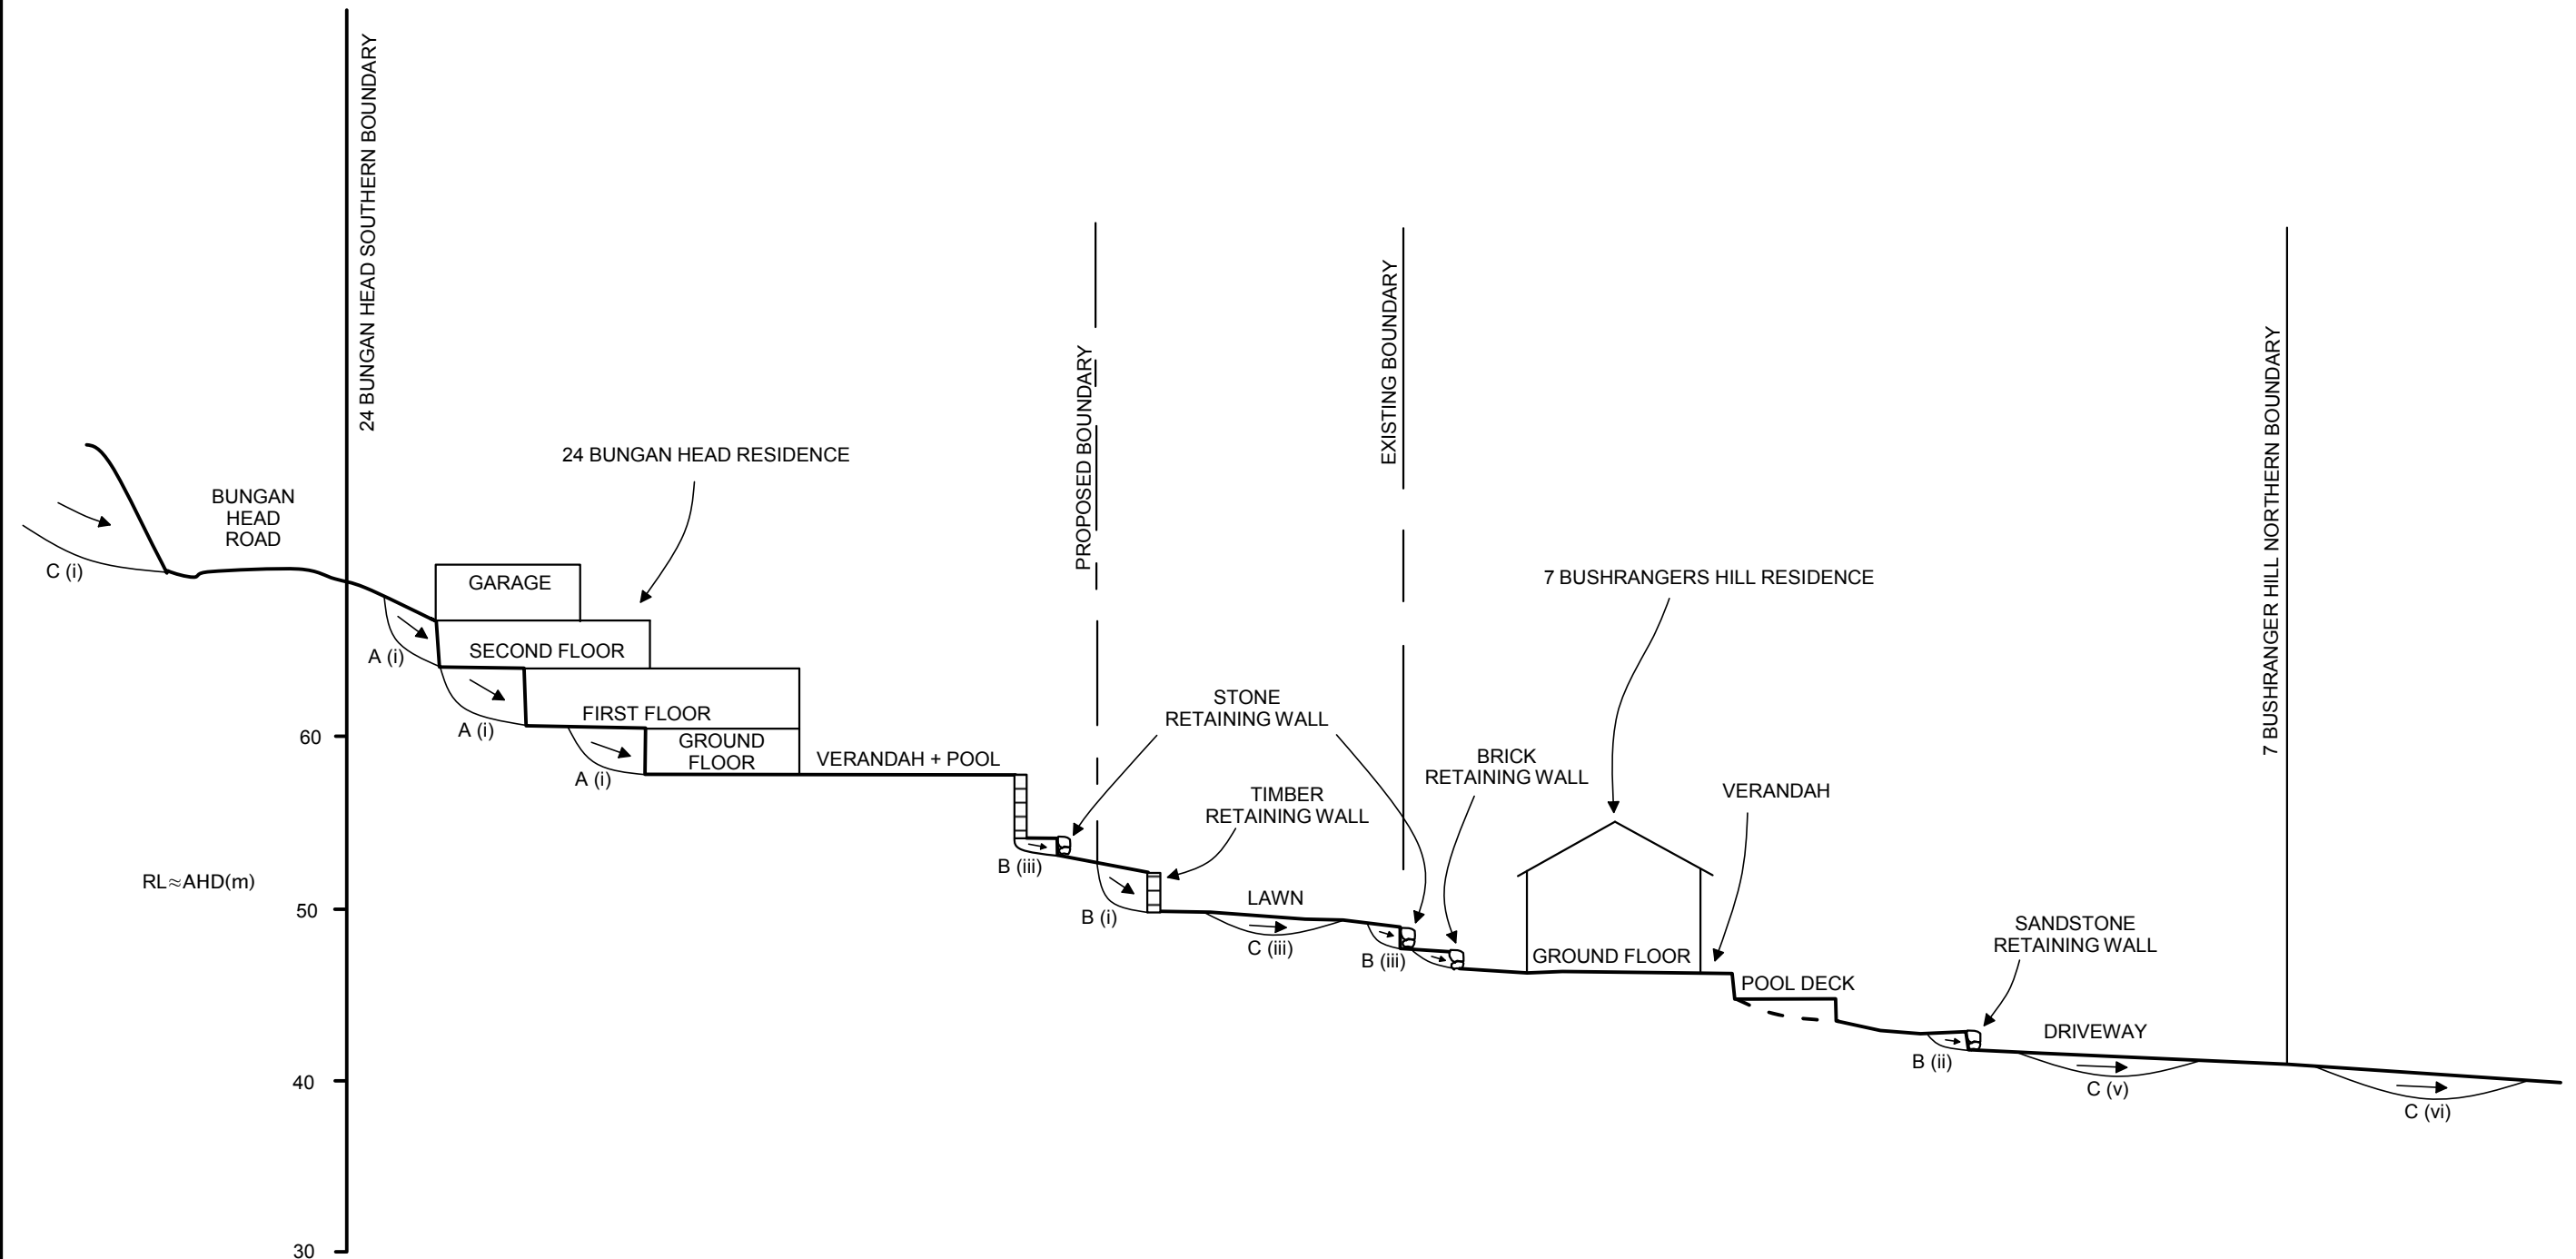
**GEOTECHNICAL SKETCH SECTION
SHOWING POTENTIAL LANDSLIDE HAZARDS**

These potential hazards are indicated in schematic form where possible on the attached Figure 3.
