REPORT ON GEOTECHNICAL SITE ASSESSMENT

PROPOSED ALTERATIONS AND ADDITIONS

74 BOWER STREET, MANLY

Project No.: 2018-182

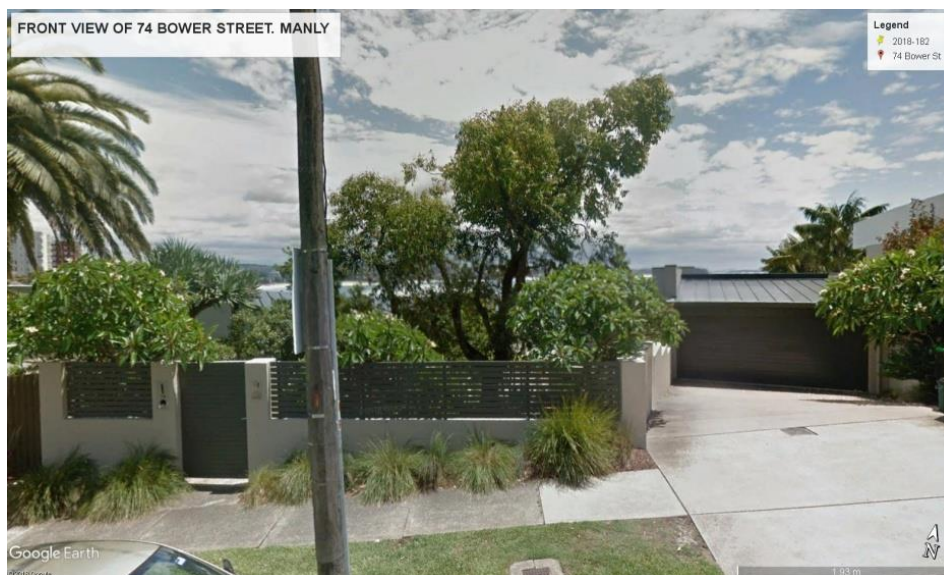
A gently north dipping concrete paved driveway within the front south eastern portion of the site, leads from Bower Street to a double lock up garage located adjacent to the south eastern house corner, at first floor level as shown in the picture below. The western side of the driveway is formed with a stepped, up to 1.50m high concrete wall which is in good condition with no signs of any cracking or settlement.

Picture 2: Front of site, looking north

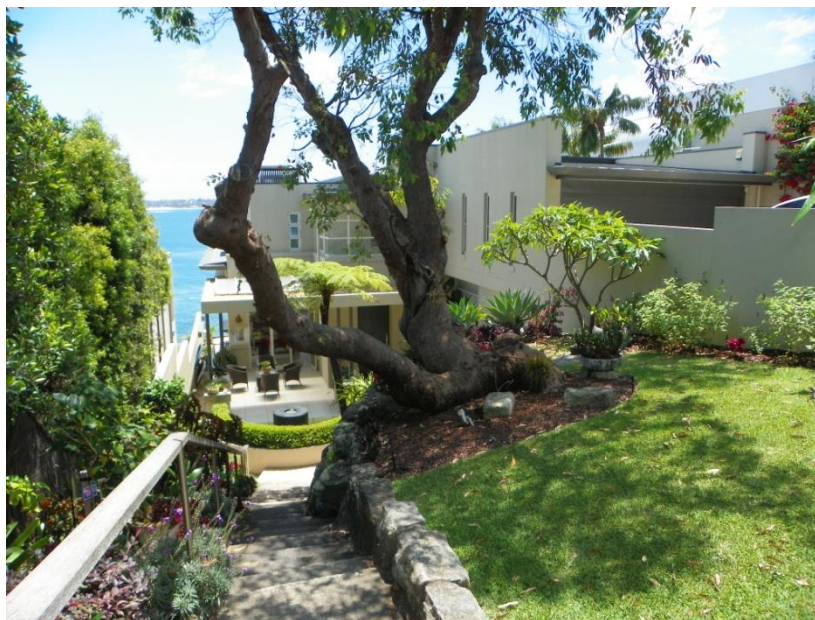
Picture 3: Front view of existing house, looking north from front entrance

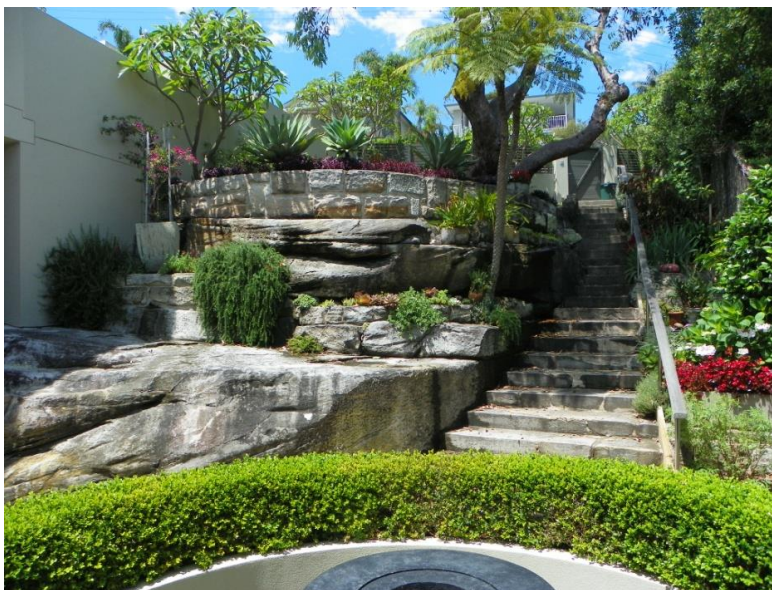
Picture 4: South western portion at front of site, looking south from ground level

The raised lawn is retained by a low (<0.50m) mortared sandstone block wall along the north and west side which is founded off massive sandstone bedrock of medium to high strength. The raised garden beds along the west side boundary are retained by low (<0.50m) stone walls at various levels. All the retaining walls are in good condition with no obvious signs of any movement or settlement.

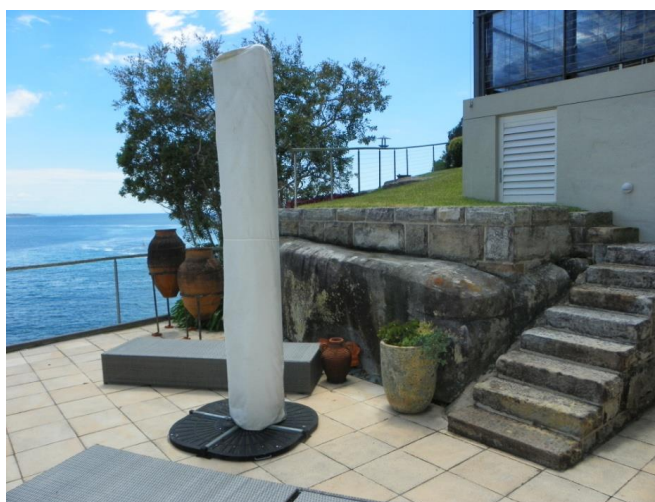
Picture 5: Raised lawn at rear of the site, looking north east from rear courtyard

The bedrock outcropping within the rear portion of the site and over the cliff face adjacent to the rear north boundary is characterised as slightly to moderately weathered sandstone of medium to high strength containing sub horizontal bedding defects dipping at 5° to 10° to the south. These bedding defects do not intersect with any persistent sub vertical joints therefore there are no unstable blocks of rock which can potentially topple/slide down and create any instability hazard.

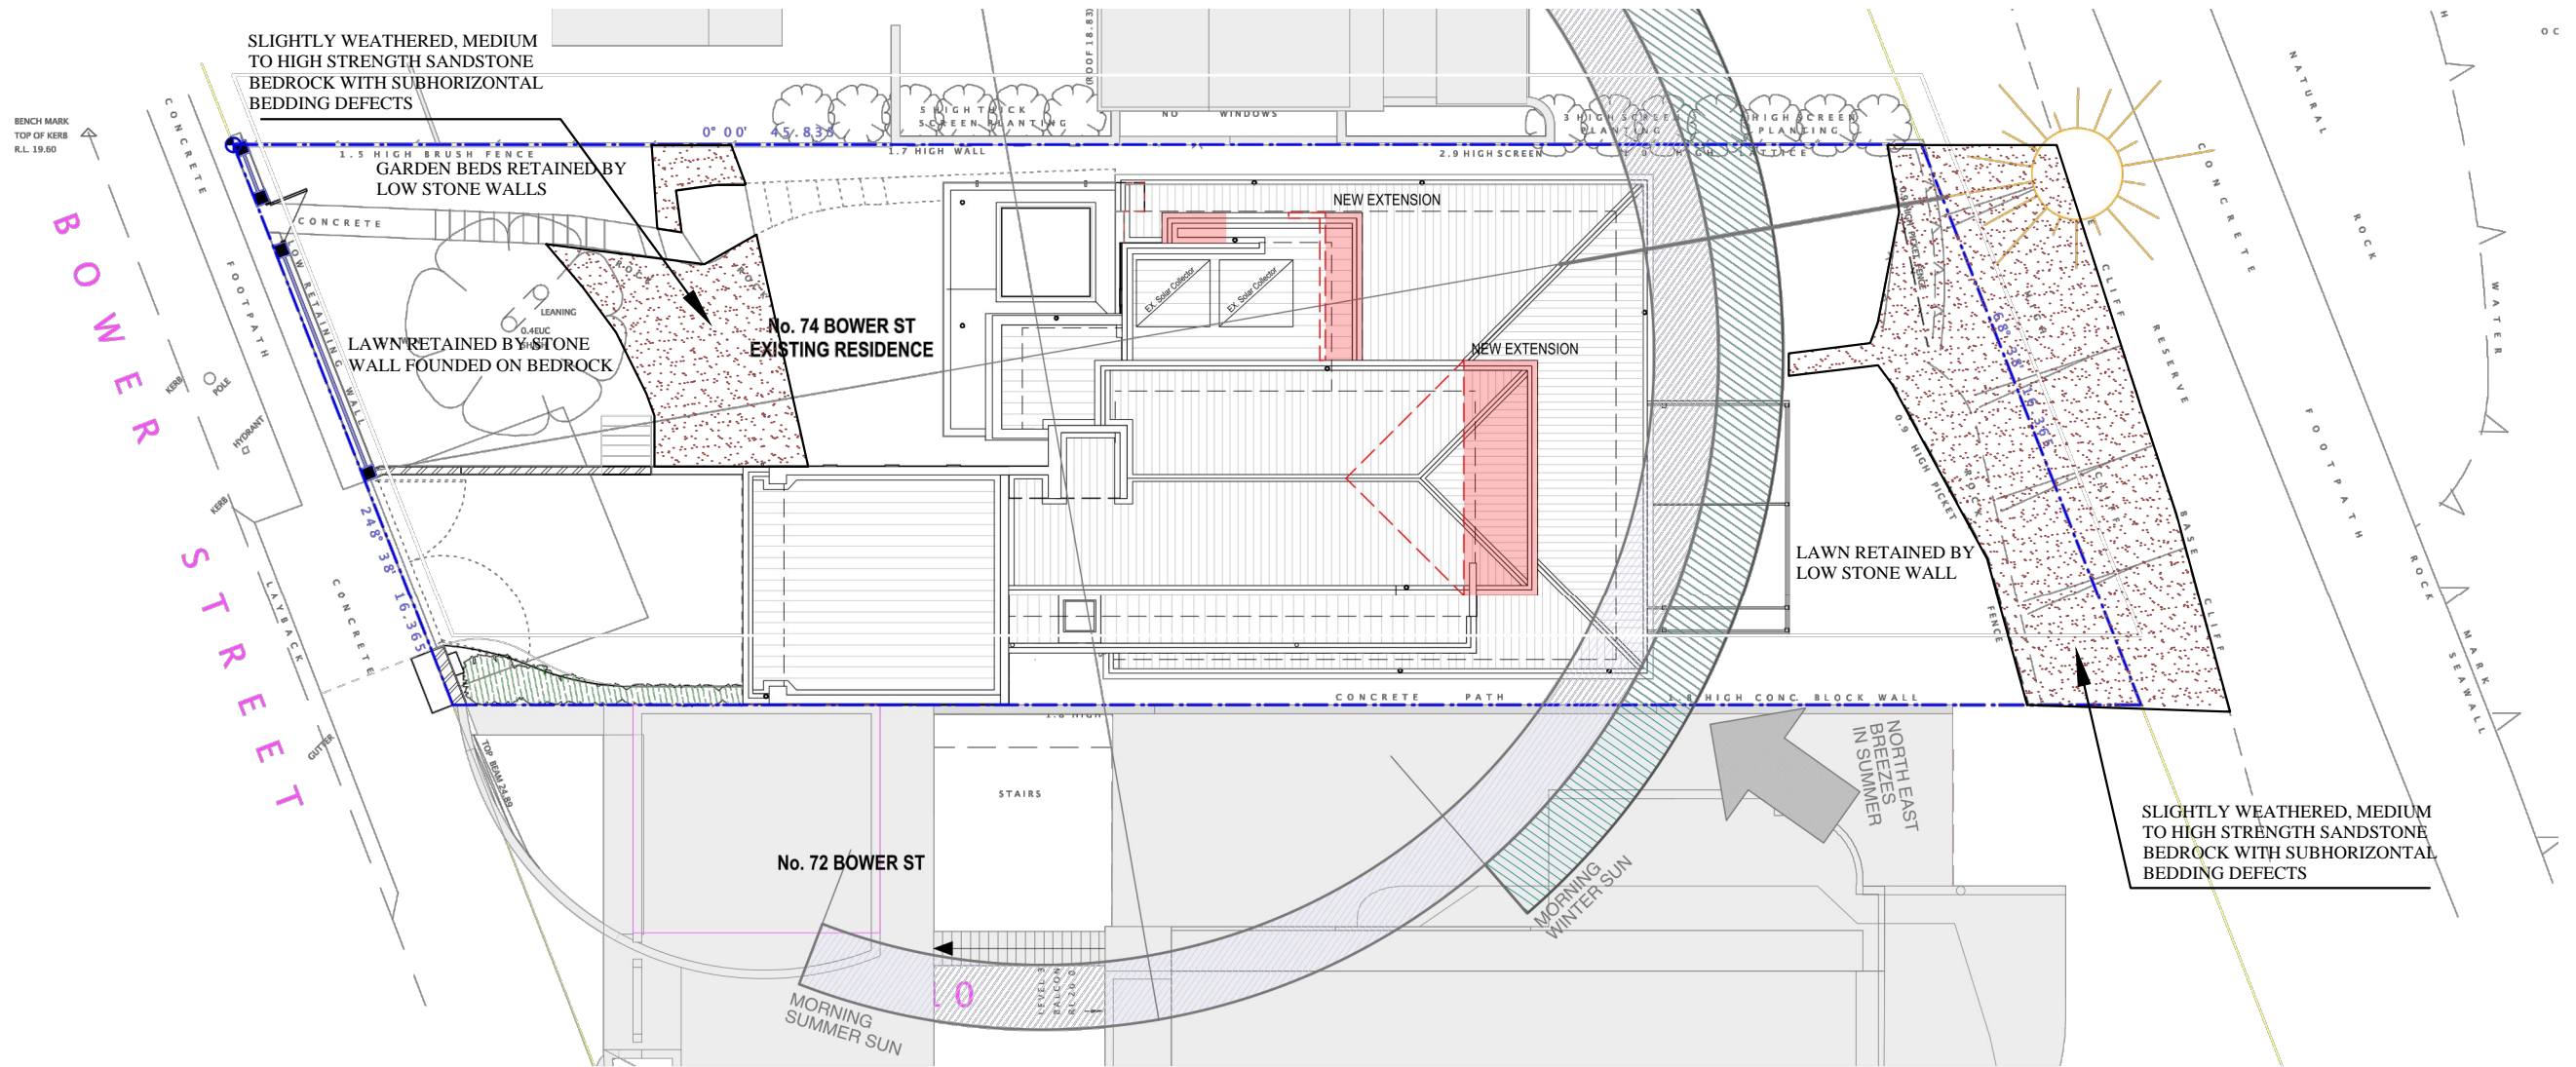
SITE PLAN FIGURE 1.

Explanatory notes are included in Appendix: 1 whilst mapping information is shown on Figure: 1, Appendix: 2.
