ACCESS CONSULTANTS ADVICE

RE: Harvey Norman Balgowlah

REF: Harvey Norman Balgowlah – Dedicated Accessible Car Spaces

PERFORMANCE SOLUTION REPORT

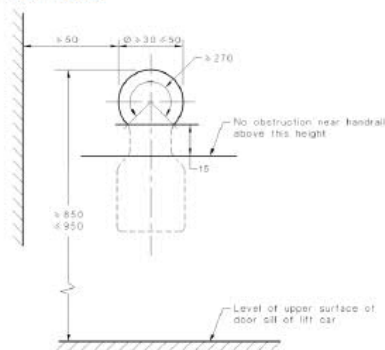
Distance from wall: 60 mm Diameter of handrail: 35 mm Top of handrail: 890 mm Support: below handrail

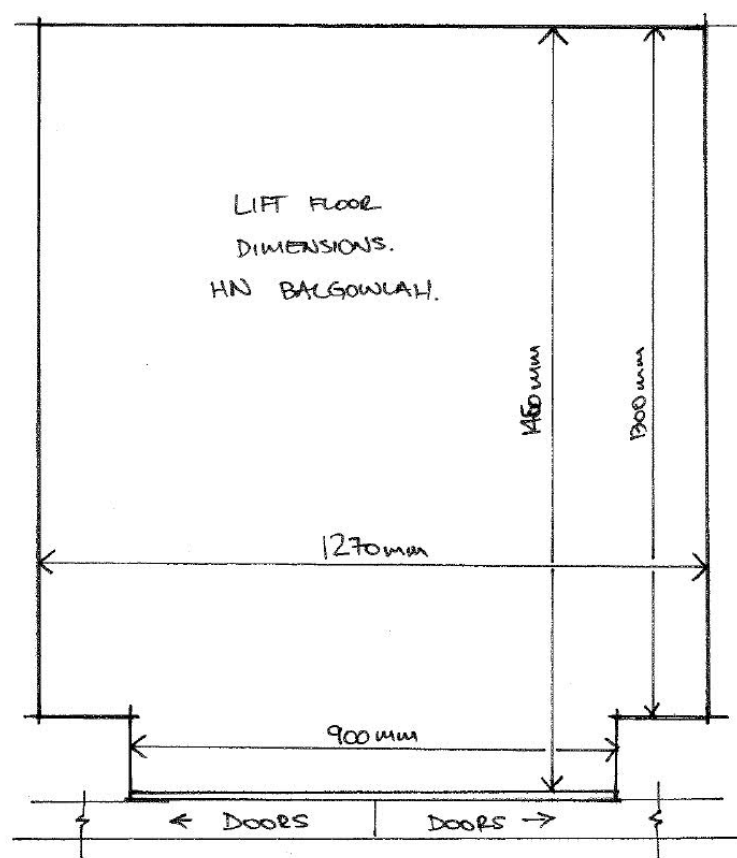
Image 4 – Lift floor dimensions

The vertical transportation compliance report identified that the existing lift complies with all parts of E3 except for the depth of the car being less than 1400mm for the full width of the floor plate. A sketch of the floor plate is below:

It can be seen in the above sketch that the lift floor plate has an overall dimension of 1450mm to the internal door face. The width of the floor plate is 1270mm wall to wall at the floor and 1250mm wall to wall at mid height.

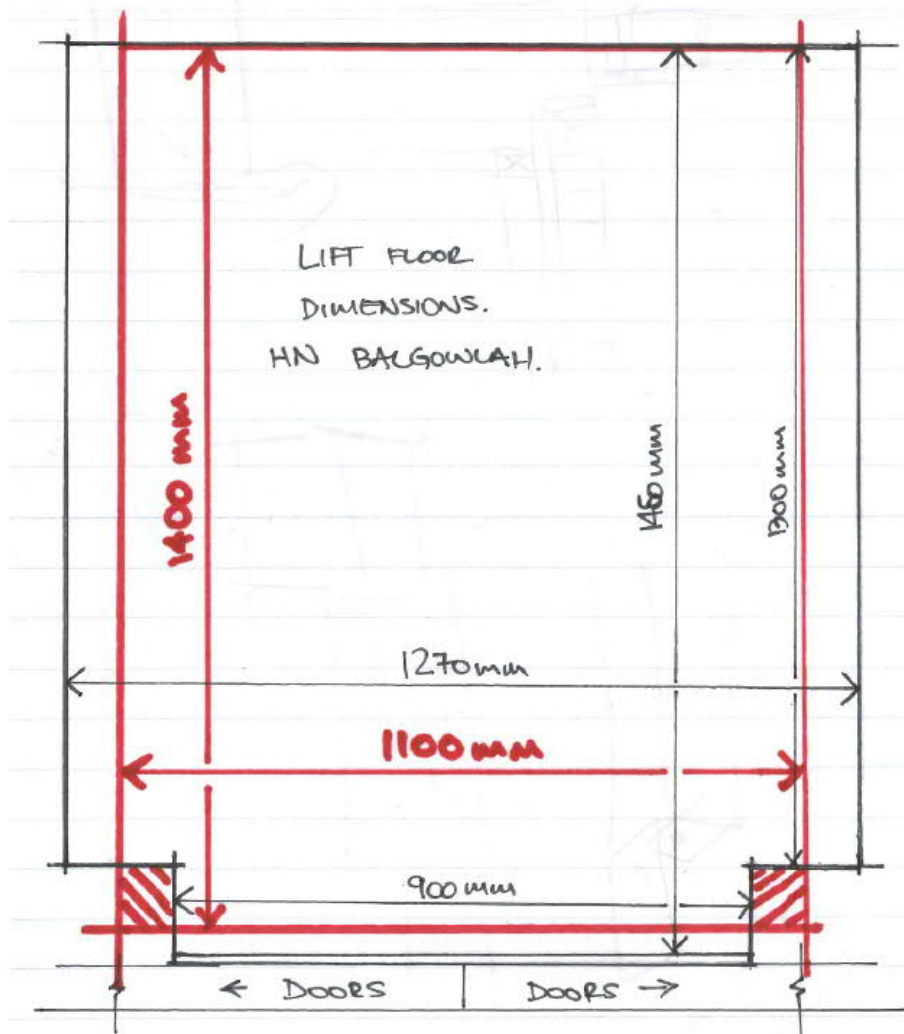
As noted above the DtS application of E3.6b requires a lift floor plate of 1100x1400mm. The existing lift, when overlaid with a DtS compliant footprint for the floor plate in red is shown in the image below:

The lift is a single-entry type and is not intended that a person would try to turn around in the lift. A user would enter the lift in the forward direction and reverse out of the lift at the destination floor or the opposite if they see fit and are capable to reverse in.

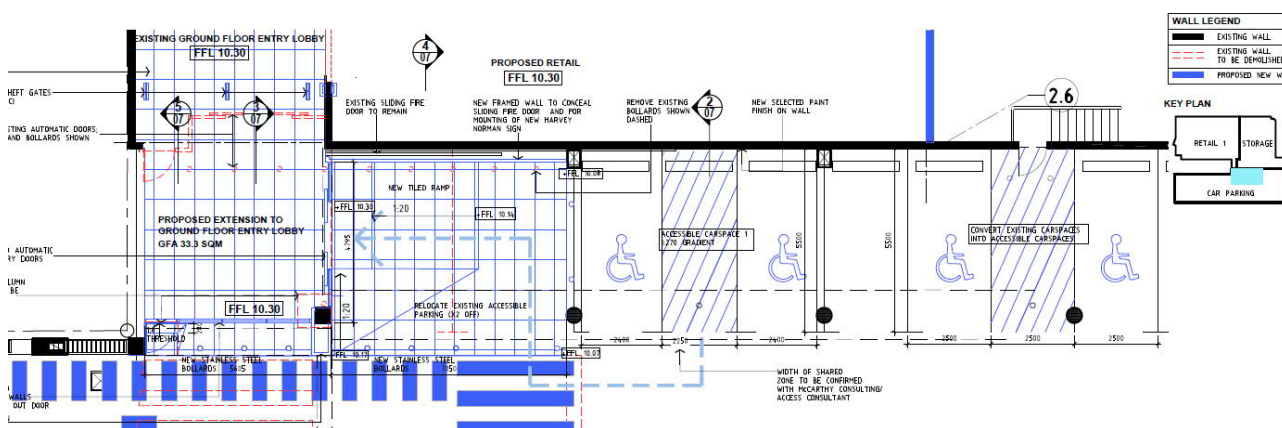
Image – Proposed store entry, four proposed accessible carparking spaces, shared spaces.

The proposed four spaces on ground floor are an increase of two over the existing provision and present an improvement in the availability of accessible carparking in the building. The spaces are proposed in a convenient location adjacent the main entry at ground floor. It is also noted that on completion of the proposed works there will be one space in excess of the minimum required under current BCA for a building of this nature.

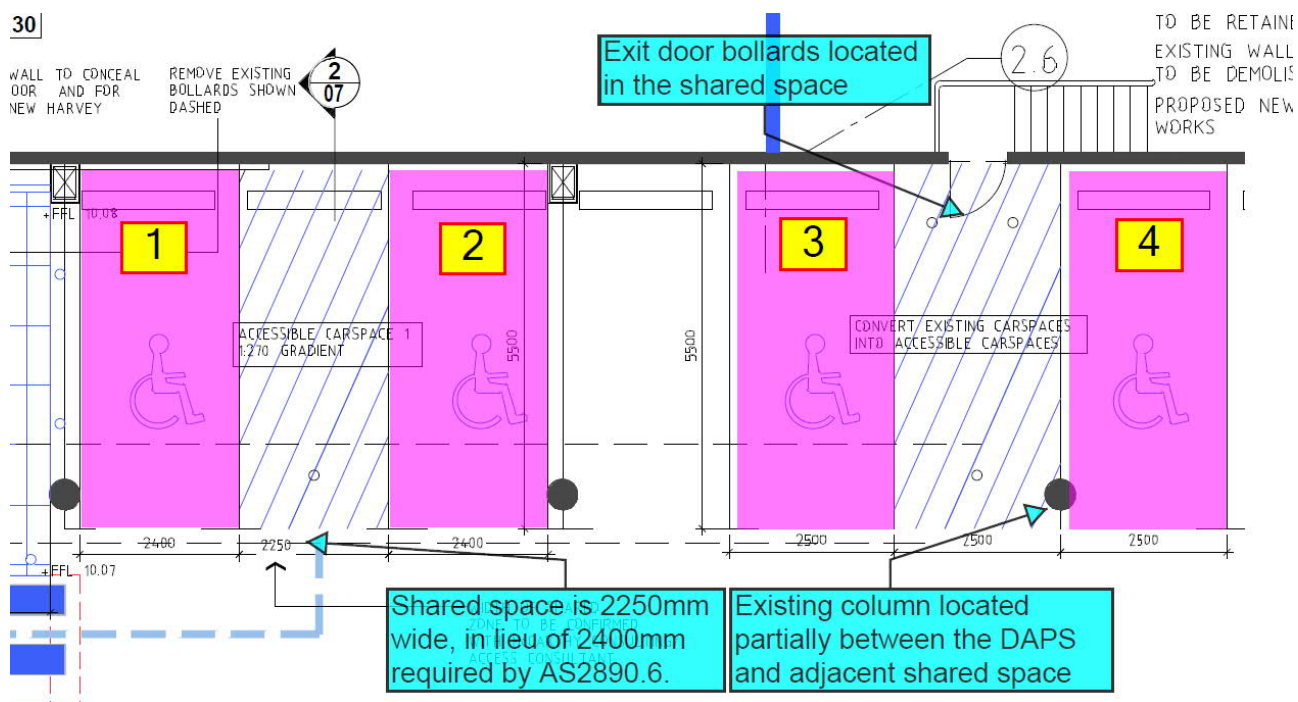
The below image identifies the identified non-compliances with the technical requirements of AS2890.6-2009 for the set out of the dedicated accessible carparking spaces.

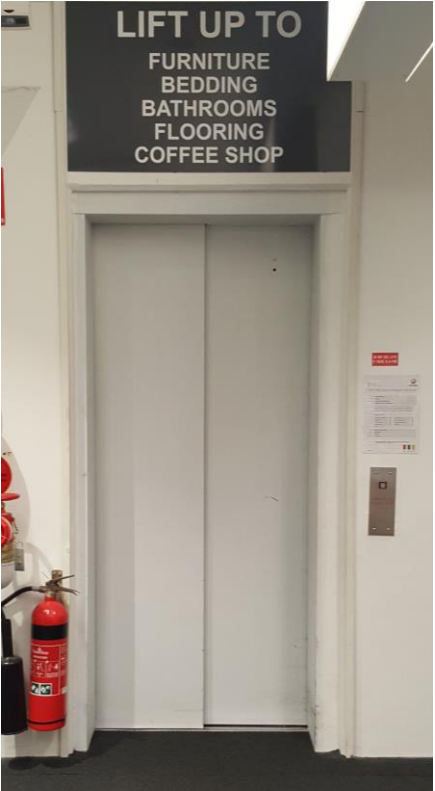
Lift	No. 1	
Classification	Passenger

Original Elevator Manufacture	Deve	
Type	Electrohydraulic	
Speed	0.3 m/s approx.	
Capacity	612 kg	
Passenger Rating	9 (AS 1735.2)	
Travel	4,343 mm approx.	
Levels Served	Two (2)	
Car Dimensions	1,250 mm W x 1,300 mm D	
Ceiling Height	2,400 mm	
Car Entrances	One (1)	
Controller	Automatic	
Door Protection	Infrared multi-beam	
Emergency Communication Device	Included

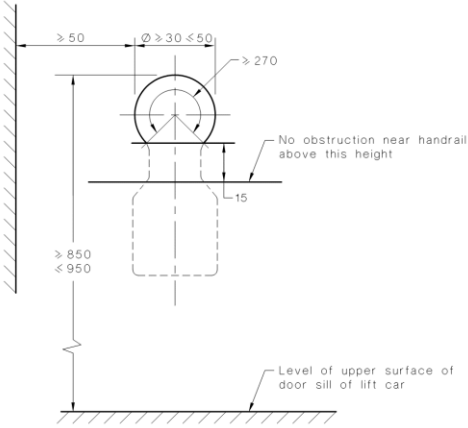
Distance from wall: 60 mm Diameter of handrail: 35 mm Top of handrail: 890 mm Support: below handrail
