Report Title: Geotechnical Report 26 Cabarita Road, Avalon Beach

Report Date: 28/02/25

GEOTECHNICAL INVESTIGATION:

Additions and Alterations at **26 Cabarita Road, Avalon Beach**

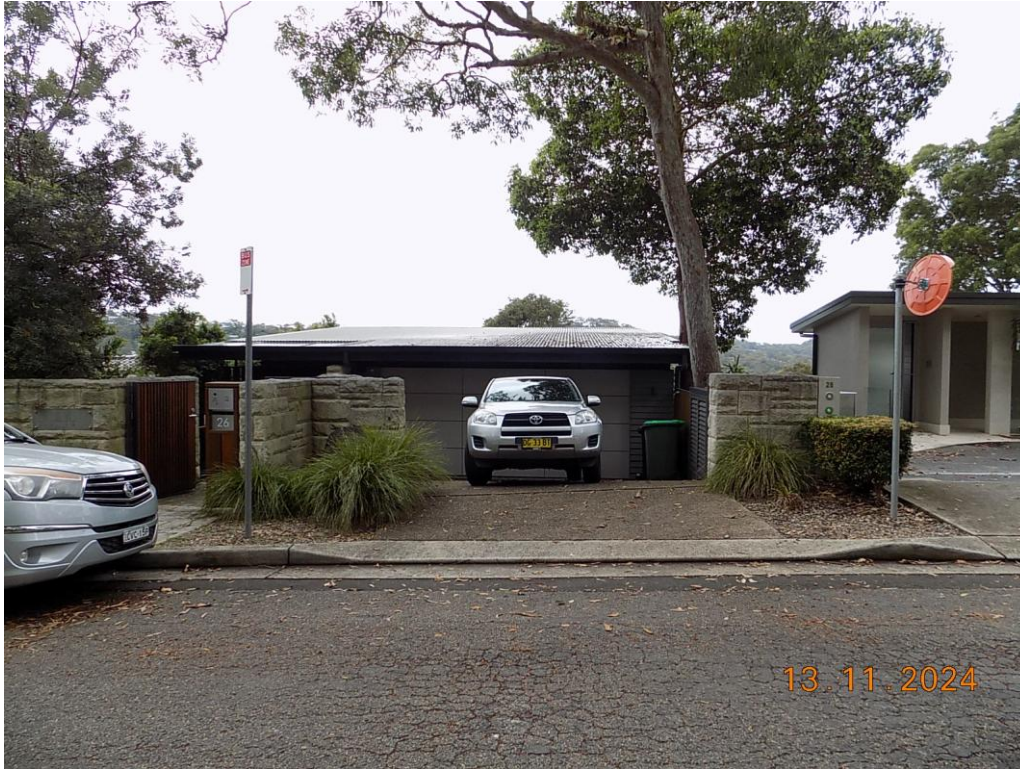
Photo 1

- 2.3** At the road frontage (Photo 1), a concrete driveway runs to a garage on level 4 of the house. An inclined lift has been installed between the house and the N common boundary. The cut for the inclined lift (Photo 2) has been battered and lined with rocks that armour the batter surface. The cut for the house is supported by a stable sandstone block retaining wall reaching up to ~1.5m high which approximates the S common boundary (Photo 3). The four-story timber clad house is supported on rendered masonry walls and concrete piers. No significant signs of movement were observed in the visible supporting walls, and the supporting piers stand vertical.

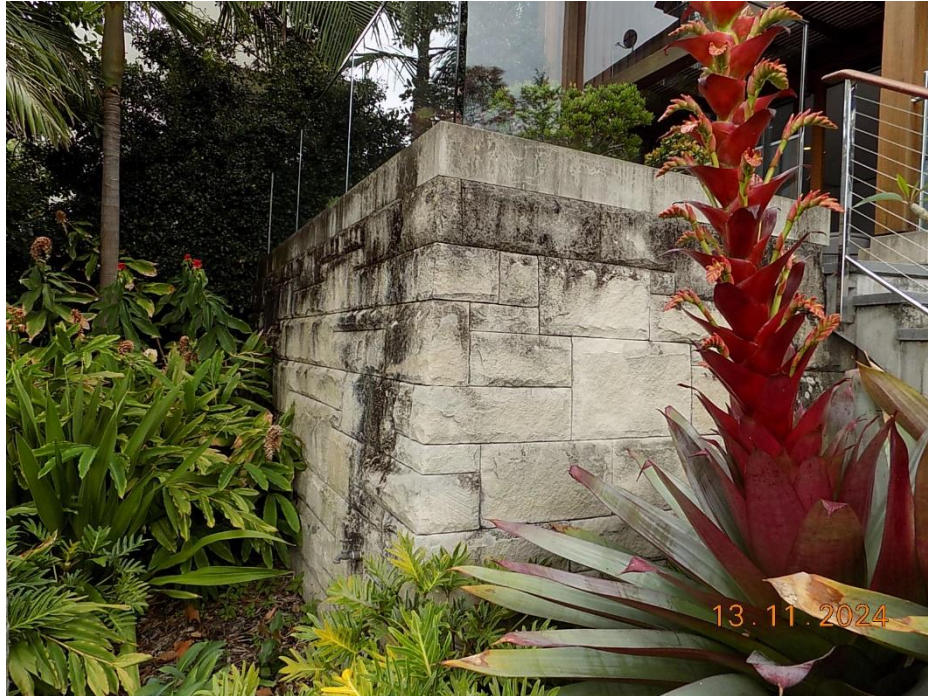
Photo 4

Fill for a tiled patio off the downhill side of the house is supported by stable sandstone block retaining walls reaching up to ~2.4m high (Photo 4). The slope between the

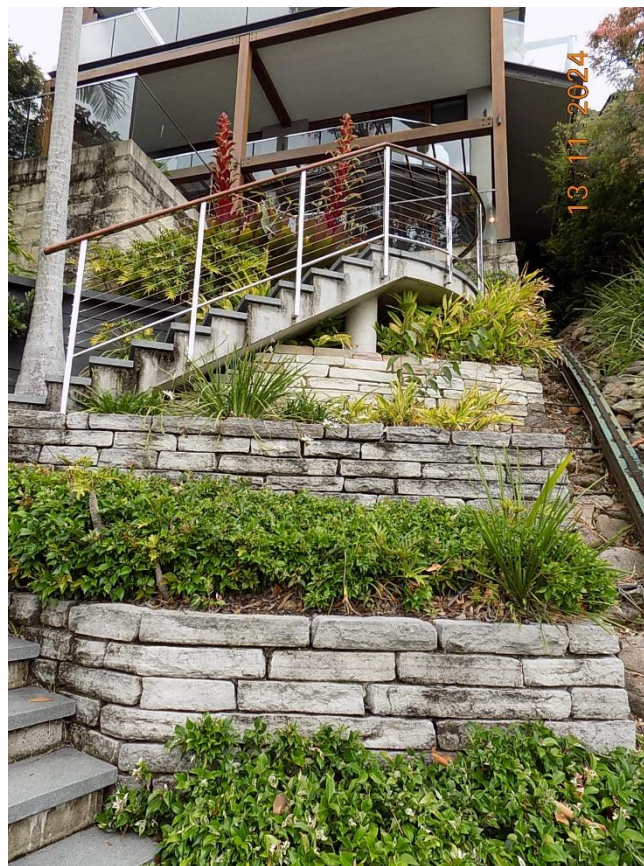
Photo 5

house and a two-story boathouse at the lower boundary is terraced, and supported with a series of stable timber and stack sandstone retaining walls, reaching up to ~1.4m in height (Photo 5).

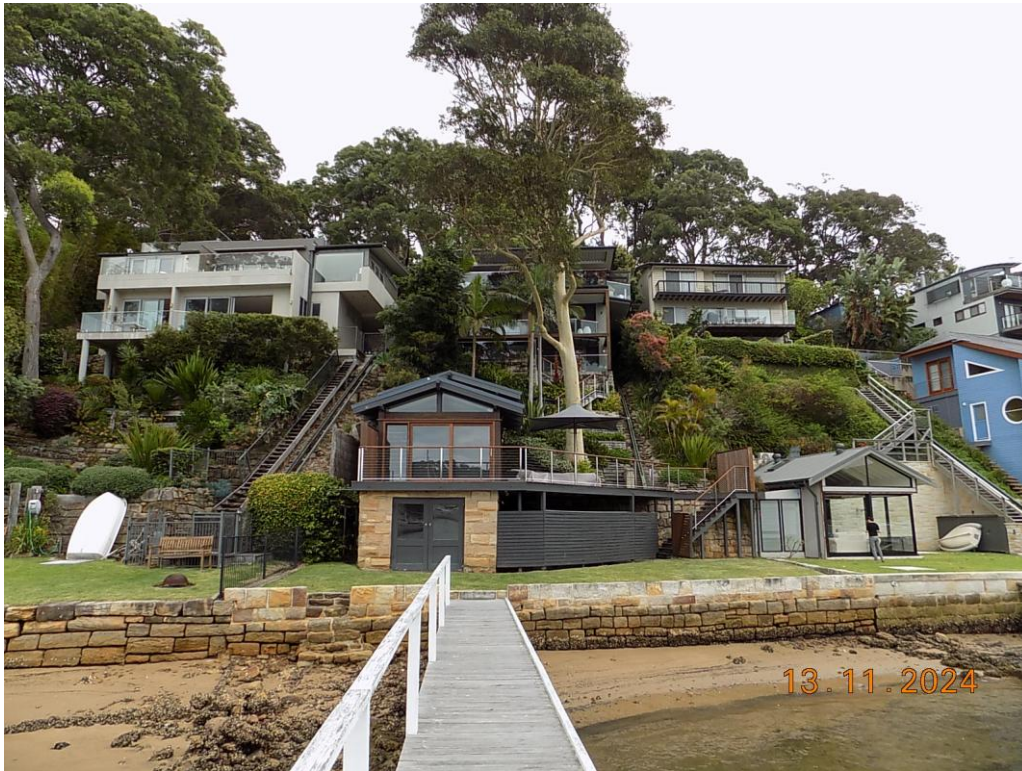
Photo 6

The two-story timber clad boathouse (Photo 6) is supported on sandstone block walls. No significant signs of movement were observed in the supporting walls. A cut for the boathouse and to landscape the downhill side of the property is supported by a stable dry stack sandstone block retaining wall reaching ~4.7m high (Photos 7 & 8). A stable formed concrete wall supports the return of this cut along the S common boundary. A deck on level 1 of the boathouse is supported on timber posts which appear to stand vertical. Below the subject property, a stable sandstone block seawall reaching ~1.4m (Photo 9) high supports fill for a level lawn. A timber jetty extends a further 25m beyond the sea wall (Photo 6).

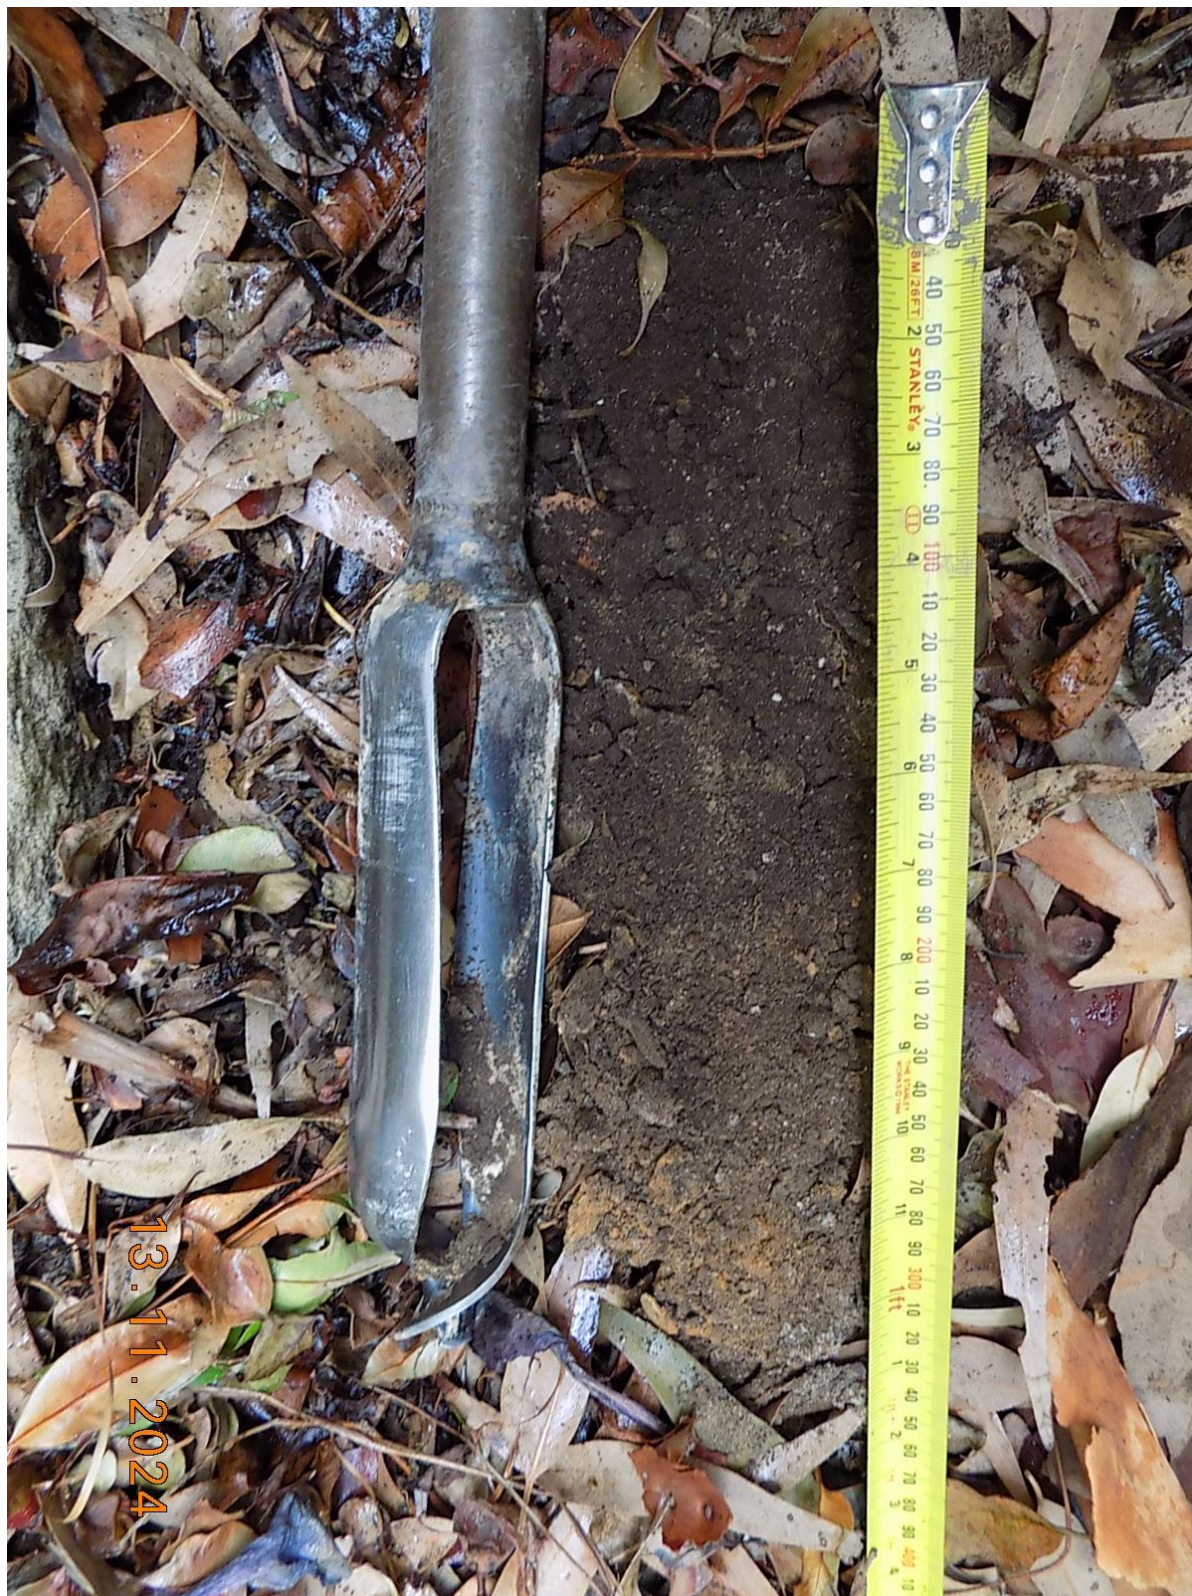
AUGER HOLE 1 (~RL10.0) – AH1 (Photo 10)

Depth (m)	Material Encountered
0.0 to 0.2	TOPSOIL , dark brown, Dense, dry, fine to medium grained.
0.2 to 0.3	CLAYEY SOIL , brown to orange, Very Stiff, dry, fine to medium grained, sandy clayey rock fragments included.

Refusal @ 0.3m. Auger not progressing through clayey soil. No water table encountered.

Photo 10 – AH1 – downhole is top to bottom

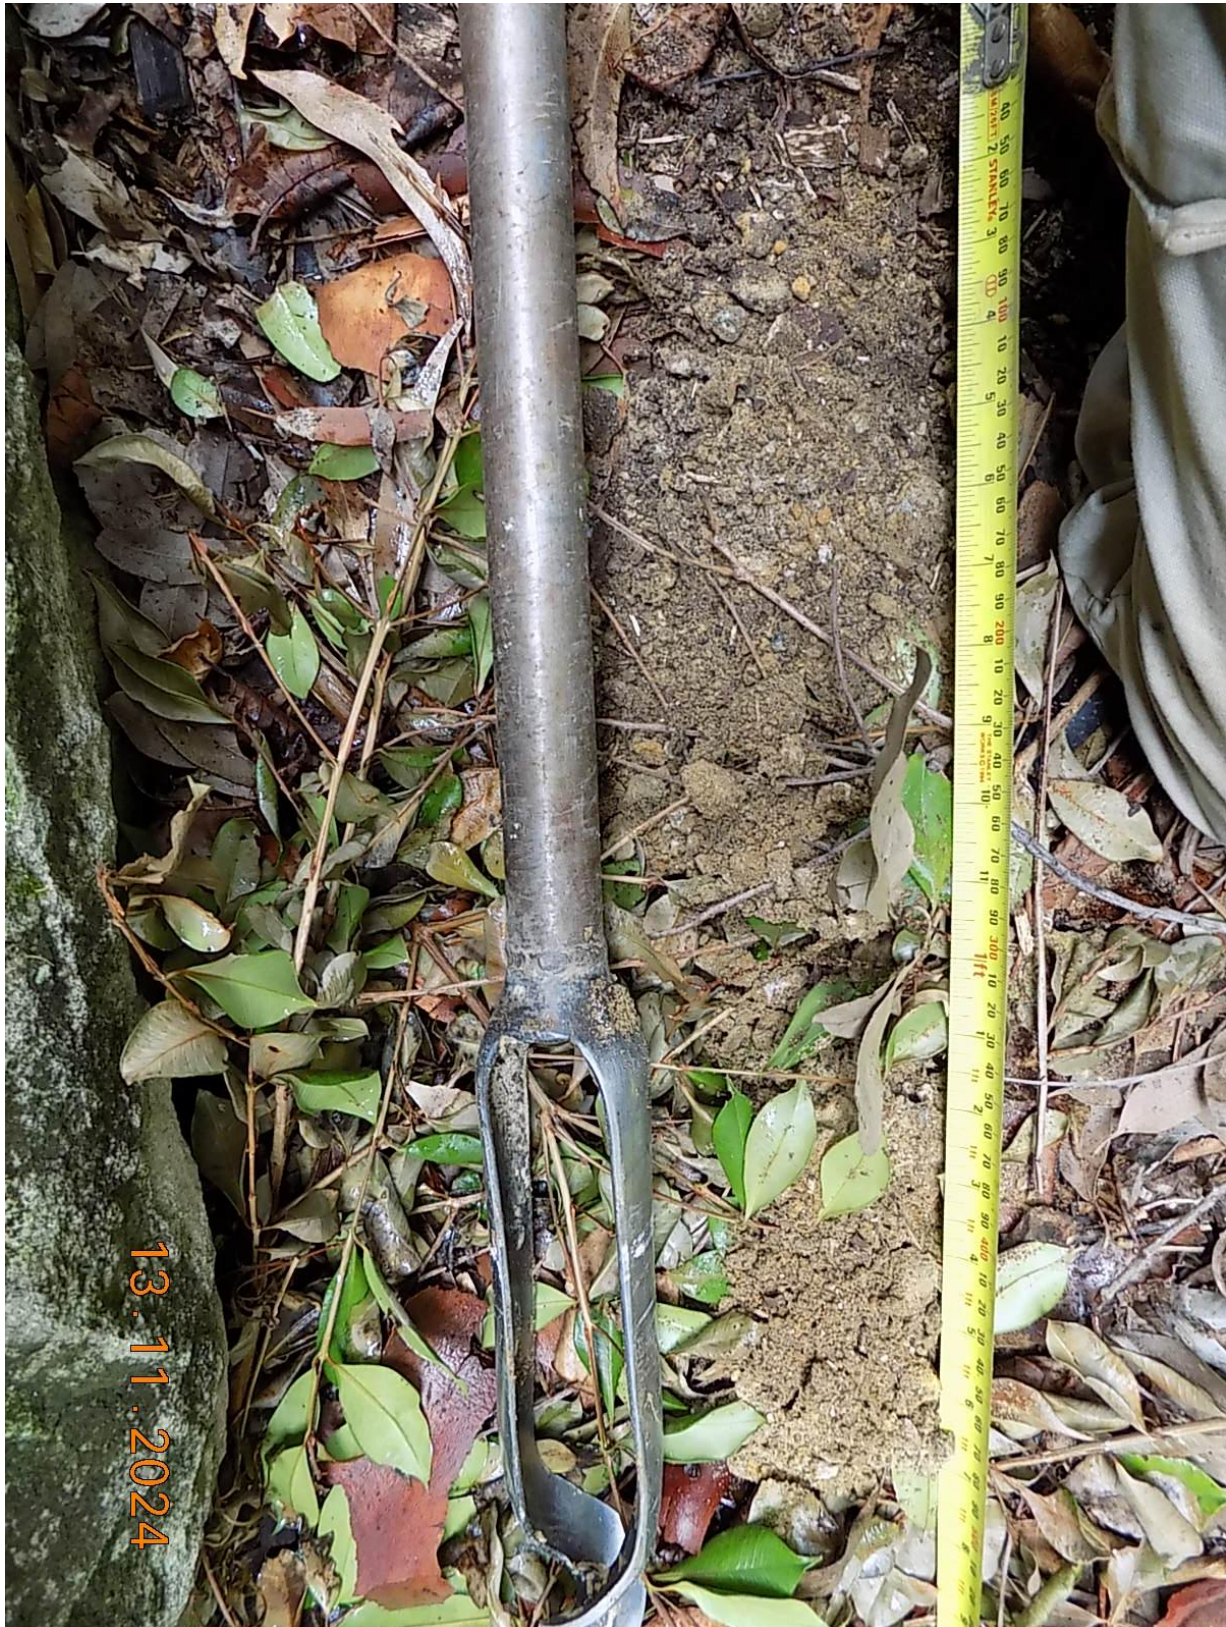
AUGER HOLE 2 (~RL9.1) – AH2 (Photo 11)

Depth (m)	Material Encountered
0.0 to 0.5	FILL , derived from foreign crushed rock material, brown, Dense, dry, fine to medium grained, rock fragments included.

Refusal @ 0.5m. Auger not progressing in fill. No water table encountered.

Photo 11 – AH2 – downhole is top to bottom
