GEOTECHNICAL INVESTIGATION:

New House, Pool, and Boatshed at 1744 Pittwater Road, Bayview

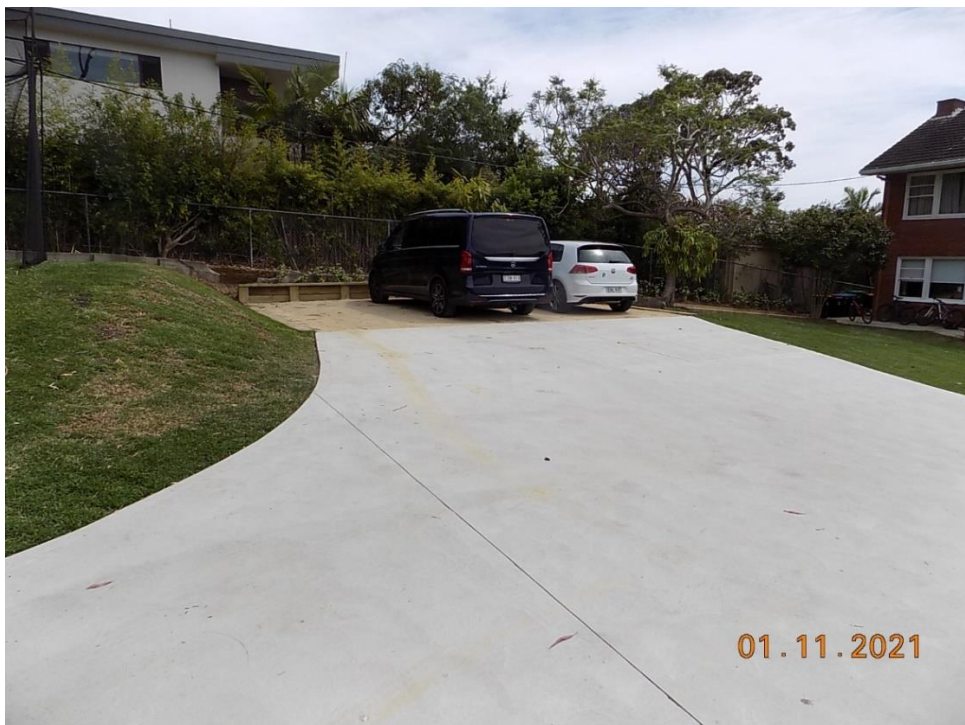
Photo 1

- 2.3** At the road frontage, a concrete driveway runs to a gravel parking area on the uphill side of the property and to a brick garage attached to the SE side of the house (Photos 1 & 2). Between the road frontage and the house is a gently sloping lawn (Photo 3). The part three-storey brick house is supported on stable brick walls and will be demolished as part of the proposed works (Photo 4). Another gently sloping lawn extends off the downhill side of the house to top of the steep bank that rises from the

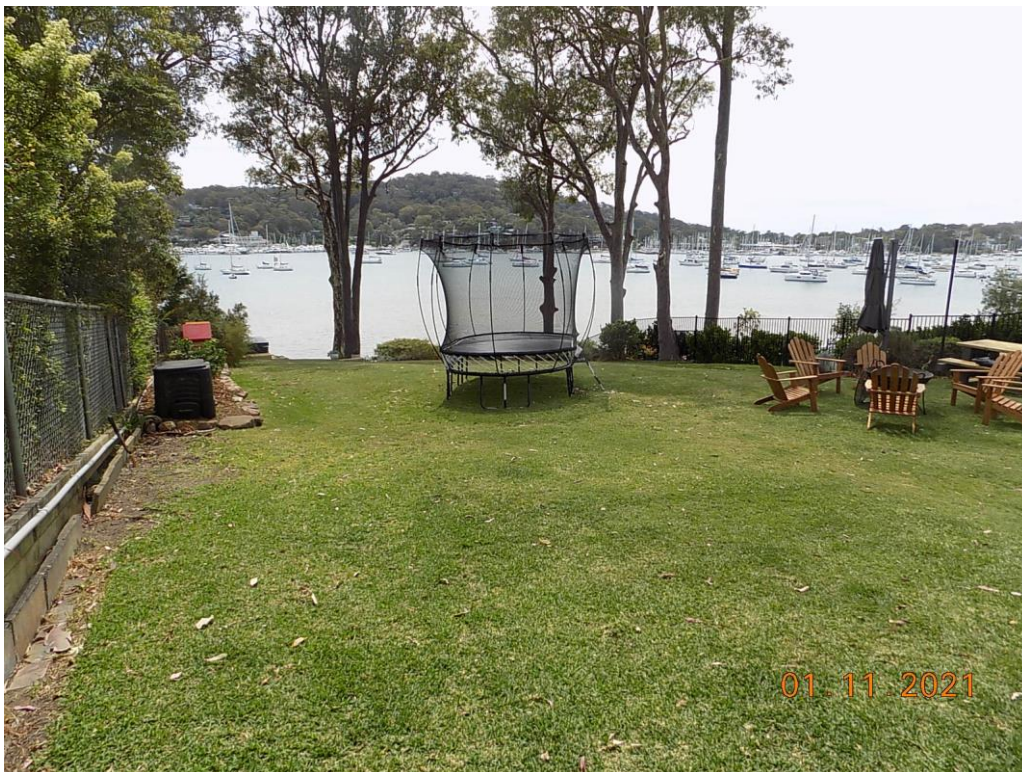
Photo 5

waterfront (Photos 5 & 6). This bank is densely vegetated and terraced with a series of stable stack rock retaining walls. A near-level lawn-covered fill extends off the toe of the bank to the waterfront. The fill is supported by a low stack rock sea wall (Photo 7). No signs of slope instability were observed on the property.

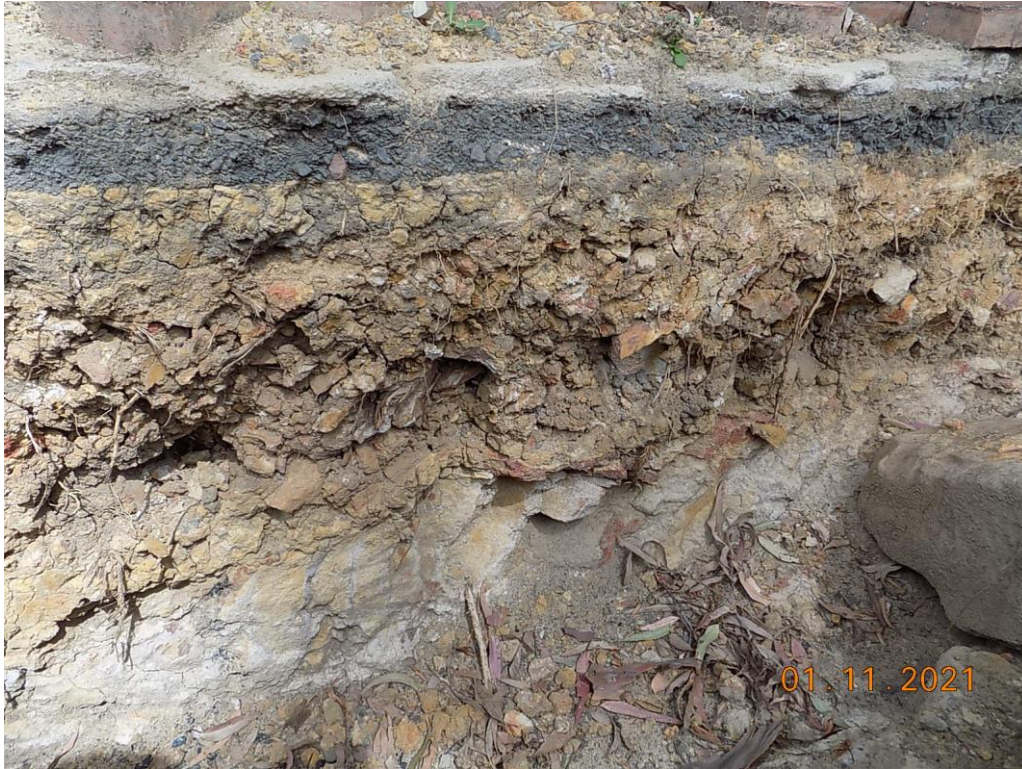
Photo 8: TRENCH

TRENCH (~RL4.5) – (Photo 8)

Depth (m)	Material Encountered
0.0 to 0.7	FILL , gravel and disturbed clay, brown and mottled orange and maroon, medium dense to very dense, dry, fine to coarse grained with rocks through the profile.
0.7 to 0.9	LOW STRENGTH SANDSTONE , grey and yellow, dry, coarse grained.

Base of trench @ 0.9m in Low Strength Sandstone. No water table encountered.

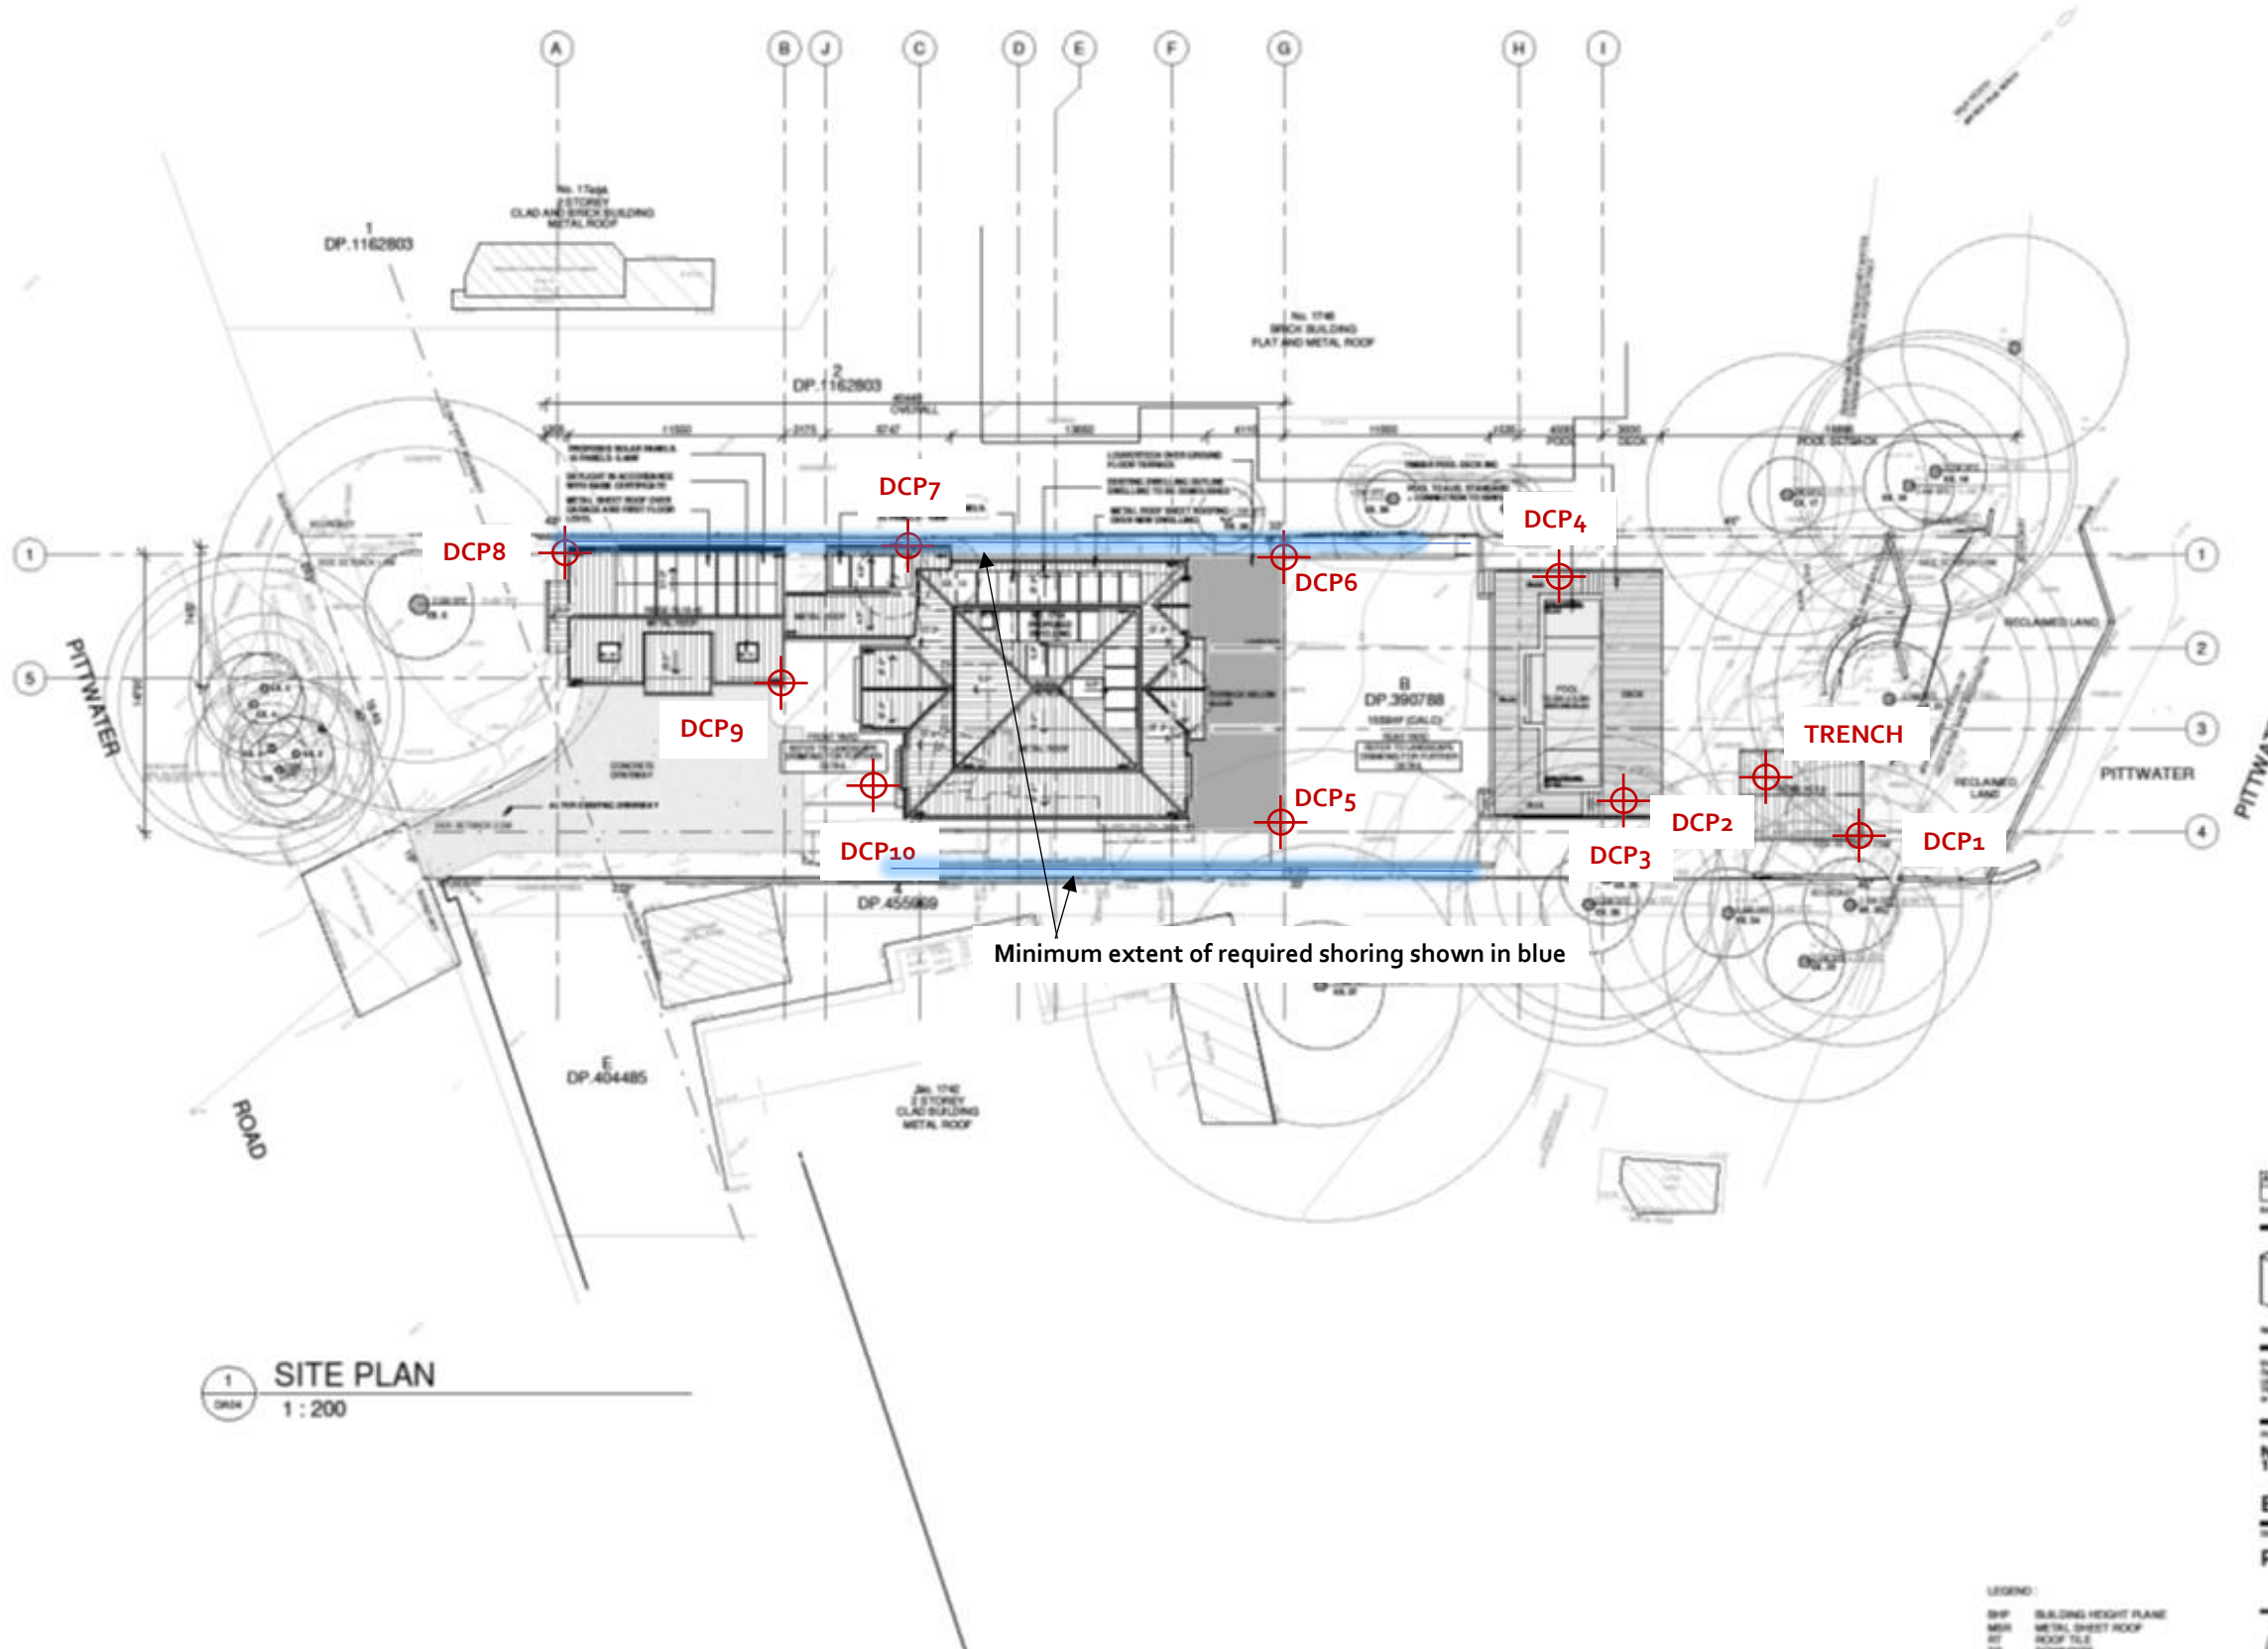
SITE PLAN – showing test locations

The ground materials within an as-dug trench were recorded (TRENCH). Ten Dynamic Cone Penetrometer (DCP) tests were put down to determine the relative density of the overlying soil and the depth to weathered rock. The locations of the tests are shown on the site plan attached. It should be noted that a level of caution should be applied when interpreting DCP test results. The test will not pass through hard buried objects so in some instances it can be difficult to determine whether refusal has occurred on an obstruction in the profile or on the natural rock surface. This is not expected to be an issue for the testing on this site. However, excavation and foundation budgets should always allow for the possibility that the interpreted ground conditions in this report vary from those encountered during excavations. See the appended "Important information about your report" for a more comprehensive explanation. The results are as follows:

The cut will require staged sacrificial temporary support such as braced form ply or similar support installed along the NW and SE sides as the excavation is progressed in spans not less than 2.0m horizontally. The support is to be designed by the structural engineer. The temporary support is to remain in place until the retaining walls are built. See the minimum extent of temporary shoring shown on the site plan attached.
