PRELIMINARY GEOTECHNICAL ASSESSMENT:

19 Curl Curl Parade, Curl Curl

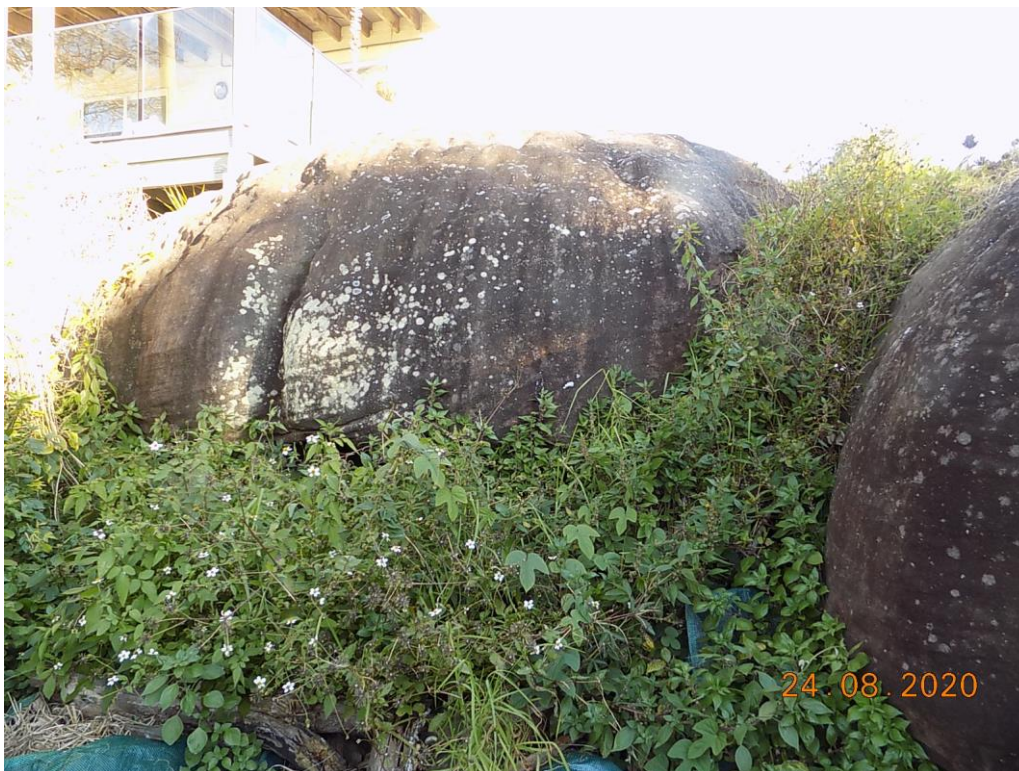
Photo 1

The natural slope falls across the property at an average angle of $\sim 14^\circ$. The fill for the road is lawn-covered and merges into the natural slope. A moderately sloping lawn falls from the road frontage to outcrops of competent Medium Strength Hawkesbury Sandstone at roughly the midpoint of the property. The outcrops are massively bedded joint blocks that step down the site to the lower boundary. The east-most joint block at the midpoint of the property is undercut to $\sim 3.0\text{m}$ (Photo 1). The undercut is bridged at the W end and the undercut joint block extends back into the slope sufficiently that the balance point is well back from the undercut and the rock is considered stable. No other undercutting or other serious geological defects were observed in the outcrops and they are considered stable. The vacant lot is mostly lawn covered. No signs of movement associated with slope instability were observed on the grounds. The adjoining neighbouring properties were observed to be in good order as seen from the road and the subject property.

Provided good engineering and building practice are followed, no further Geotechnical assessment is recommended for the proposed development.
