Proposed New Residence Lot 12, 4 Lincoln Avenue, Collaroy NSW

Geotechnical Investigation

Our ref: 6200-G1
11 September 2020

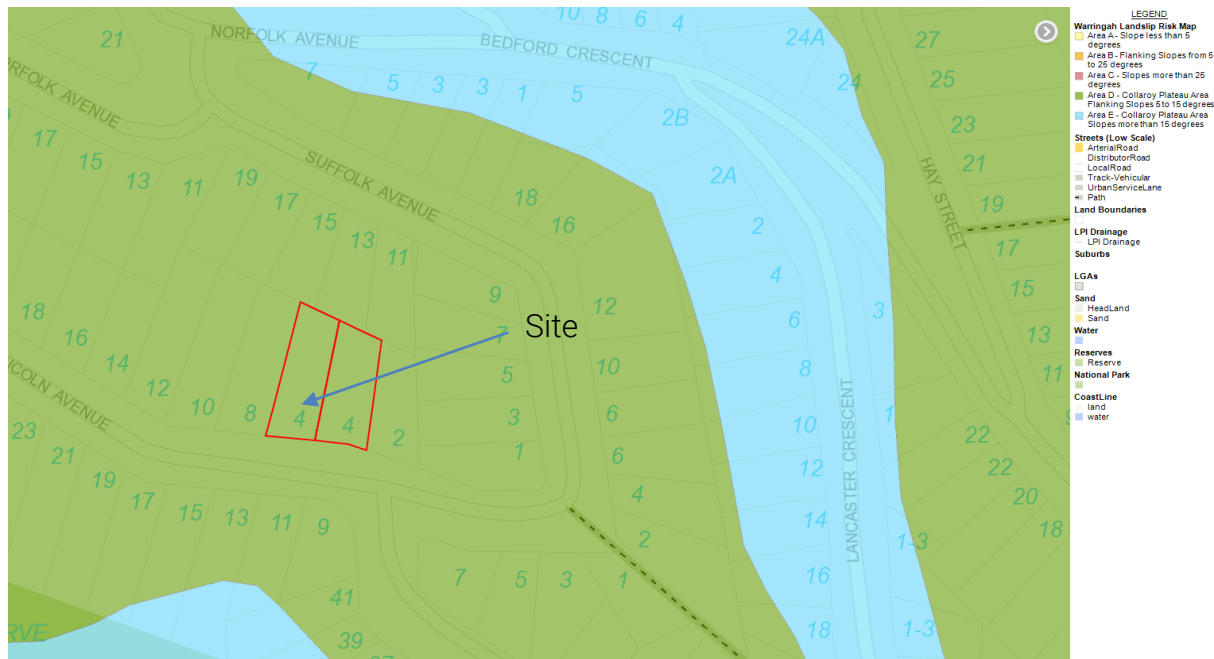
Plate 1 – Land Instability Risk Mapping (Source: Warringah Landslip Risk Map)

The Sydney 1:100,000 Geological Map indicates that the site is underlain by the basal beds of the Hawkesbury Sandstone Formation which in turn overlies Newport Formation sandstone, siltstone, shale/laminate. From the Land Instability Map presented by Northern Beaches Council, the site is located in Area D – Collaroy Plateau Area (Flanking Slopes 5 to 15°), as shown in **Plate 1**.

As the project site is located within Landslip Risk Class D (Warringah Council Local Environmental Plan 2011), a preliminary assessment of site conditions is required to determine whether a full geotechnical report (with respect to slope risk assessment) is required.

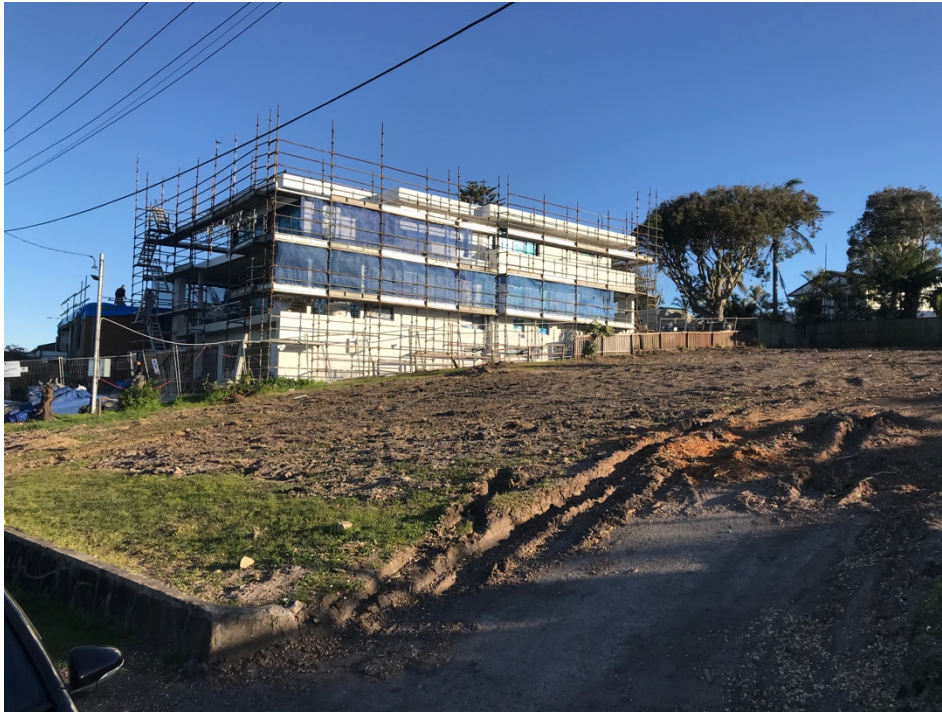
Photo 1

At the time of the investigation, the previous dwelling has been demolished (Please see Photo 1). A minor mortared masonry retaining wall ranging from 0.6m to 1.0m in height running along Lincoln Avenue was encountered to retain the ground above (Please see Photo 2). Signs of cracking and aging were observed. (Please see Photo 3 & 4). No rock outcrops were observed during the site walkover (though Google aerial photos covering #6 Lincoln appear to show possible rock exposed during the building construction at footing level.

General view of proposed site area.

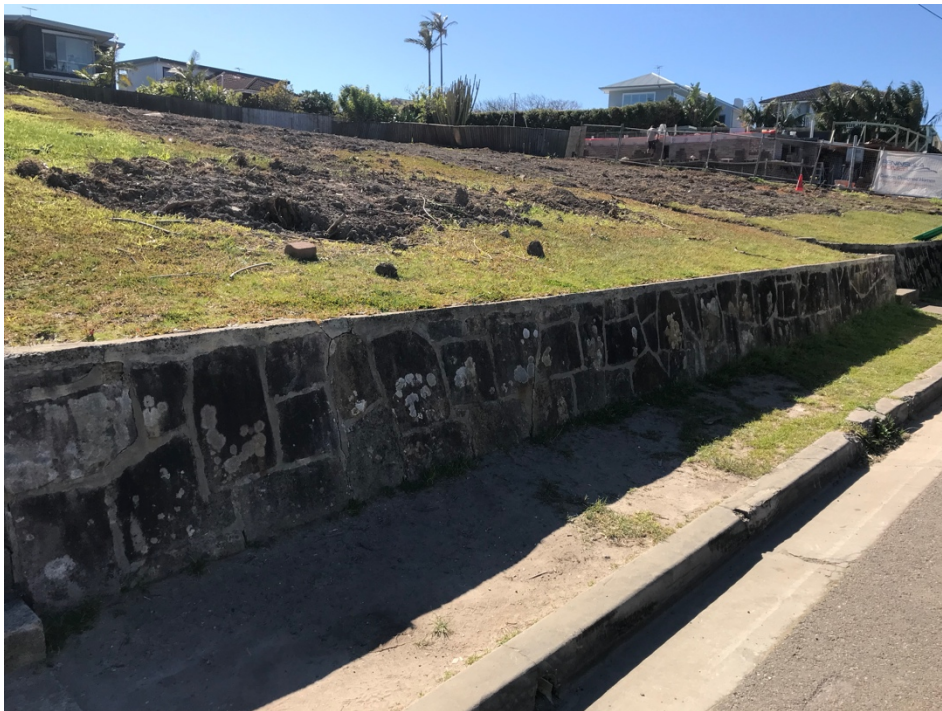
Photo 2

- A. Toppling or failure of existing retaining wall at the front of the site along Lincoln Avenue (only relevant for current conditions) to be removed or replaced as part of the proposed development
- B. Translational slide in soils overlying bedrock. This would be exacerbated by the proposed 3.5m deep excavation.

South-West to North-East view of 1m retaining wall along Lincoln Avenue at the front of the site area.

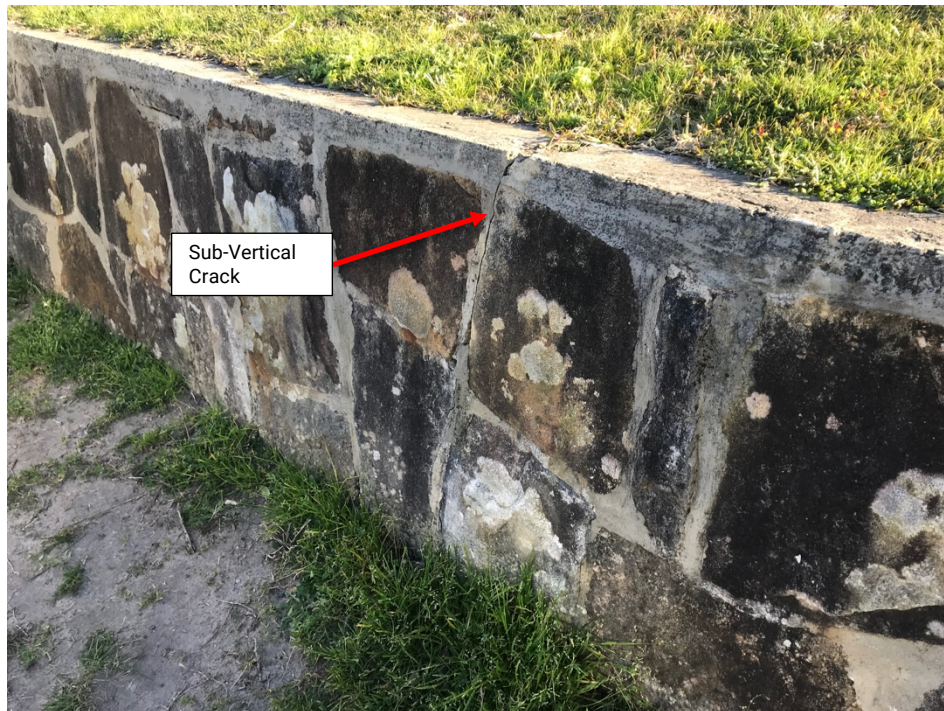
Photo 3
Sub-vertical crack
discovered on
retaining wall.

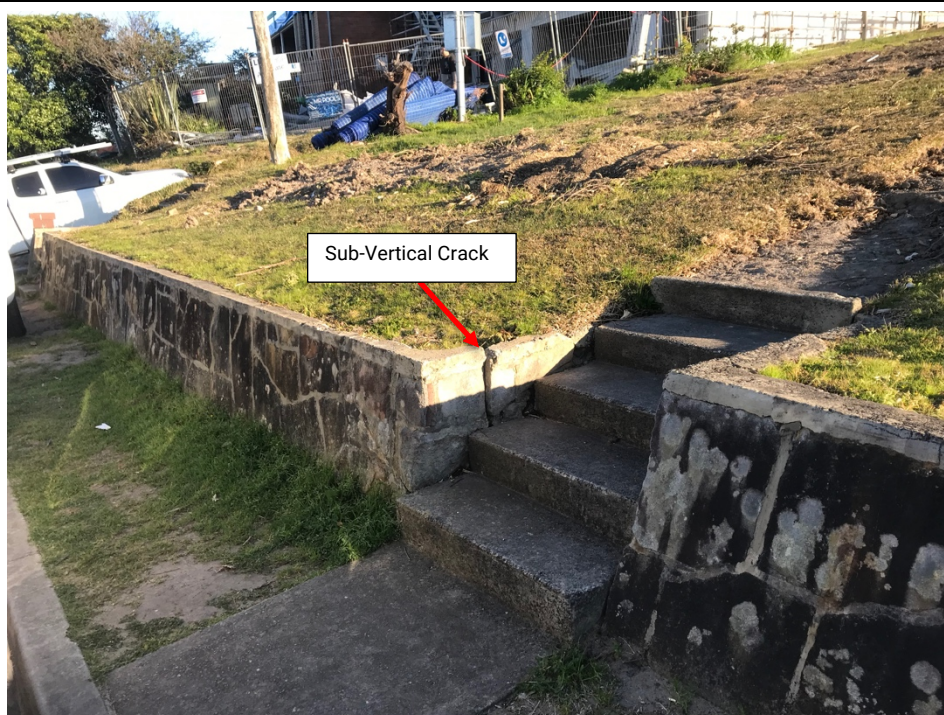
Photo 4
Sub-vertical crack
discovered on the
side of retaining wall.
