Geotechnical Assessment

Project: Dual Occupancy Dwellings
52A Abbott Road, North Curl Curl NSW

Prepared for:
Lukas Paling

Ref: AG 25179
16 May 2025

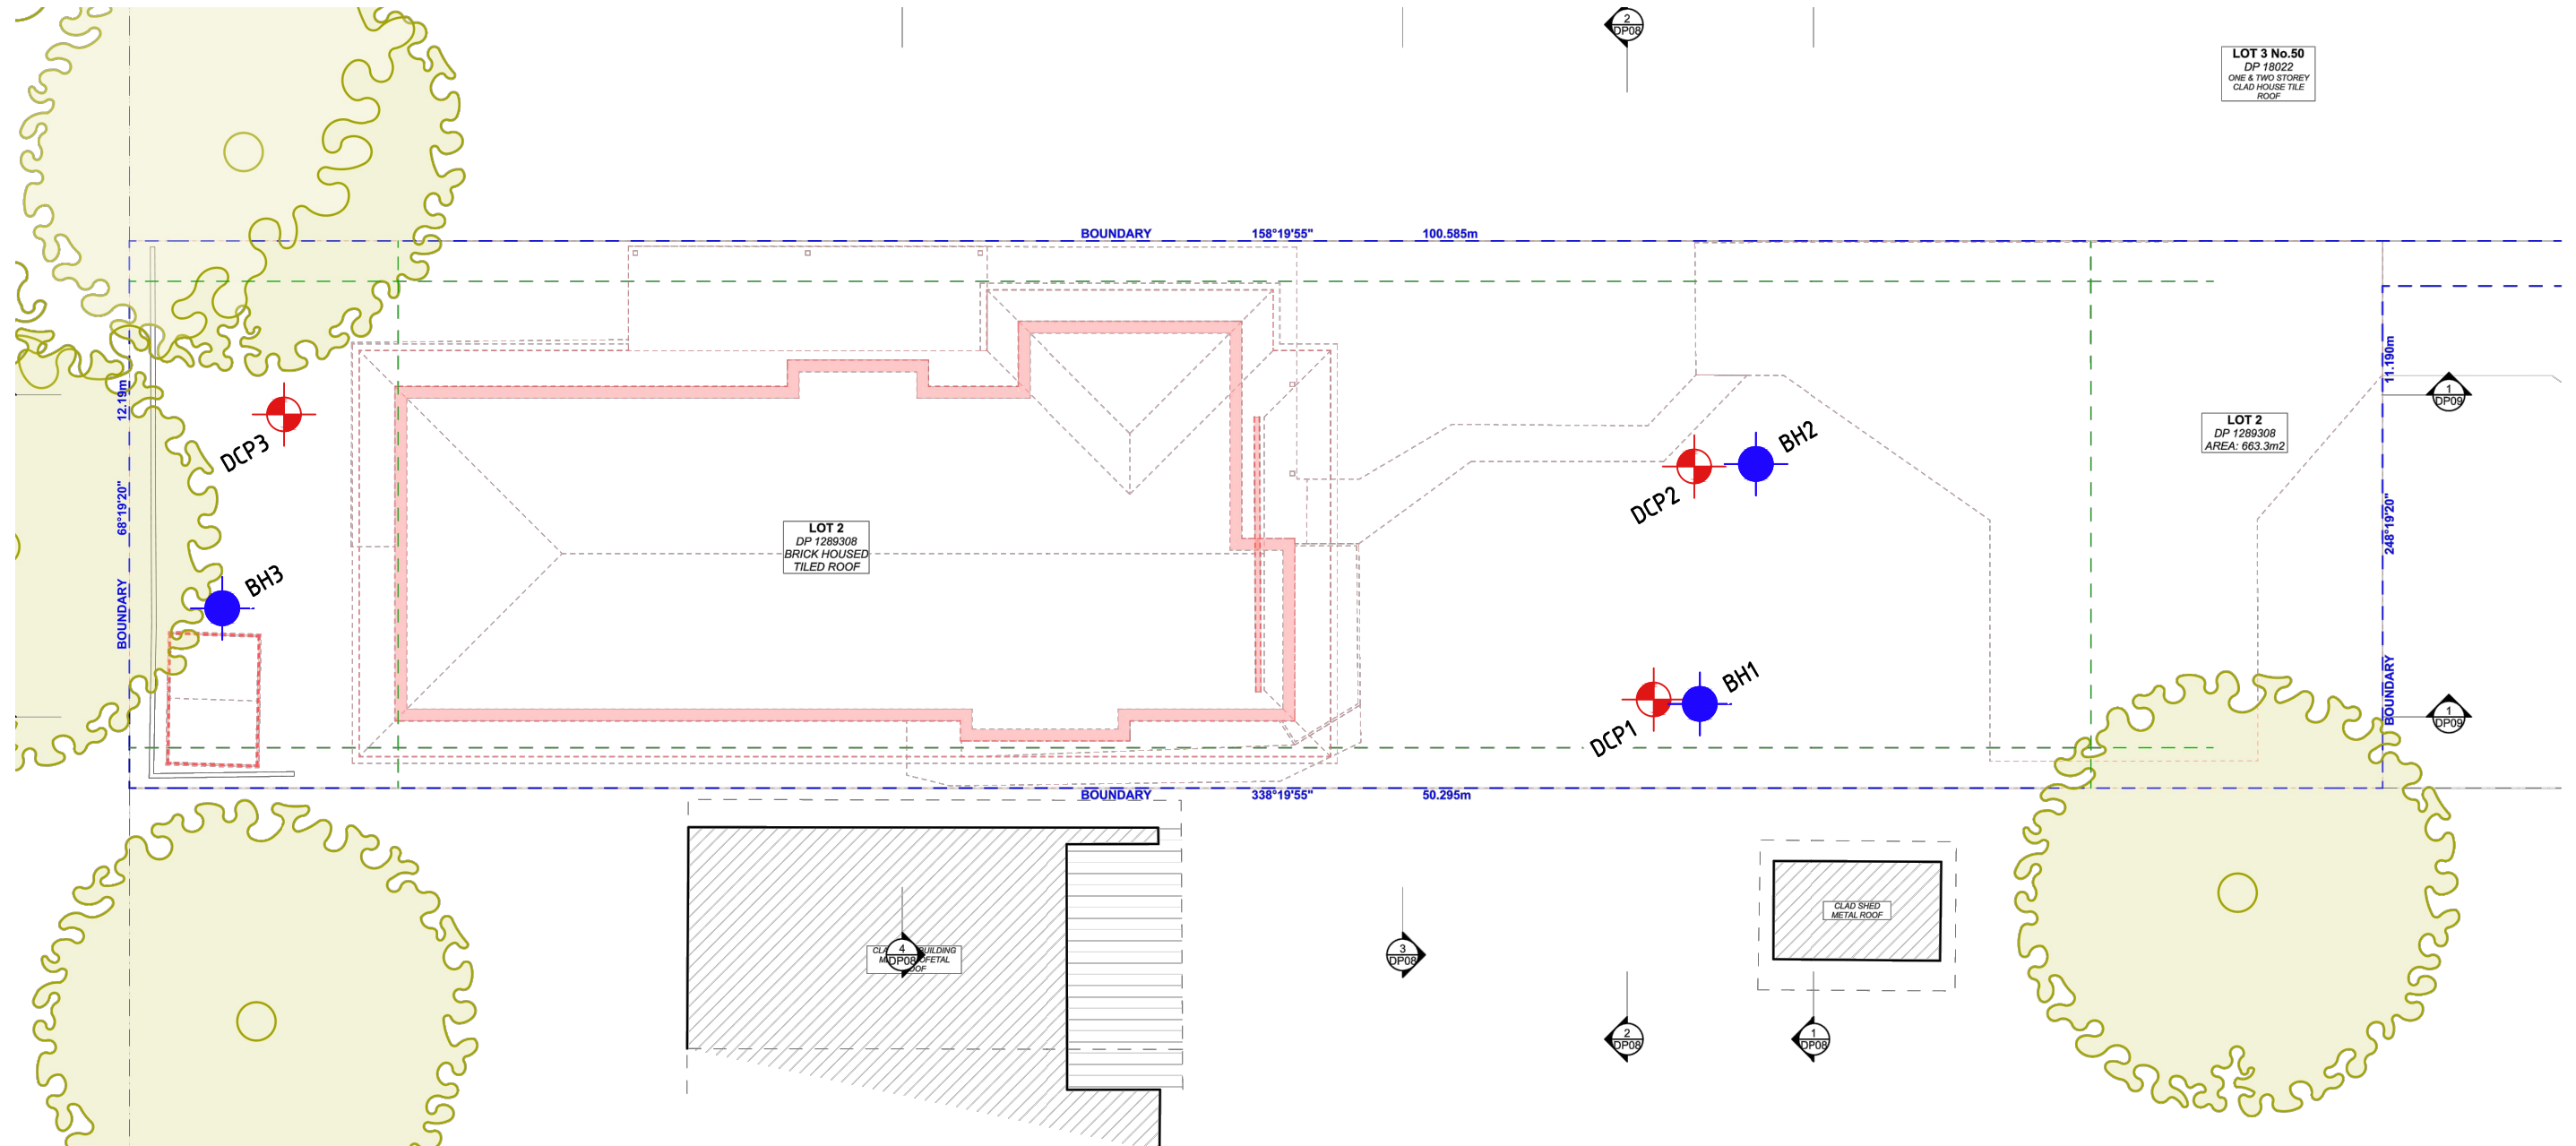
SITE PLAN/GROUND TEST LOCATIONS
SCALE NTS

Test	Summary
DCP 1	Refusal @ 0.6m Bouncing on suspected hard fill.
DCP 2	End test at 4.5m. Grey sand on moist tip. Rods moist (not wet). Bedrock not encountered.
DCP 3	Practical refusal, no longer progressing in inferred dense sand. Rods moist (not wet). Bedrock not encountered.

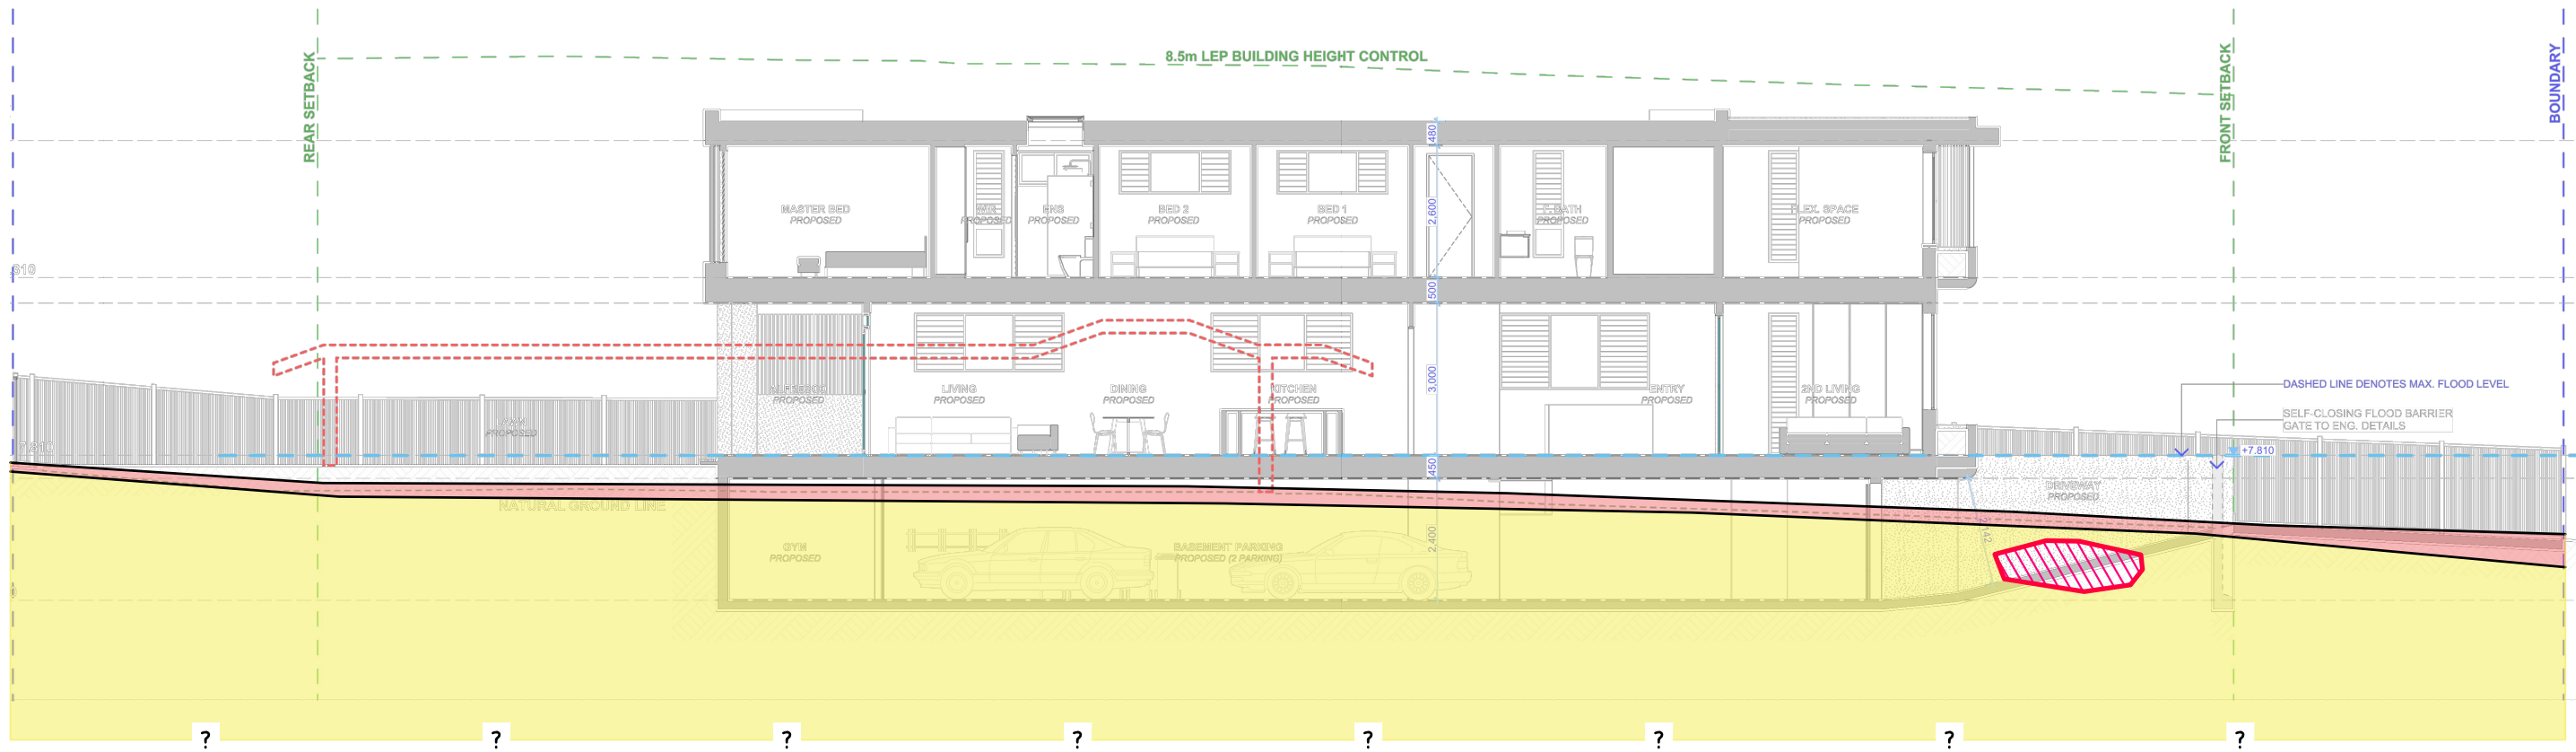
INFERRED GEOLOGICAL SECTION
SCALE NTS

Unit	Material	Comments
1	Topsoil / Fill	Sandy topsoil and fill material. Unit 1 is inferred to be uncontrolled and poorly compacted
2	Sand	Fine to medium grained sand of alluvial origin, to depths up to and greater than 4.5m. Loose at shallow depths and becoming medium dense at depth.
3	Sandstone	Not encountered within 4.5m depth. Depth to bedrock is unknown.

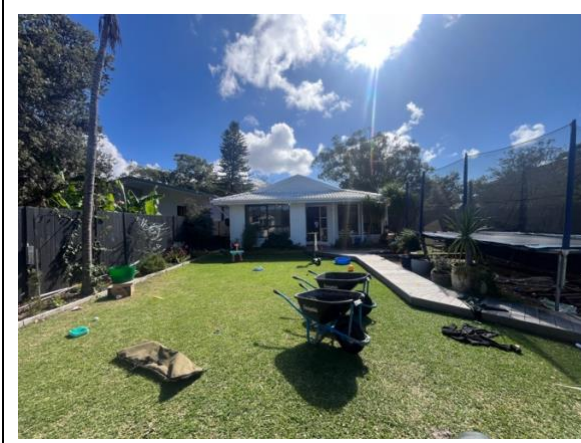
Photo 1: Looking north, residence frontage

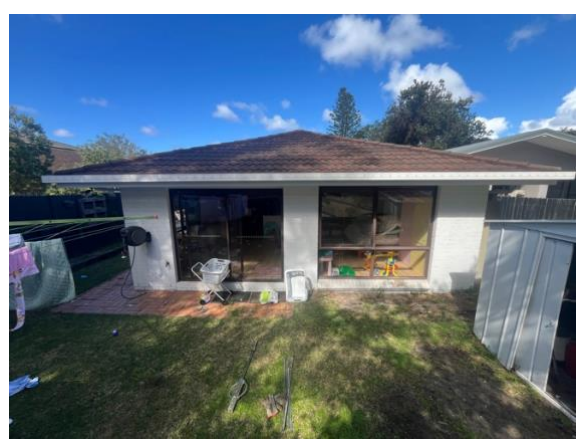
Photo 2: Looking south, residence rear.

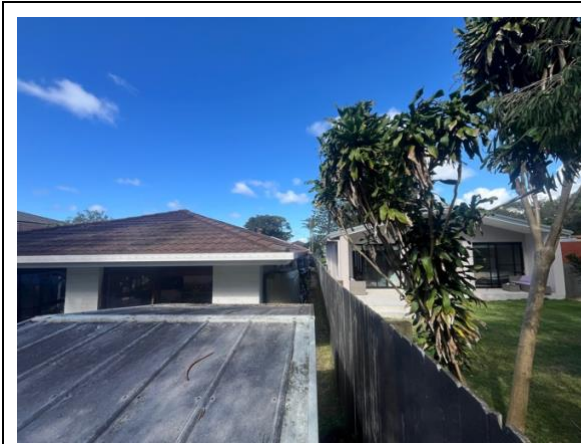
Photo 3: Looking south along western boundary

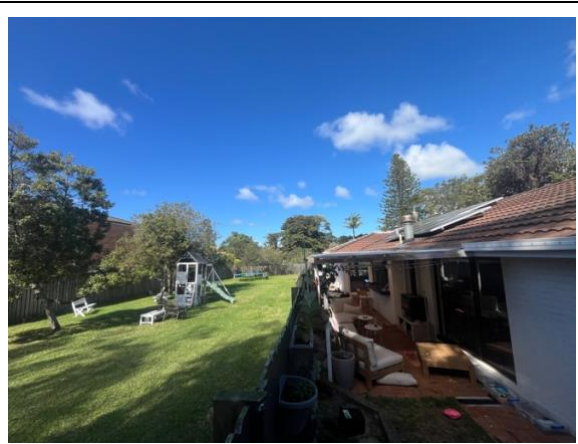
Photo 4: Looking south along eastern boundary
