**GEOTECHNICAL RISK MANAGEMENT POLICY FOR PITTWATER**  
**FORM NO. 1 – To be submitted with Development Application**

Report Title: Geotechnical Report 15 Hudson Parade, Avalon  
Report Date: 12/06/20  
Author: BEN WHITE  
Author's Company/Organisation: WHITE GEOTECHNICAL GROUP PTY LTD

## **GEOTECHNICAL INVESTIGATION:**

Alterations and Additions at **15 Hudson Parade, Avalon.**

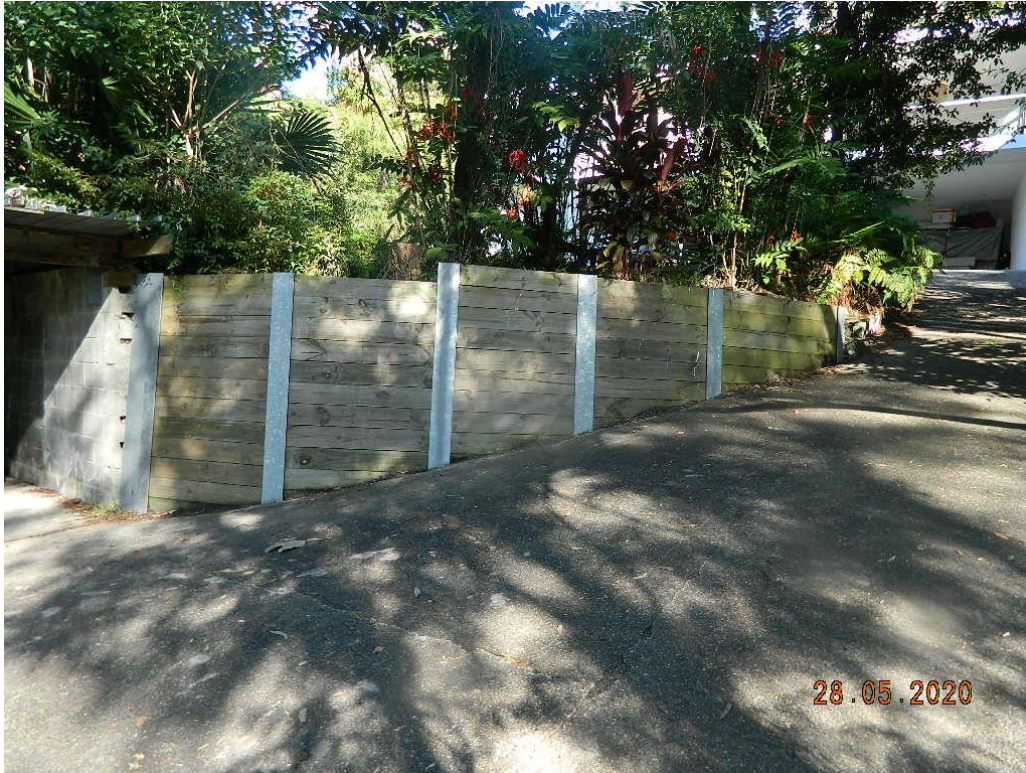
Photo 3

- 2.1** The site was inspected on the 28<sup>th</sup> of May, 2020.
- 2.2** This residential property is on the high side of the road and has a N aspect. It is located on the moderately graded middle reaches of a hillslope. The natural slope rises across the property at an average angle of ~13°. The slope above the property rises at increasing angles. The grade below the site gradually eases
- 2.3** At the road frontage a concrete driveway runs to a carport near the lower boundary and a garage within the house (Photos 1 & 2). Filling has been placed above the carport and beside the driveway (Photo 3). It is supported by a combination of

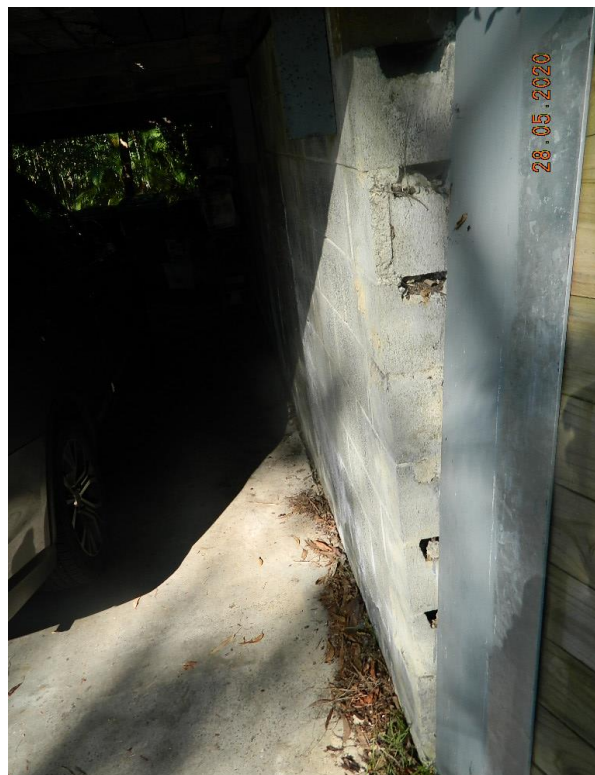
Photo 4

concrete block and soldier pile retaining walls. The downhill side of the concrete block retaining wall is tilting to a maximum angle of  $\sim 3.5^\circ$  downslope (Photo 4). This portion of the wall will be demolished as part of the proposed works. The E side of the concrete block retaining wall lines the common boundary (Photo 5). On the lower corner the wall has separated  $\sim 0.2\text{m}$  from the adjoining wall and it is tilting to a maximum angle of  $\sim 5.5^\circ$  from vertical (Photo 6). See 'Section 16 Remedial Works'. The soldier pile retaining wall displays no significant signs of movement and is considered stable (Photo 3). The old, two storey brick house displays no significant signs of movement in the external supporting walls that could be associated with slope instability (Photo 7).

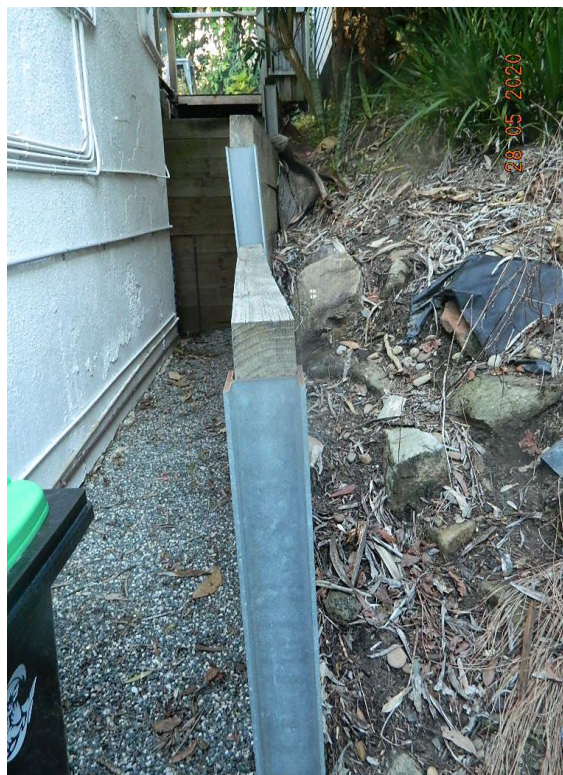
Photo 8

A  $\sim 2.0\text{m}$  cut has been made into the slope beside the SW side of the house (Photo 8). The excavation extends into the neighbouring property and is supported by a soldier pile retaining wall. The NW section of the retaining wall is tilting at up to  $\sim 3.7^\circ$  from vertical. The upper E supporting steel post of the wall is braced by the suspended timber walkway that is attached to the subject house. The suspended timber walkway is located near the SW corner of the house (Photo 9). Under the walkway old sandstone block retaining walls support cuts and fills (Photos 10 & 11). The retaining walls are in a dilapidated state. See 'Section 16 Remedial Works'. An excavation has been made into slope beside the walkway for a lawn area (Photo 12). The cut is battered to an angle of  $\sim 45^\circ$  and mortared sandstone flagging has been placed over the cut face. No signs of slope instability were observed on the property. The adjoining neighbouring properties were observed to be in good order as seen from the street and subject property.

The concrete block and soldier pile retaining walls (Photos 5, 6, 8, 10 & 11) are to be monitored by the owners on an annual basis or after heavy prolonged rainfall events, whichever occurs first. A photographic record of these inspections is to be kept. Should further movement occur the walls are to be remediated so they meet current engineering standards. We can carry out these inspections upon request.
