**re: GEOTECHNICAL ASSESSMENT / LANDSLIDE RISK APPRAISAL
PROPOSED INDEPENDENT LIVING DEVELOPMENT
PENINSULA GARDENS RETIREMENT VILLAGE, 79 CABBAGE TREE RD BAYVIEW NSW**

**REPORT ON
GEOTECHNICAL ASSESSMENT / LANDSLIDE RISK APPRAISAL**

**PROPOSED INDEPENDENT LIVING DEVELOPMENT
PENINSULA GARDENS RETIREMENT VILLAGE
No.79 CABBAGE TREE RD BAYVIEW NSW**

report ref: R/17-049.A

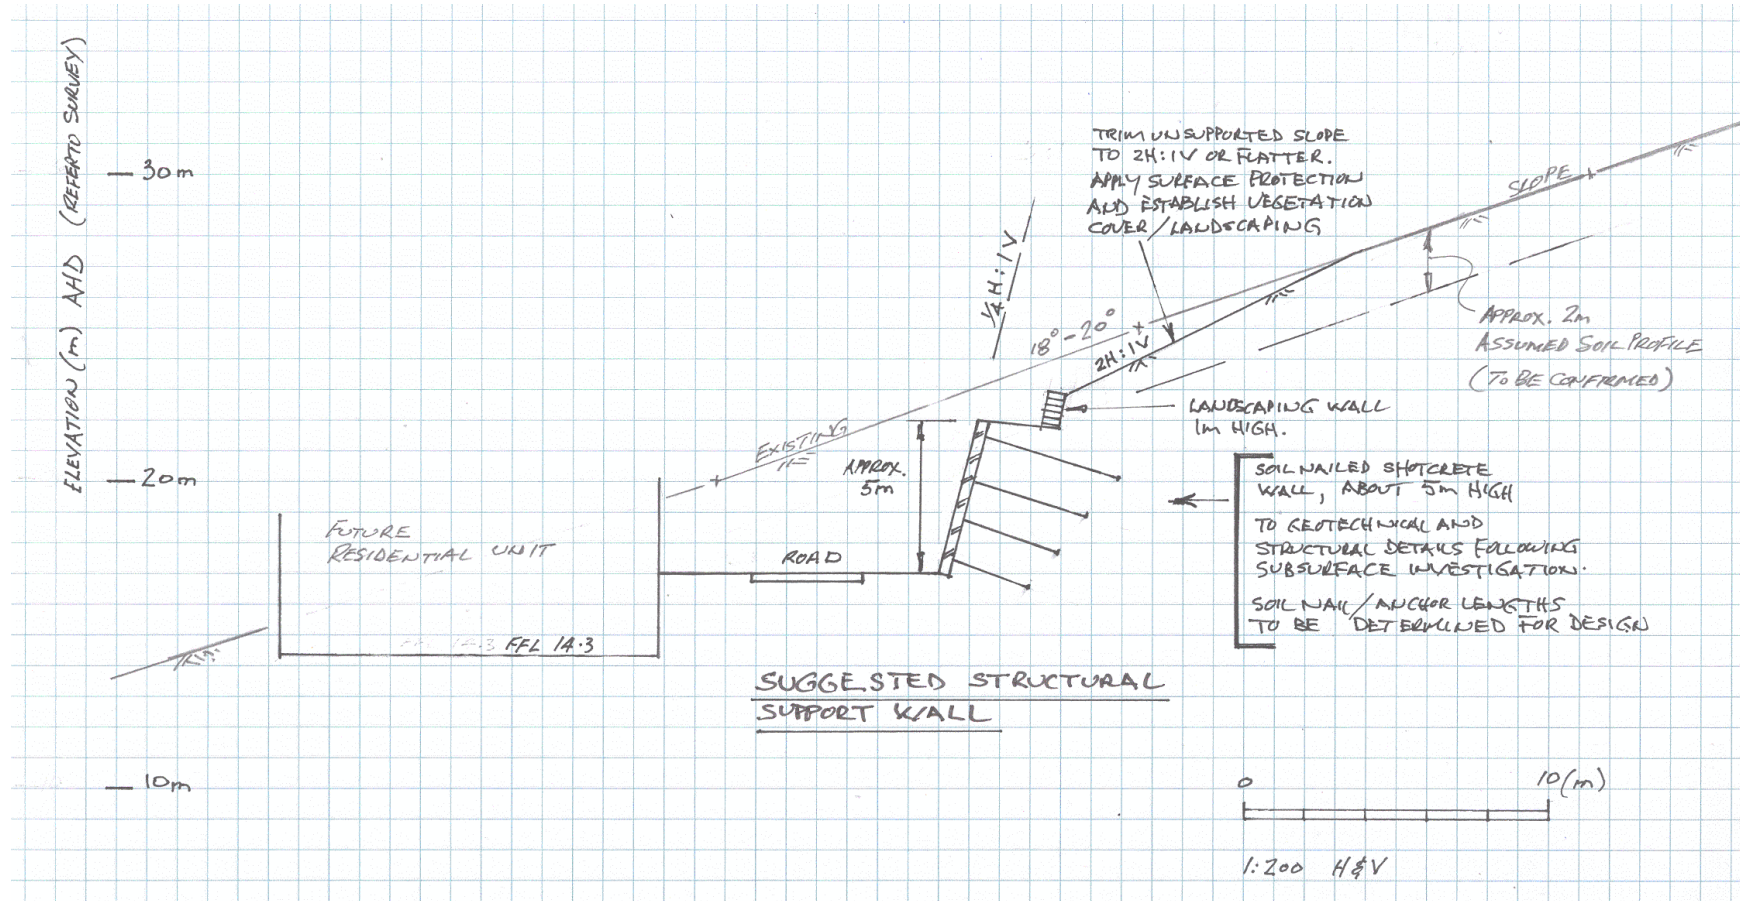
Figure 4C

An example of a structural support wall is provided in Figure 4C, comprising a soil nailed shotcrete facing for the lower 5m height, and a bench with a low landscaping wall and 2H:1V trimmed batter above. Construction staging for such a design can be determined so as to maintain stable slope conditions during construction.

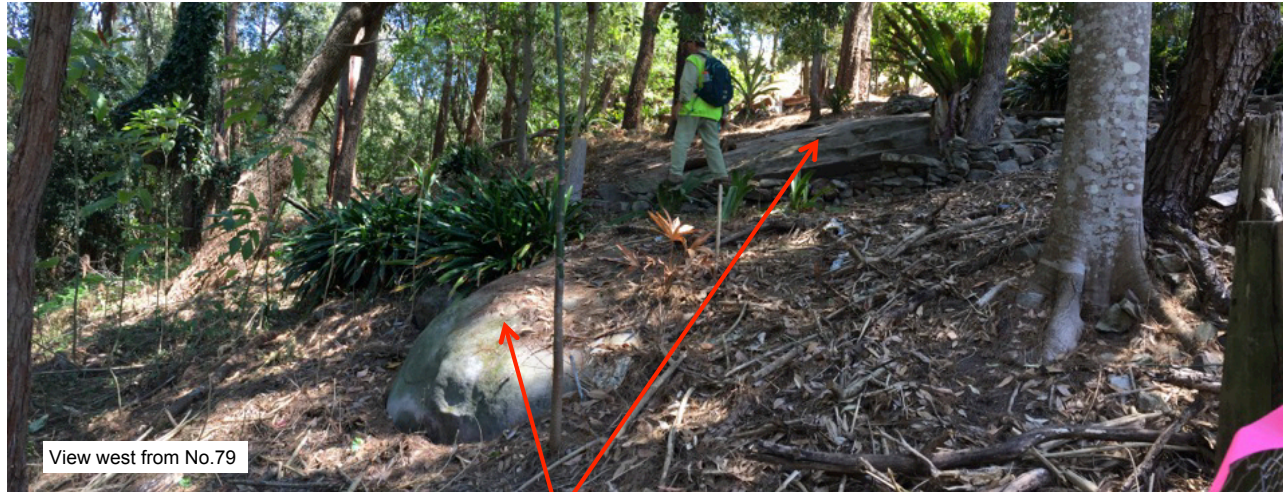
View west from No.79

Large sandstone floaters

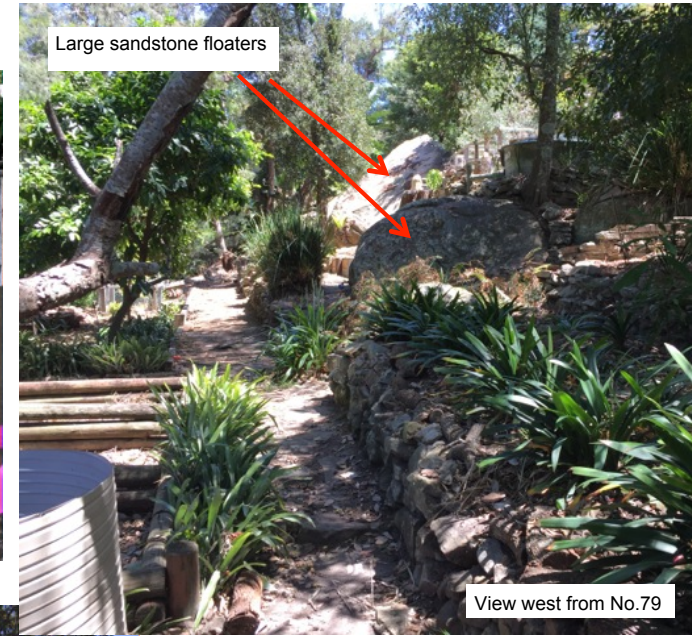
Large sandstone floaters

View west from No.79

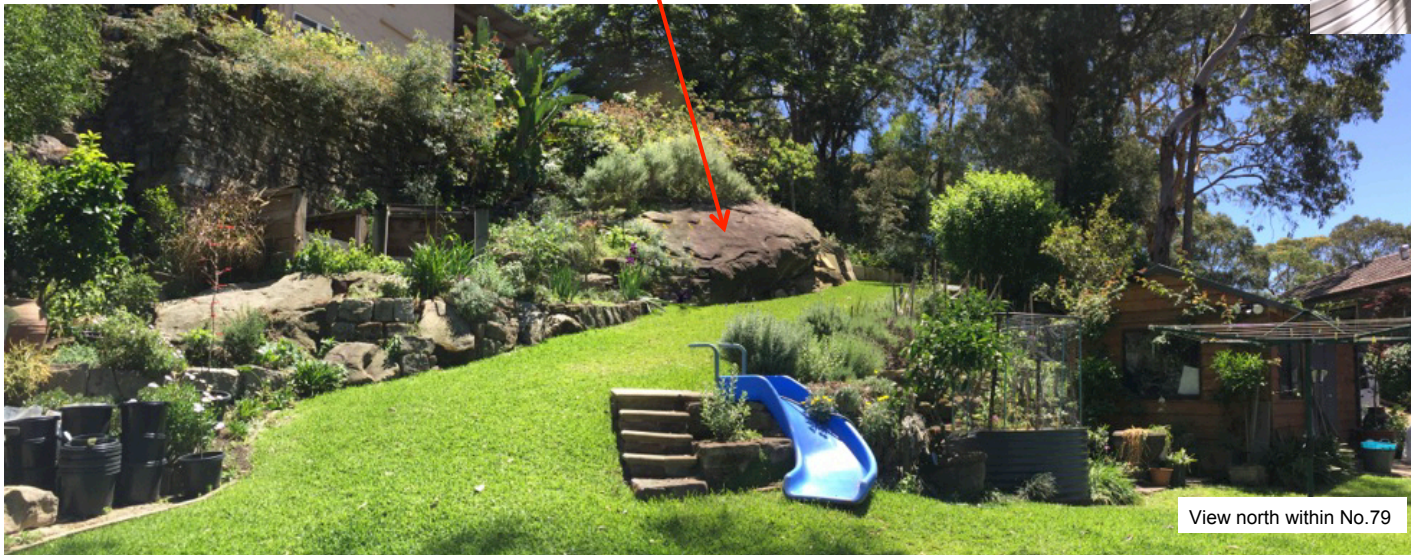
View north within No.79

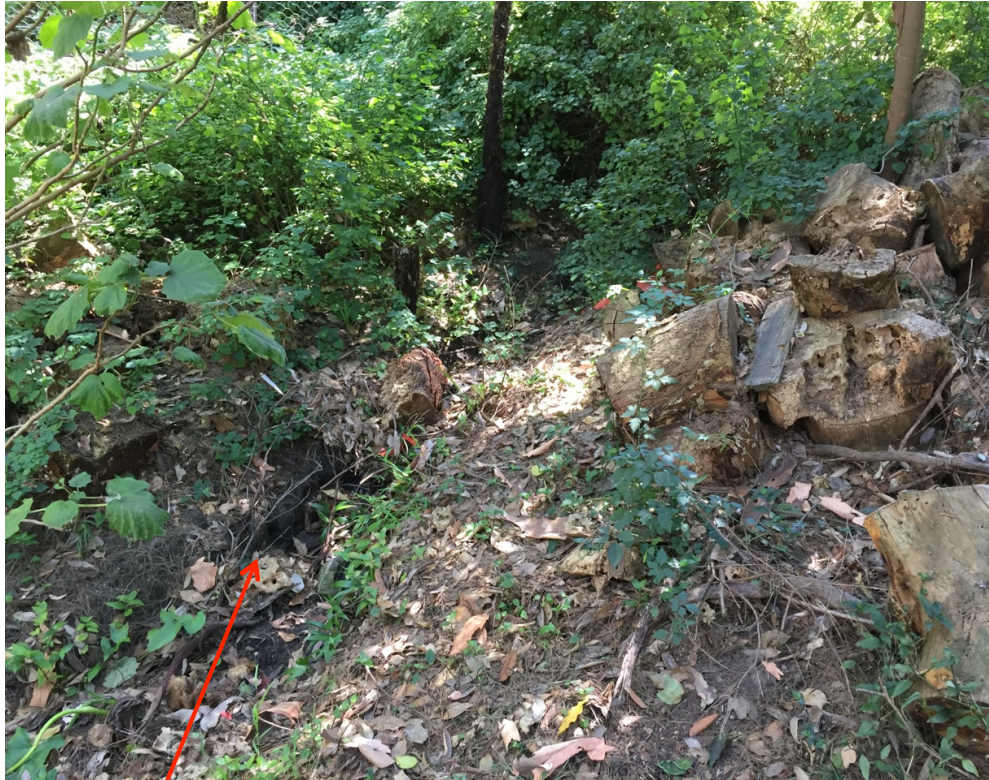
[Traverse T2] Drainage line emanating from No.83

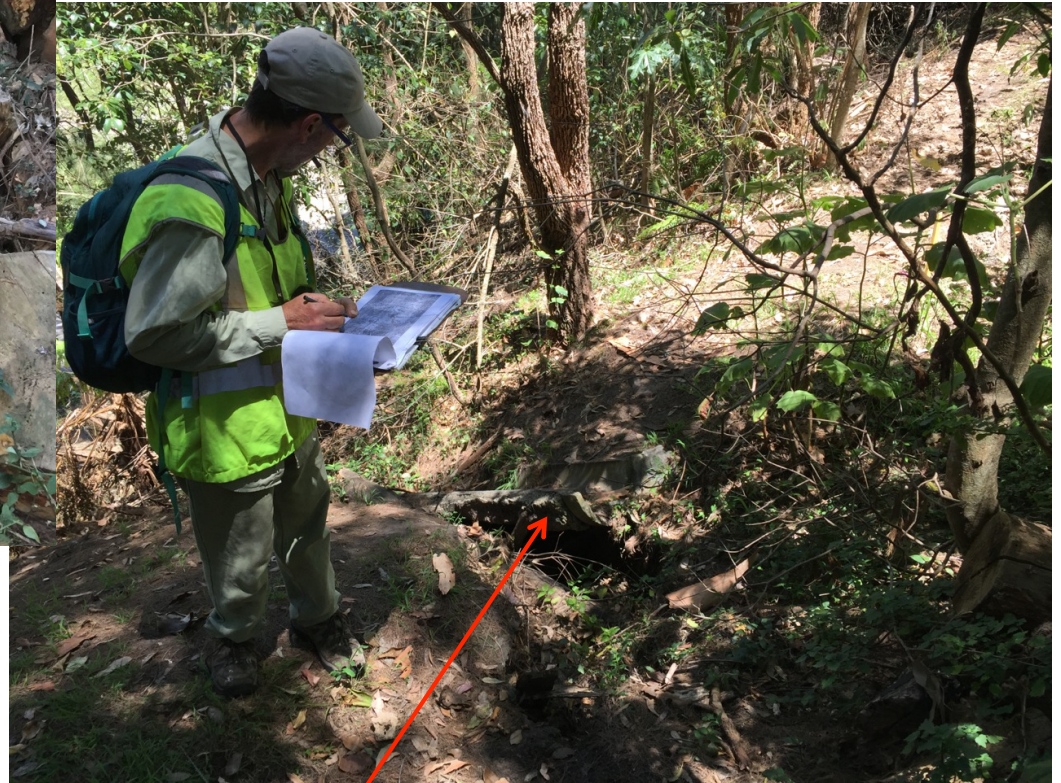
[Traverse T2]
Half-round concrete batter drain eroded beneath
by water from drainage line off No.83

- j) In regard to Clause 6.5(g)(iv) of the Geotechnical Risk Management Policy (conditions regarding ongoing management of the site/structure), the following measures are recommended (further details in Appendix A):-
- maintenance and/or improvements (as necessary) for surface drainage about the site and roof water disposal, in accordance with the approved design;
 - monitoring of the performance of drainage systems about the site, particularly during and following rainfall events;

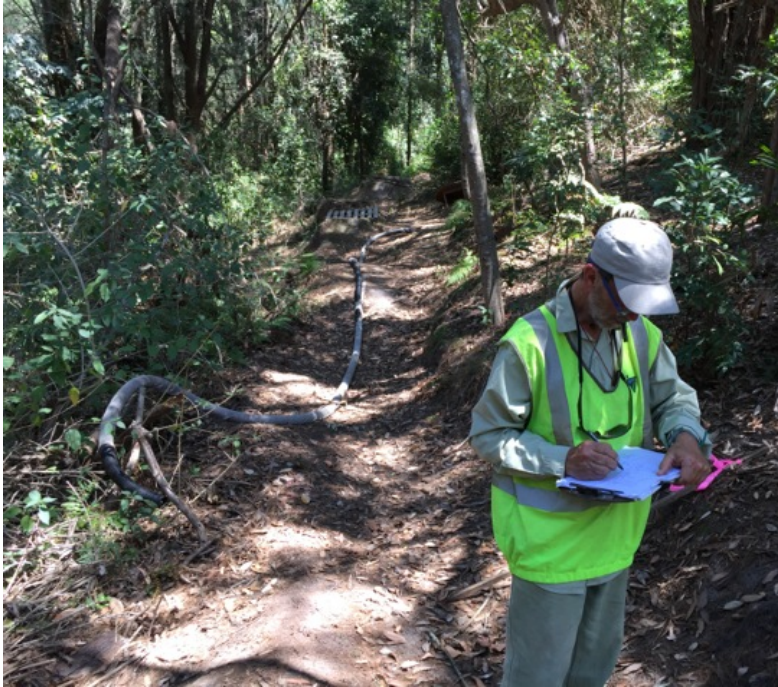
[Traverse T2] View west along "BMX" track

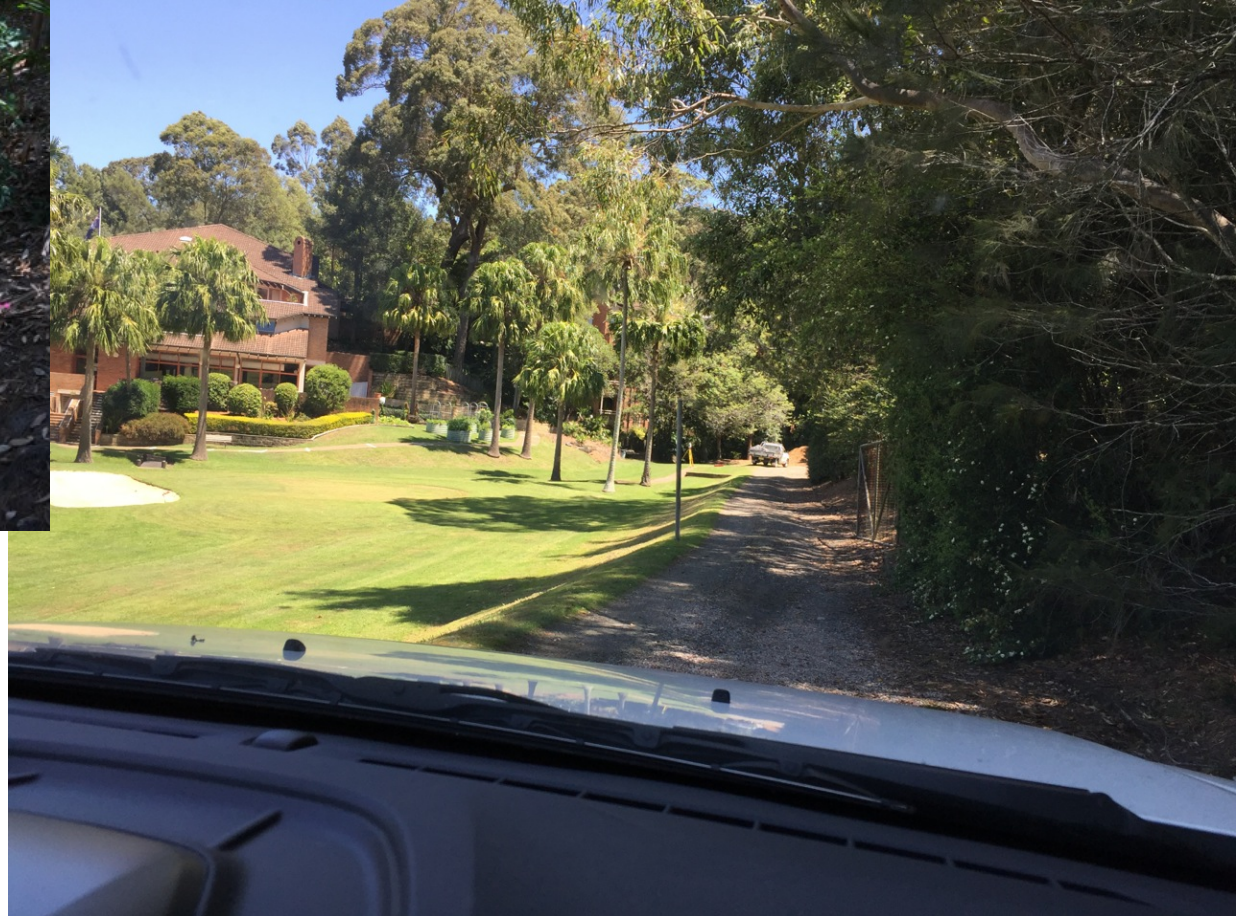
View west along vehicular access track at base of northern hillside

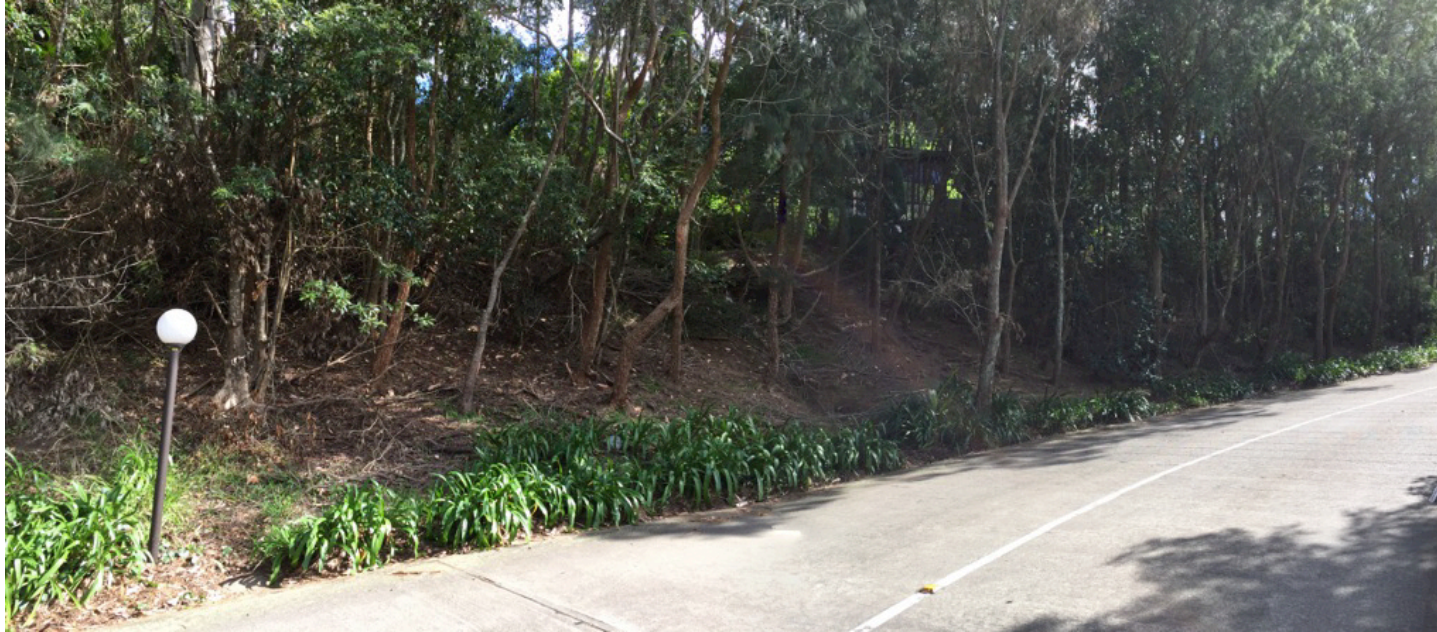
Cut batter on western side of internal access road

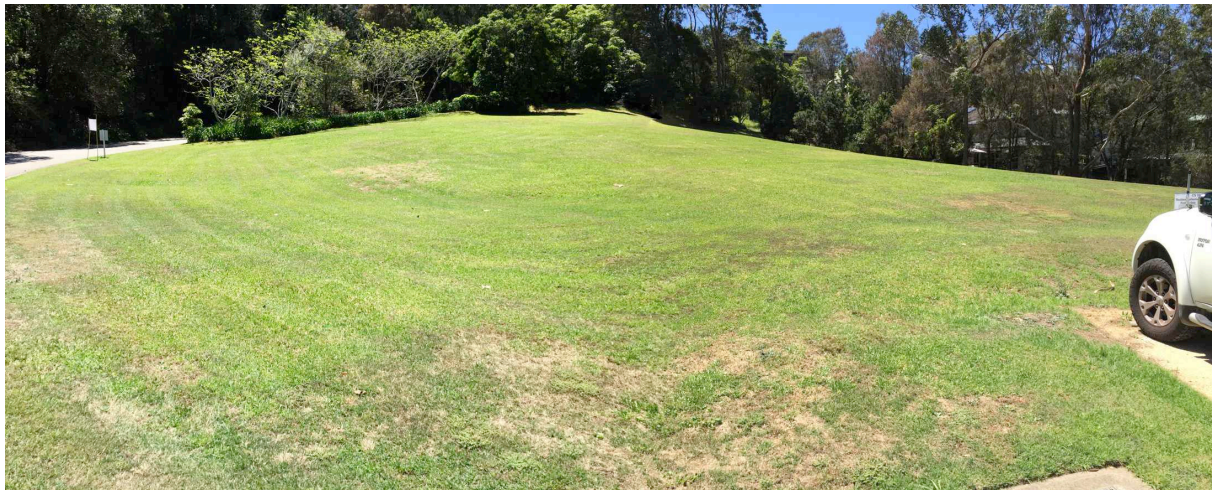
View north across lower grassed footslope area east of internal access road (site for eastern residential units)
