## WSA assessment

Date: <b>06/07/2020</b>	Contract No: <b>GLA003-001</b>	Asset Owner: <b>Sydney Water</b>	Operator : <b>S. Kimber</b>	Section number: <b>1</b>	Pipe Asset Id: <b>Line 1</b>
Time of inspection:	Cleaning: <b>not cleaned</b>	Standard: <b>WSA 05-2008 2.2</b>	LRP <b>Inside Face of the Wall</b>	Conduit Unit Length	Method of Inspection <b>Television Camera</b>

Town: Suburb: <b>Frenchs Forest</b> Street: <b>Arden Place</b> Asset Location <b>Reserve, park, public area</b>	Catchment: Asset Owner: <b>Gladys Forest Pty Ltd</b> Precipitation.: Flow control <b>No measures</b>	US MH: <b>SPP01246</b> Survey Dir: <b>upstream</b> DS MH: <b>SPP01246</b> Inspect Length : <b>2.92 m</b>
--	---	---

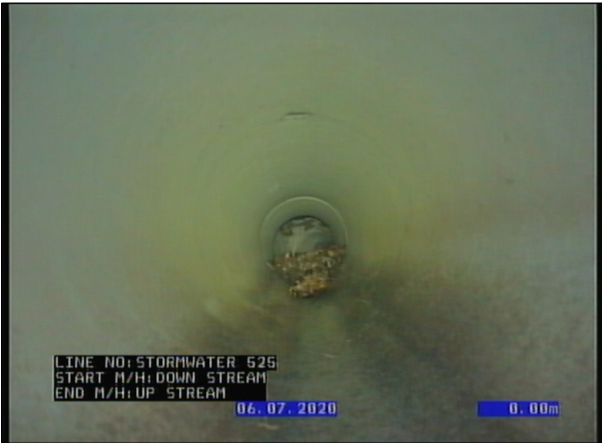
Photo: 4\_1A  
0m, Start node, maintenance hole, Nodename: SPP01246

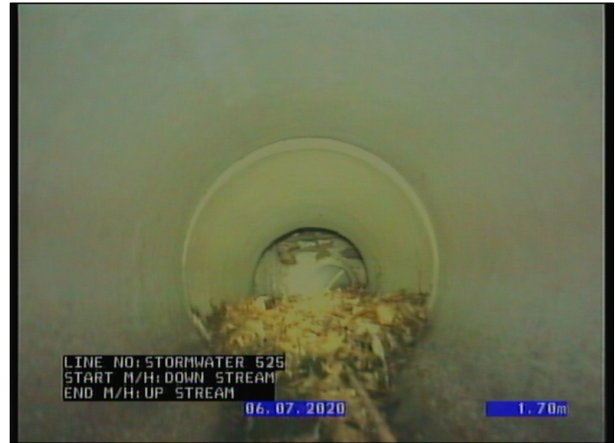
Photo: 4\_2A  
2.64m, Joint displaced radially, radial displacement 5-10mm , at 12 o'clock

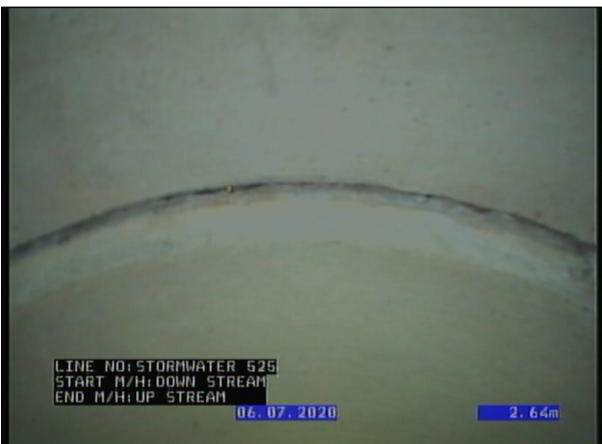
Photo: 4\_2B  
2.64m, Joint displaced radially, radial displacement 5-10mm , at 12 o'clock

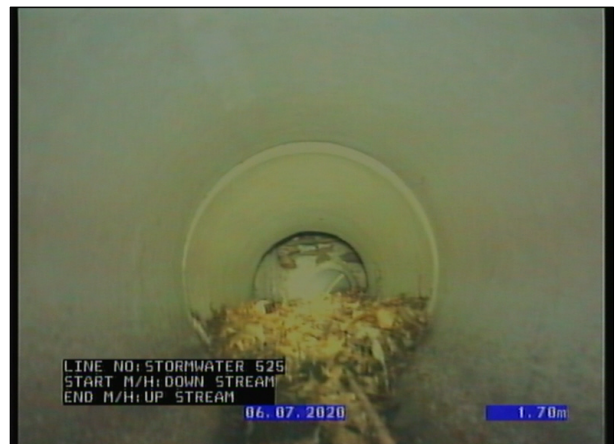
Photo: 4\_3A  
2.92m, Inspection (survey) abandoned, Build up of leaves from pit

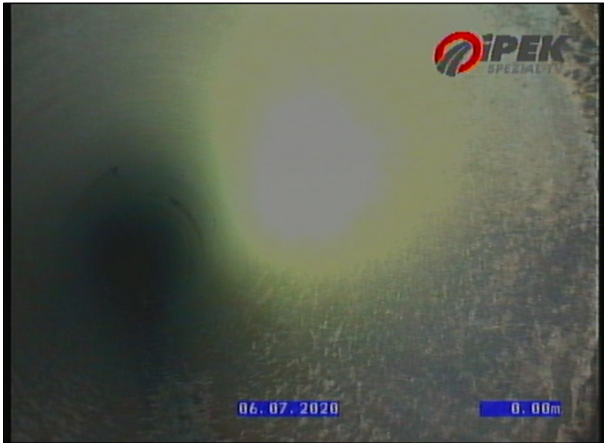
Photo: 2\_1A  
0m, Start node, maintenance hole, Nodename: SPP01246

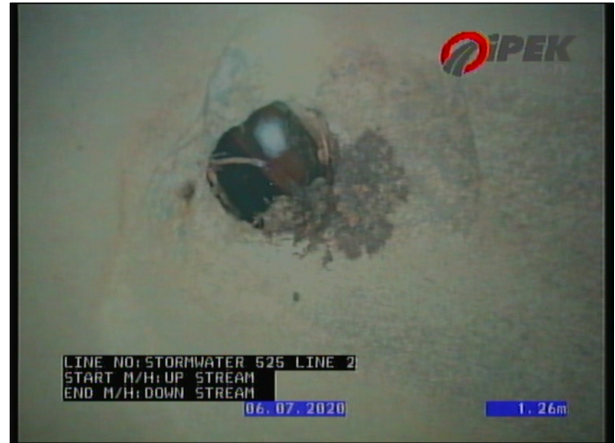
Photo: 2\_2A  
1.26m, Connection, good workmanship, connection appears to be open, height 50mm , at 2 o'clock

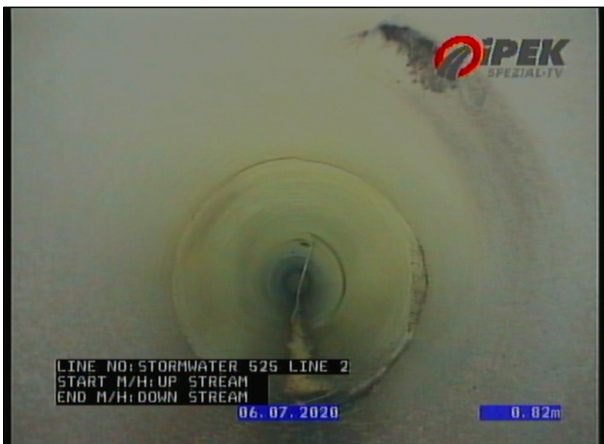
Photo: 2\_3A  
1.66m, Breaking, all pieces are present but some of them are visibly displaced from position, length of break 100 , from 12 to 12 o'clock

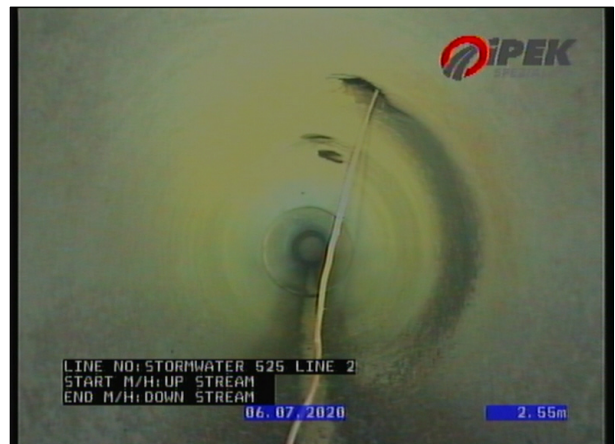
Photo: 2\_4A  
3.25m, Connection, good workmanship, connection appears to be open, height 50mm , at 1 o'clock

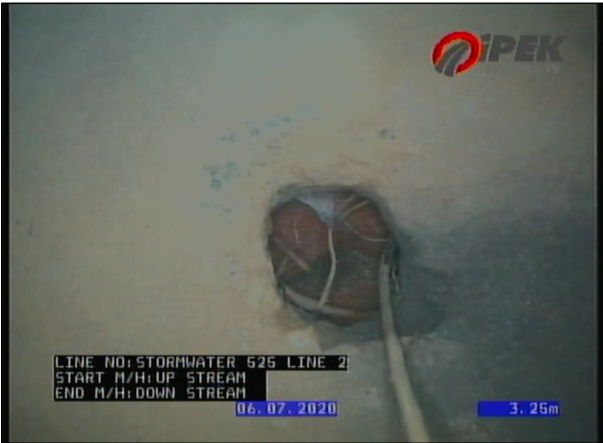
Photo: 2\_4B  
3.25m, Connection, good workmanship, connection appears to be open, height 50mm , at 1 o'clock

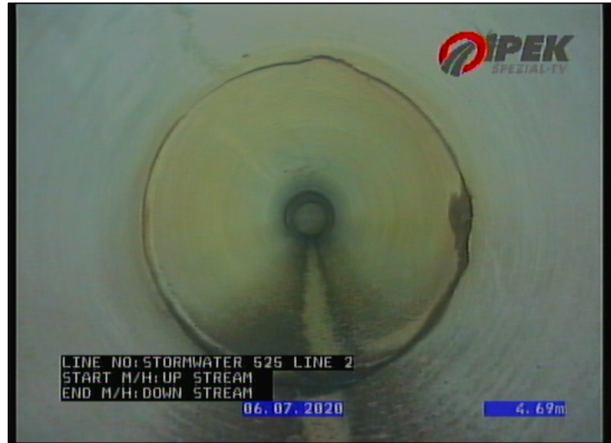
Photo: 2\_7A  
5.53m, Infiltration, sweating, at joint , from 3 to 7 o'clock

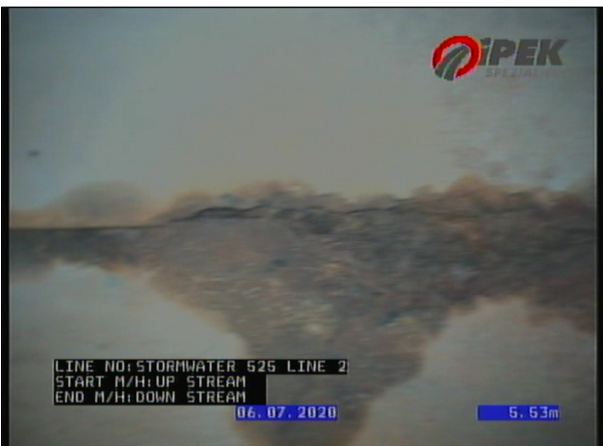
Photo: 2\_7B  
5.53m, Infiltration, sweating, at joint , from 3 to 7 o'clock

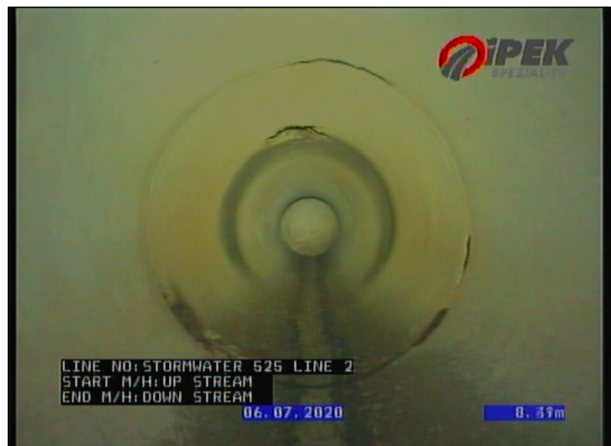
Photo: 2\_7A  
9.29m, Breaking, all pieces are present but some of them are visibly displaced from position, length of break 100 , from 12 to 12 o'clock

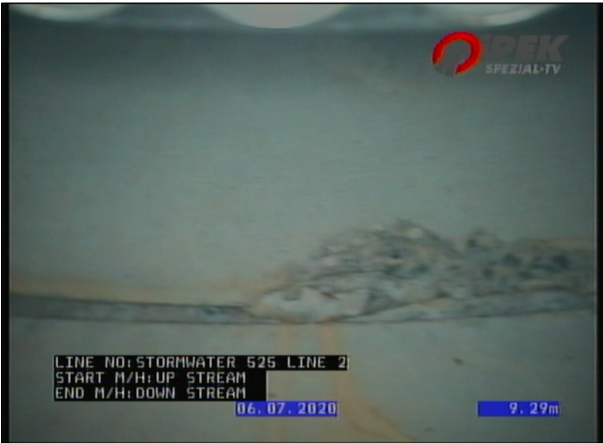
Photo: 2\_7B  
9.29m, Breaking, all pieces are present but some of them are visibly displaced from position, length of break 100 , from 12 to 12 o'clock

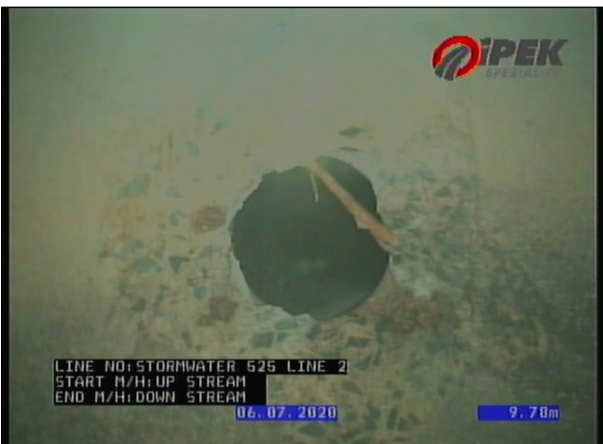
Photo: 2\_9B  
9.78m, Connection, poor workmanship, connection appears to be open , height 50mm

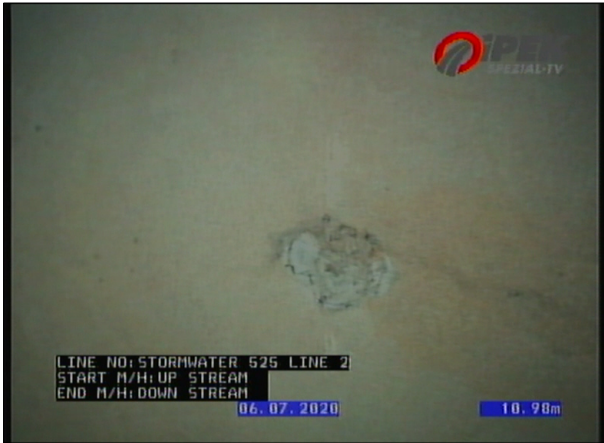
Photo: 2\_8B  
10.99m, Some coarse aggregate is visible , Obstruction: <5% ,  
at 1 o'clock

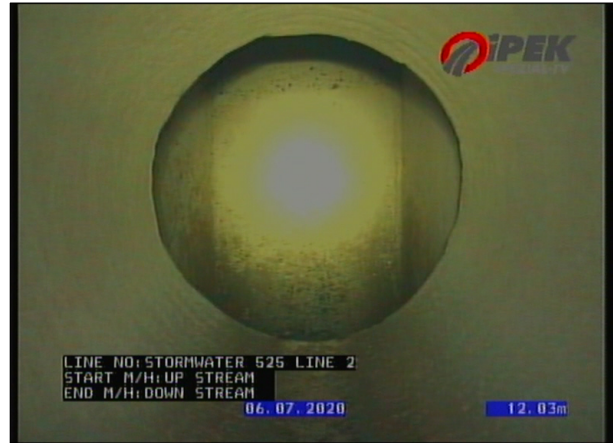
Photo: 2\_9A  
12.63m, Finish node, maintenance hole, Nodename: SPP01594

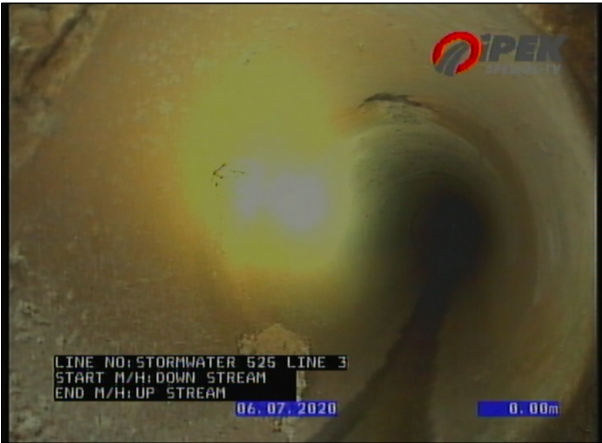
Photo: 6\_1A  
0m, Start node, maintenance hole, Nodename: SPP04649

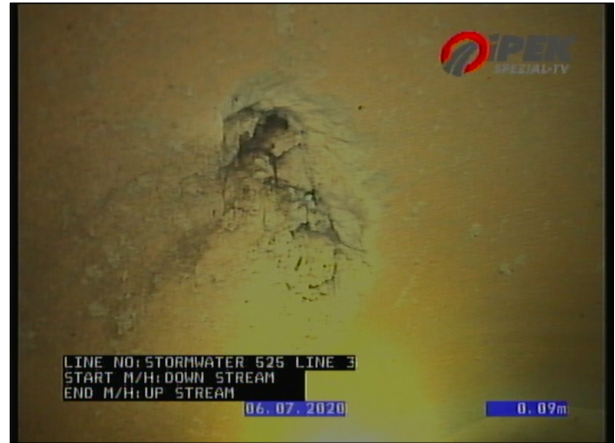
Photo: 6\_2A  
0.09m, Breaking, all pieces are present but some of them are visibly displaced from position, length of break 100 , at 10 o'clock

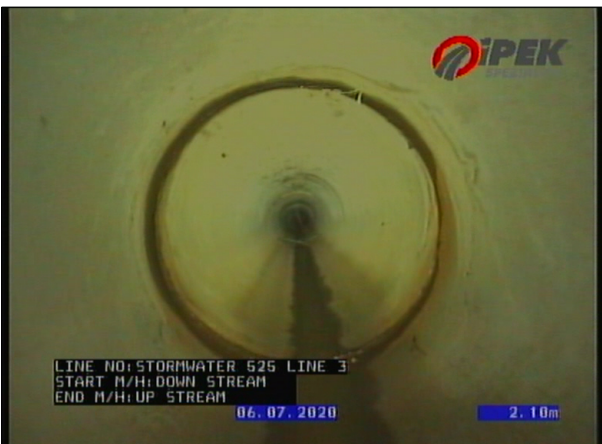
Photo: 6\_3A  
2.88m, Infiltration, sweating, at joint , from 12 to 12 o'clock

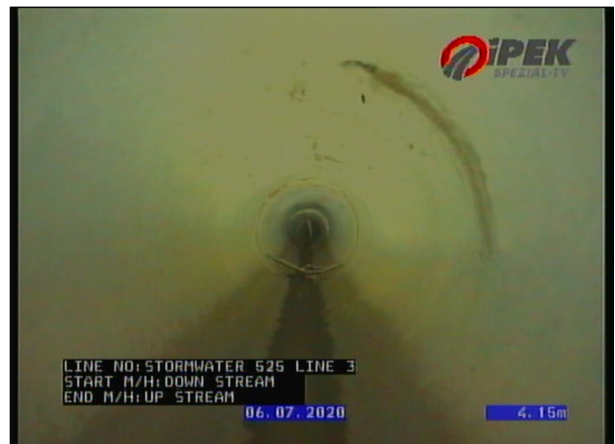
Photo: 6\_4A  
4.72m, Infiltration, sweating , at 1 o'clock

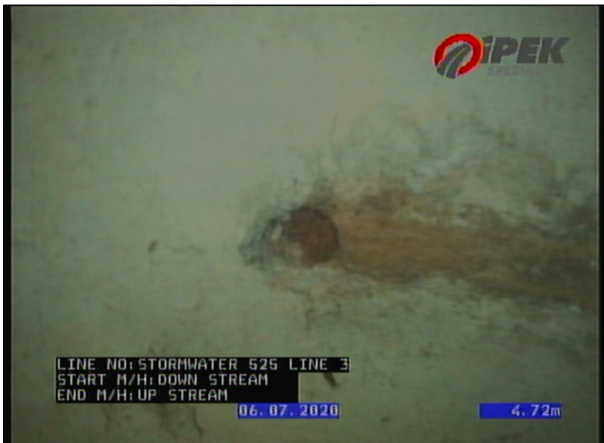
Photo: 6\_4B  
4.72m, Infiltration, sweating , at 1 o'clock

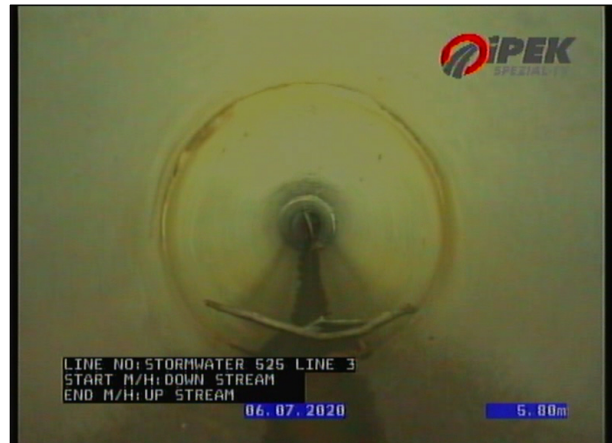
Photo: 6\_4A  
6.71m, Deposits in the invert, other material Branch ,  
Obstruction: <5% , at 6 o'clock

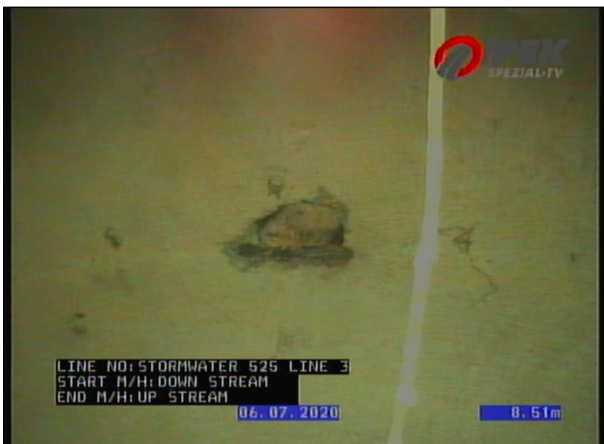
Photo: 3\_6A  
8.51m, Hole in wall , Obstruction: <5% , at 12 o'clock

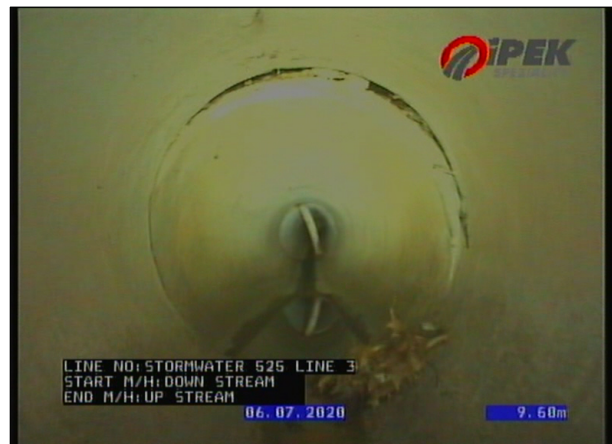
Photo: 6\_5A  
10.41m, Joint displaced radially, radial displacement 11-20mm ,  
at 1 o'clock

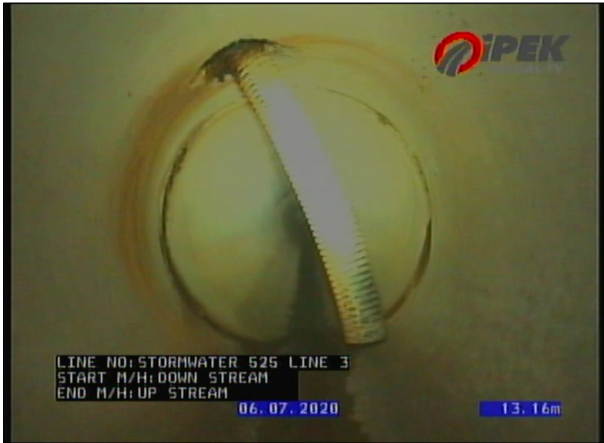
Photo: 6\_6A  
13.78m, Intruding connection, magnitude of intrusion: >75% , at 11 o'clock

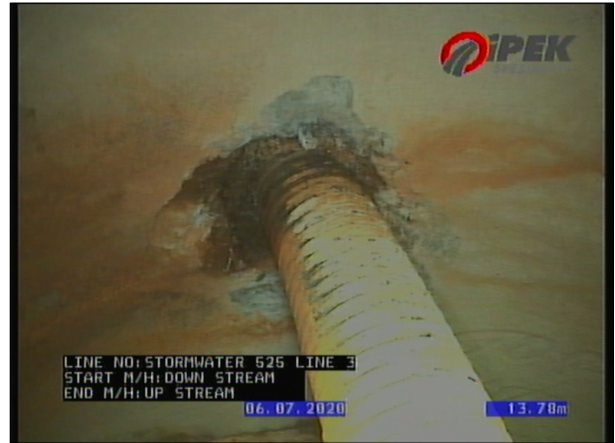
Photo: 6\_6B  
13.78m, Intruding connection, magnitude of intrusion: >75% , at 11 o'clock

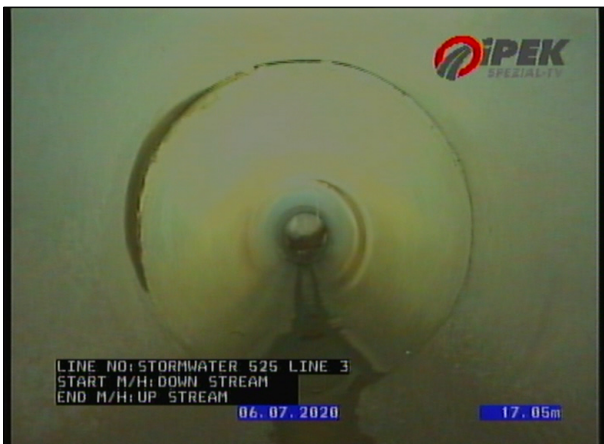
Photo: 6\_8A  
17.77m, Infiltration, sweating, at joint , at 10 o'clock

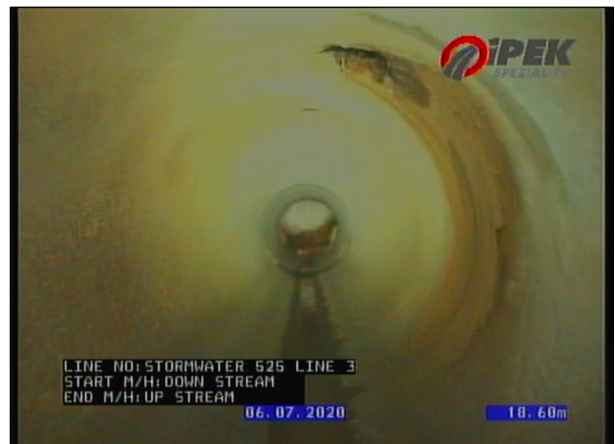
Photo: 6\_9A  
19.19m, Infiltration, sweating , at 1 o'clock

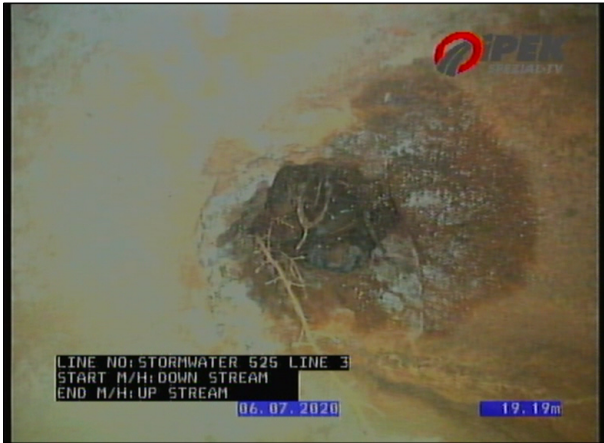
Photo: 6\_9B  
19.19m, Infiltration, sweating , at 1 o'clock

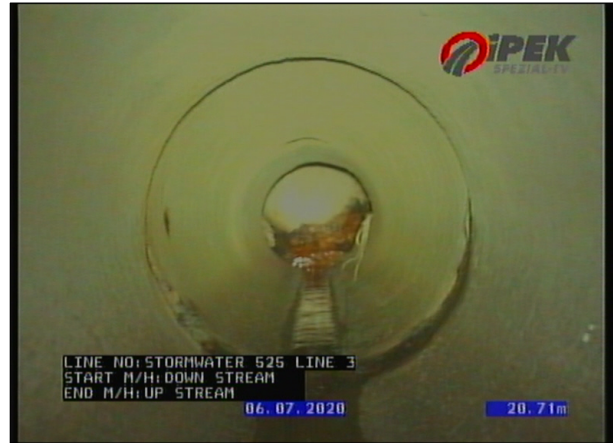
Photo: 6\_10A  
21.48m, Hard or compacted material in the invert, at joint,  
Obstruction: <5% , from 7 to 8 o'clock

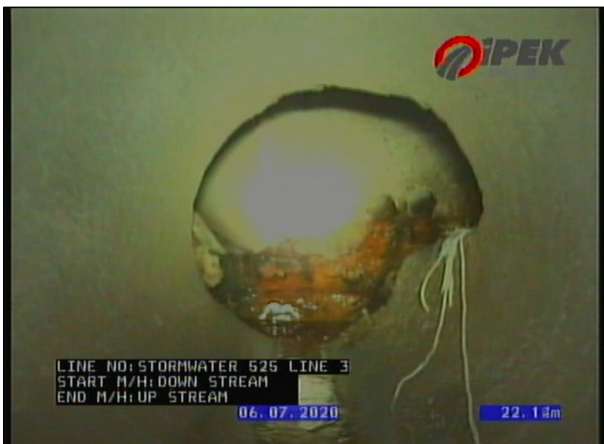
Photo: 6\_11A  
23.21m, Finish node, maintenance hole, Nodename: SPP01247

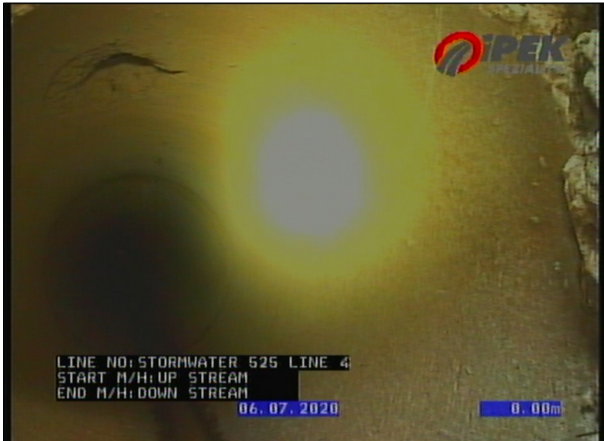
Photo: 4\_1A  
0m, Start node, maintenance hole, Nodename: SPP04649

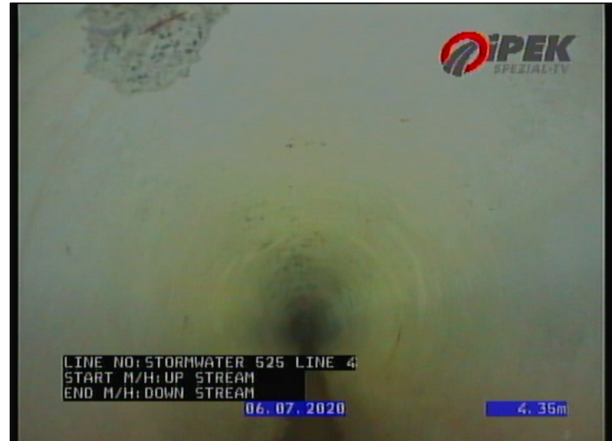
Photo: 4\_2A  
4.86m, Some coarse aggregate is visible , Obstruction: <5% , at 11 o'clock

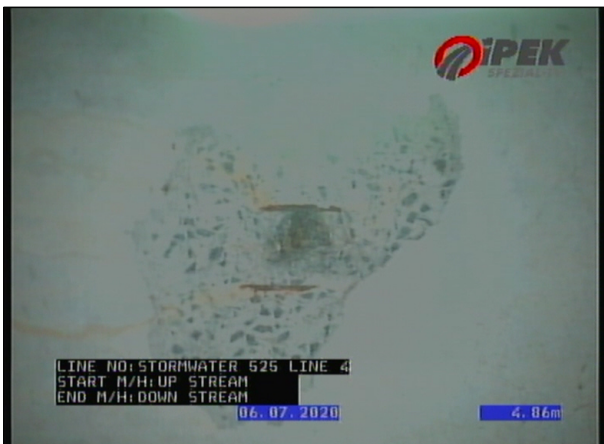
Photo: 4\_2B  
4.86m, Some coarse aggregate is visible , Obstruction: <5% , at 11 o'clock

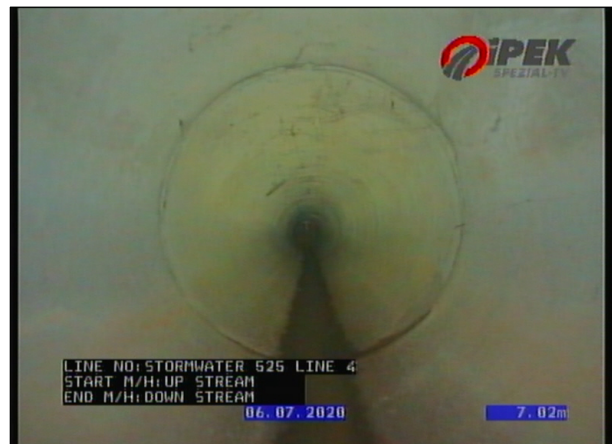
Photo: 4\_3A  
7.91m, Breaking, all pieces are present but some of them are visibly displaced from position, length of break 100 , from 10 to 1 o'clock

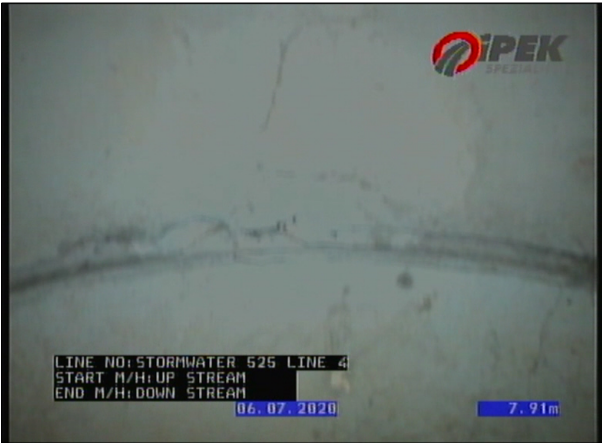
Photo: 4\_3B  
7.91m, Breaking, all pieces are present but some of them are visibly displaced from position, length of break 100 , from 10 to 1 o'clock

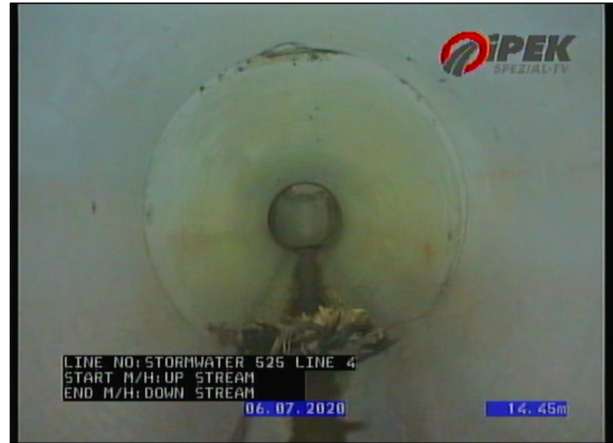
Photo: 4\_3A  
15.42m, Joint displaced radially, radial displacement 5-10mm , at 1 o'clock

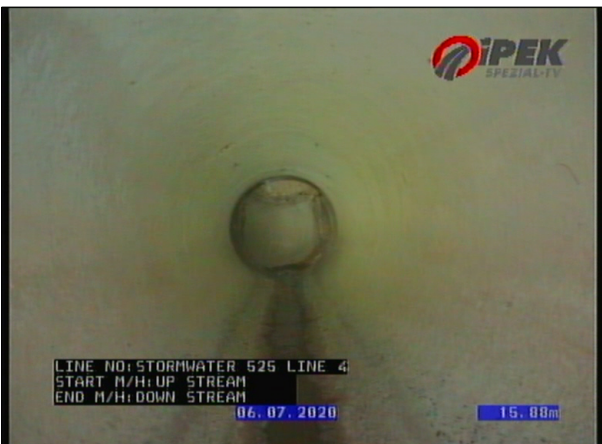
Photo: 4\_4A  
15.88m, Inspection (survey) abandoned, Buildup of leaves
