## **Geotechnical Assessment**

**Project:** Alterations and Additions  
40 Towradgi Street, Narraweena, NSW

**REF: AG 19121**  
30<sup>th</sup> July, 2019

For Alterations and Additions at  
40 Towradgi Street, Narraweena, NSW

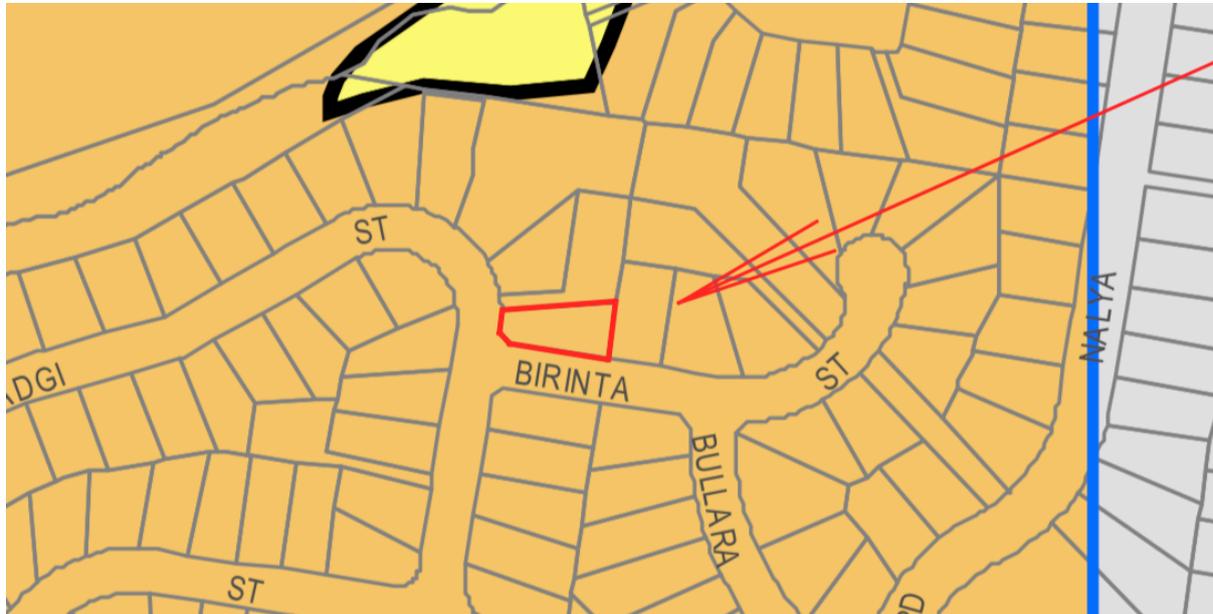
**WARRINGAH LANDSLIP RISK MAP**

- No evidence of significant soil creep, tension cracks or other indicators of slope instability were identified at the time of our visual assessment.
- The existing retaining wall displayed no evidence of significant cracking or settlement that could be attributed to slope instability.
- The property is classified ‘**Area B**’ in Northern Beaches Council WLEP Landslip Risk Map Sheet LSR\_007 (WLEP Landslip Risk Map **Image 2** below).

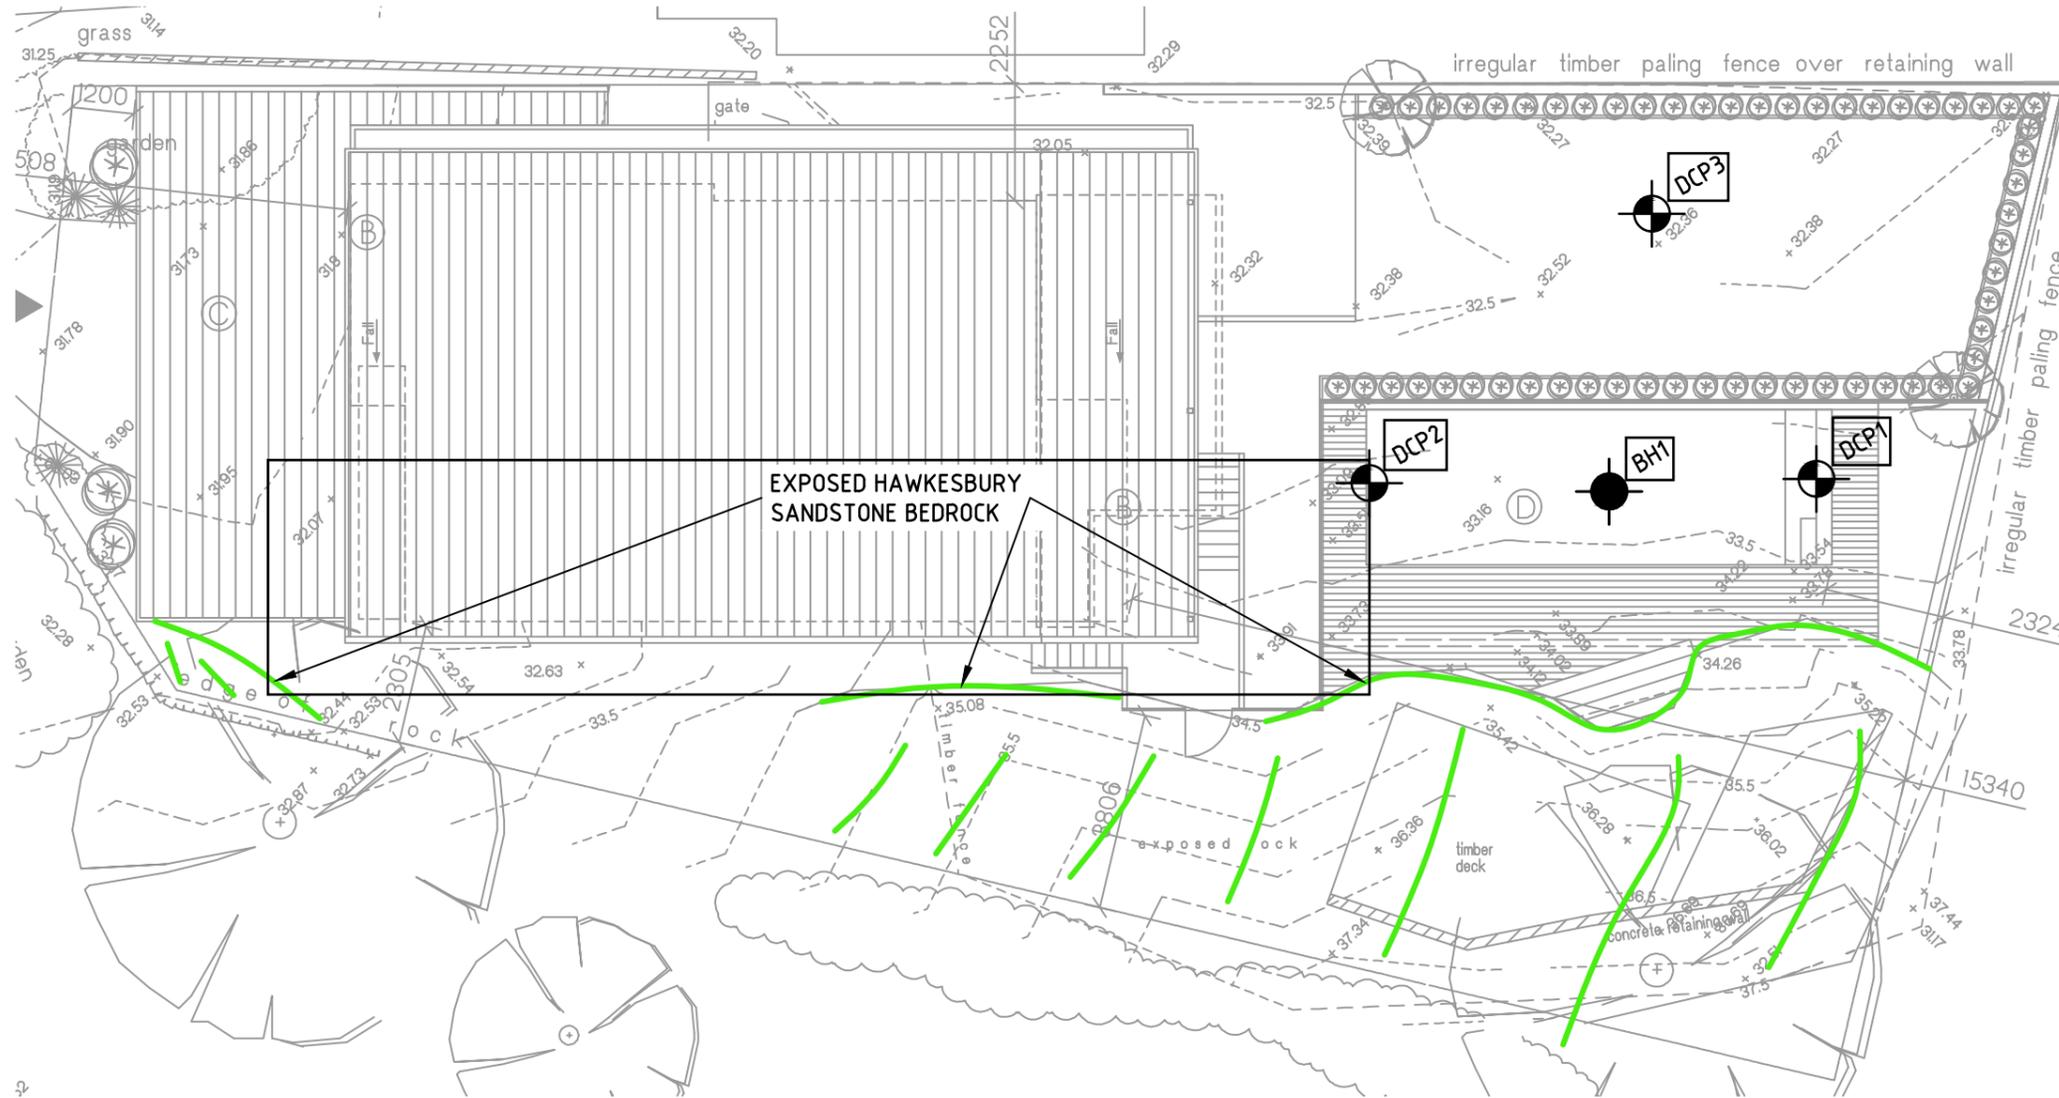
**SITE PLAN/GROUND TEST LOCATIONS**

BH1 - Depth	Material description
0.00 to 0.25m	SANDY SILT. Fill. Fine to medium grained, dark brown to black, loose, moist. Grass roots, weathered sandstone fragments in matrix.
	Borehole terminated at 0.25m due to grinding on weathered bedrock. No standing water table encountered.

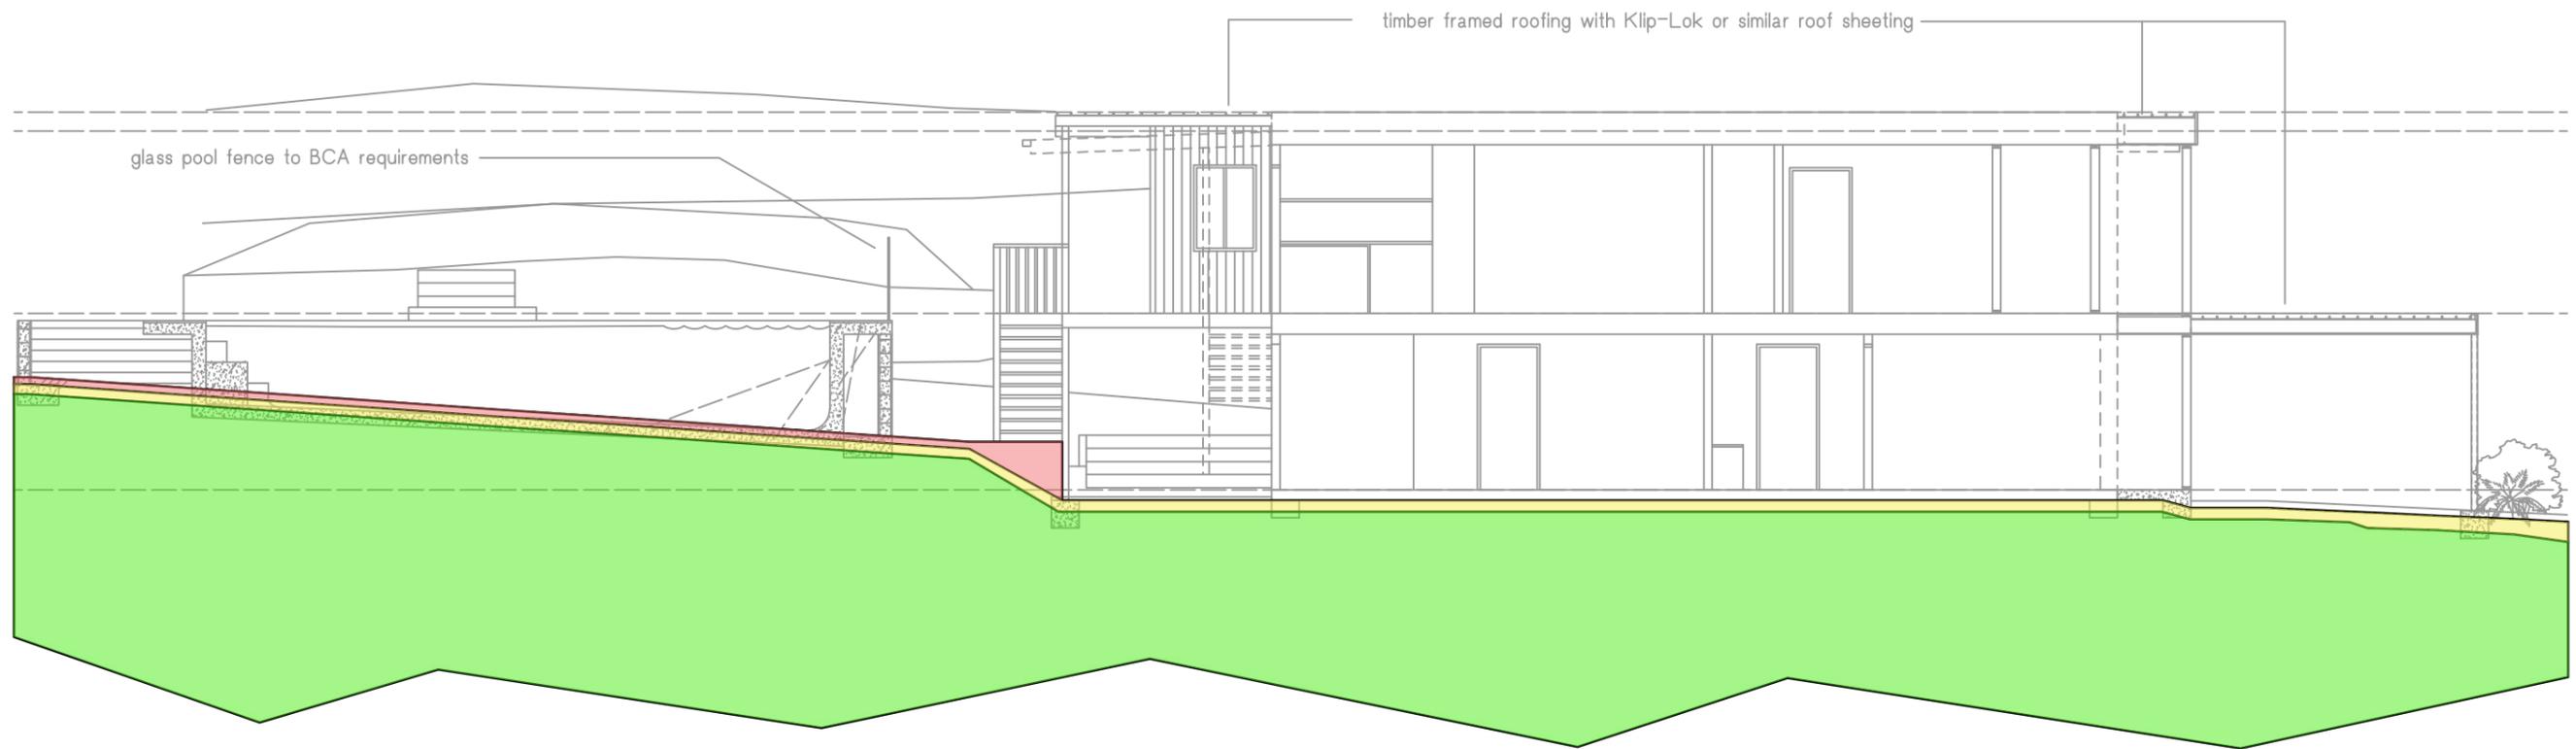
**INFERRED GEOLOGICAL SECTION**  
SCALE NTS

The soil profile consists of minor fill (O & A Horizons) overlying thin sandy clays (B Horizon) and weathered sandstone bedrock (C Horizon). Based on our observations and the results of testing onsite, we would expect competent weathered bedrock, to be found within 400-500mm from current surface levels across the site, where not already exposed.
