GEOTECHNICAL INVESTIGATION REPORT

PROPOSED SUBDIVISION

49 BLACKBUTTS ROAD, FRENCHS FOREST

Project No.: 2023-107

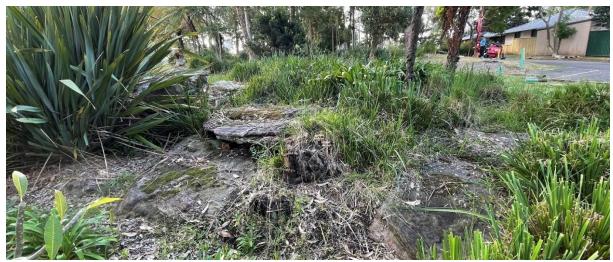
Interpreted sandstone boulders were observed predominantly towards the middle of the site, all appeared to be in a stable condition as seen in Photograph 4.

Photograph 4: View of the interpreted sandstone boulders, looking north

Boulders were identified at or underlying the existing ground surface, predominantly towards the front north of the site. The boulders that were observed during the site investigation appeared to be stable and did not arise any concerns, however following the demolition and clearance of the site structures any exposed boulders will need to be geotechnically inspected to assess their need for stabilization or removal.
