Site Condition Assessment

Date 3/10/24 Site # 23464

House No. 14 Street DAVENPORT

Suburb WARRIEWOOD

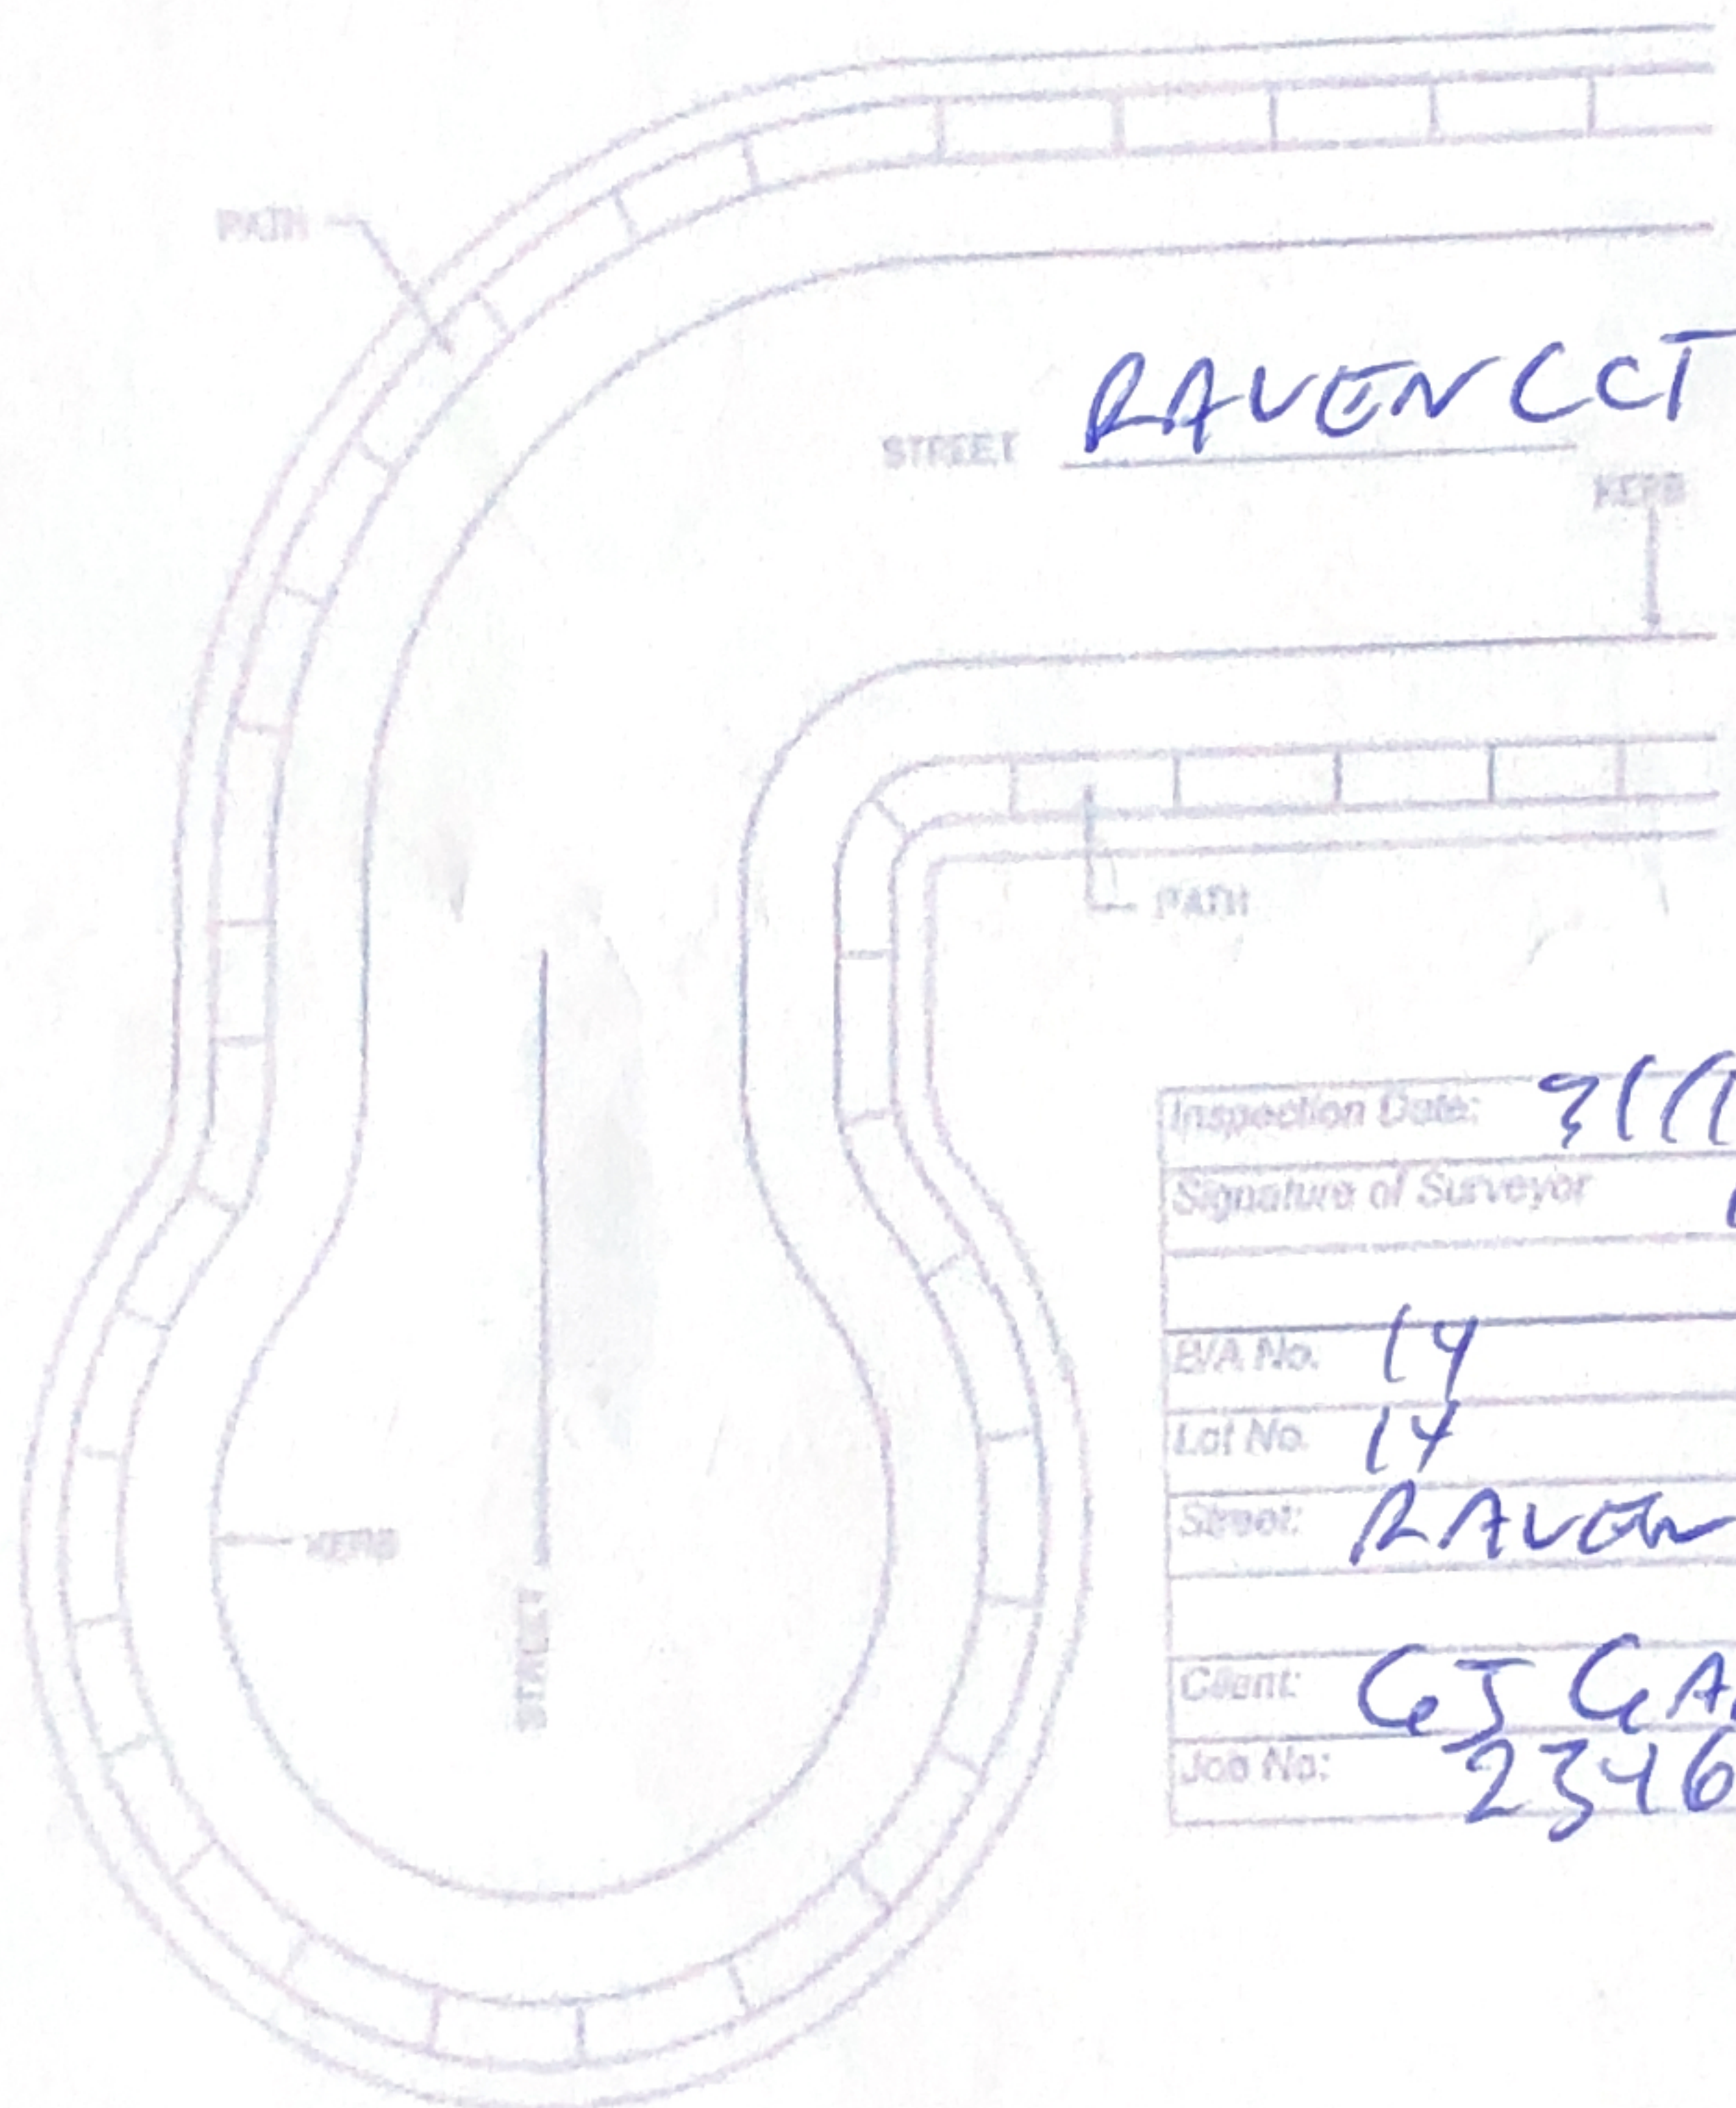
Condition of Footpath / Kerb & Gutter prior to Commencement of Building works

Any Kerb & Gutter: ☒ Yes ☐ No
Any Footpath: ☒ Yes ☐ No
Damage: ☐ Yes ☒ No
Damage: ☐ Yes ☒ No
