# **GEOTECHNICAL RISK MANAGEMENT POLICY FOR PITTWATER** FORM NO. 1 – To be submitted with Development Application

Development App	· · · · · · · · · · · · · · · · · · ·	wood Vale Pty Ltd	
		I	Name of Applicant	
	Address of site	8 Fores	st Road, Warriewood, NSW	
	on made by geotech ical report	hnical engineer or engineering g	eologist or coastal engineer (where applicable) as part of a	
I, <u>Da</u>	niel Bliss (Insert Name)		JK Geotechnics Pty Ltd or Company Name)	
the Geote	chnical Risk Manager tify that the organisat	ment Policy for Pittwater - 2009 and	echnical engineer or engineering geologist or coastal engineer as of I am authorised by the above organisation/company to issue this sional indemnity policy of at least \$2million.

# REPORT TO WARRIEWOOD VALE PTY LTD

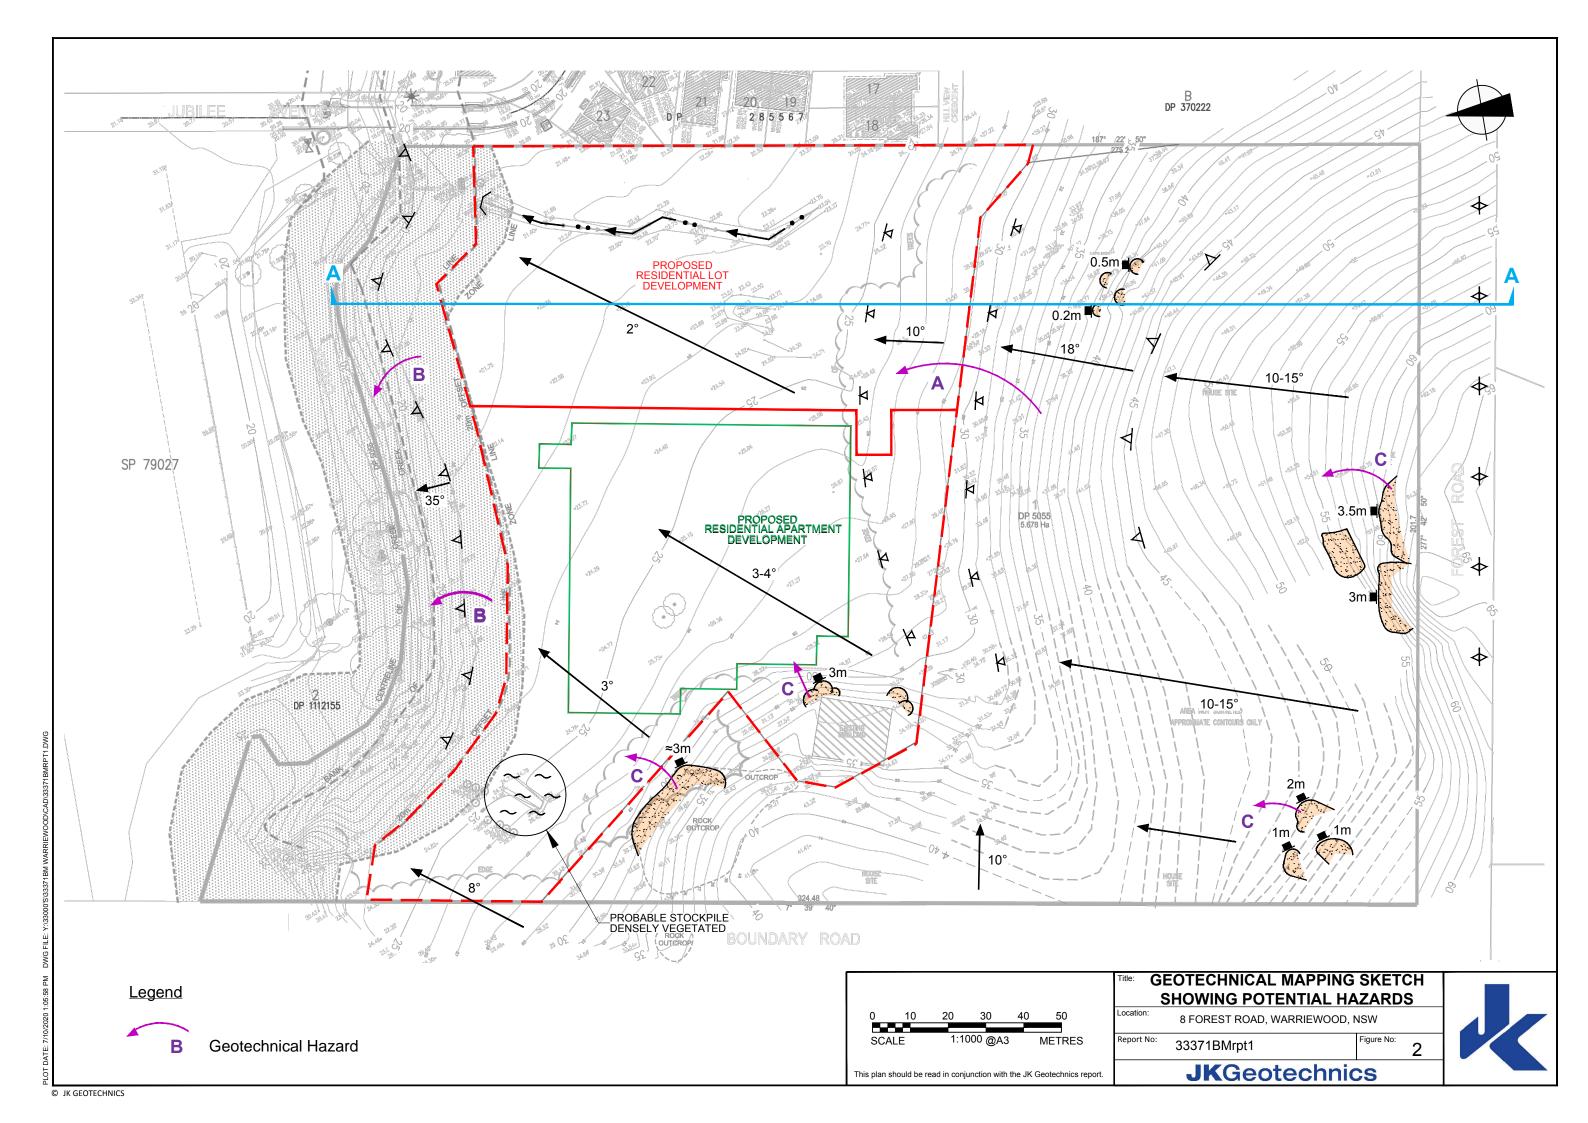
The attached Figure 2 presents a geotechnical sketch plan showing the principal geotechnical features present at the site. Figure 2 is based on the Partial Detail Survey of Lot 1 DP 5055 prepared by Pulver Cooper & Blackley (Ref. 87815, Rev G, dated 9/11/2017). Additional features on Figure 2 have been measured by hand held inclinometer and tape measure techniques and hence are only approximate. Should any of the features be critical to the proposed development, we recommend they be located more accurately using instrument survey techniques. Figure 3 presents a typical cross-section through the site based on the survey data augmented by our mapping observations. Figure 5 defines the geotechnical mapping symbols used.

These potential hazards are indicated in schematic form on the attached Figures 2 and 3.
