Preliminary Geotechnical Assessment

Project: New Residence 4 Pusan Place, Belrose NSW

REF: AG 20000 23 October 2020

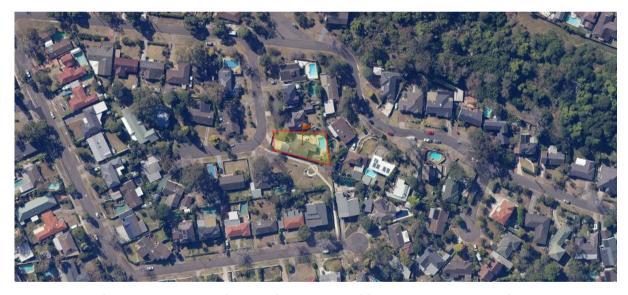
Image 2: Site location. 4 Pusan Place, Belrose NSW – (© SIX Maps NSW GOV)

Parameter	Description
Retaining Structures	Stable, low concrete block retaining walls at south-eastern site boundary, ~0.75m in height. Low, stable keystone sandstone wall retaining metal carport drive, ~1.25m in height.
Neighbouring environment	Residentially developed to the north and east. Pusan reserve to the south. Pusan Place to the west.
Geology	The Sydney 1:100,000 Geological Sheet 9130 (NSW Dept. Mineral Resources, 1983) indicates that the site is underlain by the Middle Triassic Hawkesbury Sandstones of the Wianamatta Group (Rh), which is not exposed on site.
Geotechnical observations	No significant geotechnical hazards were identified at the time of visual assessment.
