GEOTECHNICAL INVESTIGATION:

New House, Pool and cabana at **33 Hillcrest Avenue, Mona Vale**

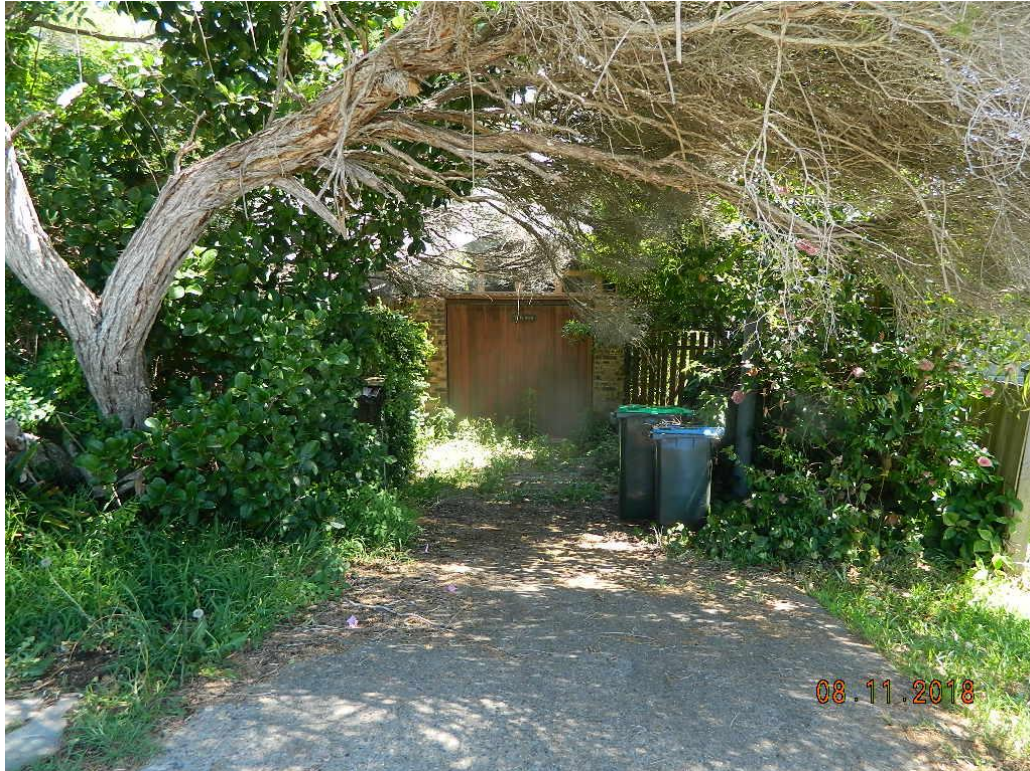
Photo 1

- 2.3** At the road frontage a concrete and sandstone paved driveway runs to a garage on the uphill side of the house (Photo 1). A ~0.6m high brick retaining wall to the S of the driveway supports a cut that levels a paved patio on the uphill side of the house (Photo 2). The root system of a large palm has damaged the wall but it will be demolished as part of the proposed works. The two-storey brick and timber clad house will be demolished as part of the proposed works (Photo 3). The slope between the downhill side of the house and the lower boundary is densely-vegetated with exotic weeds and shrubs (Photo 4). No significant signs of movement were observed on the

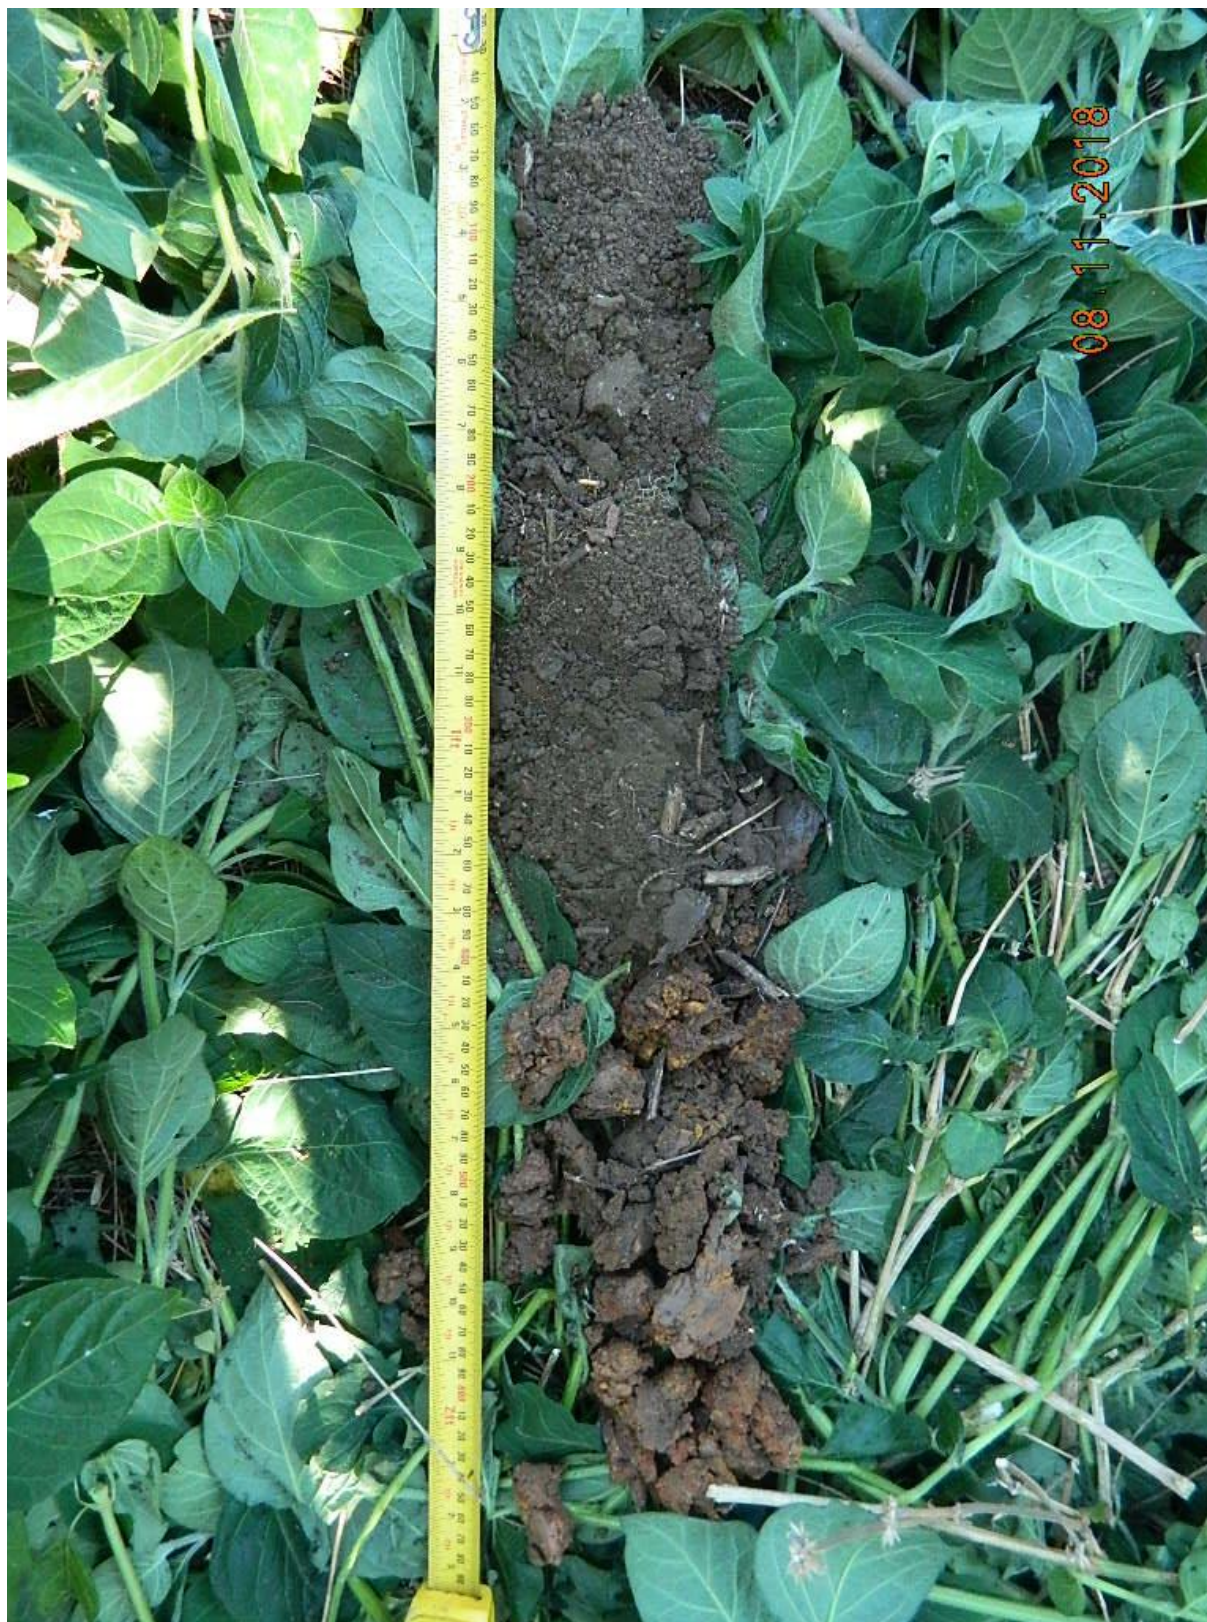
AUGER HOLE 1 (~RL46.6) – AH1 (Photo 5)

Depth (m)	Material Encountered
0.0 to 0.4	TOPSOIL , sandy soil, brown, organic matter throughout, fine to medium grained, rock fragments, loose, dry.
0.4 to 0.6	CLAY , firm, brown and orange, malleable, dry.

End of test @ 0.6m in clay. No watertable encountered.

Photo 5: Auger Hole 1: Top of hole at top of image
