## **GEOTECHNICAL INVESTIGATION:**

New Semi-Detached Houses and Pools at 103 Ocean Street, Narrabeen

# **INFILTRATION TESTING:**

#### For Proposed Infiltration Trench at 103 Ocean Street, Narrabeen

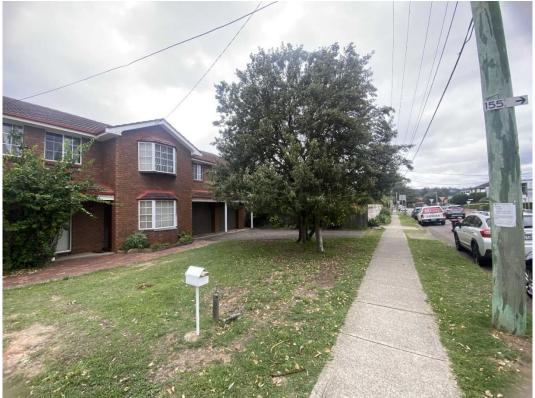
Photo 2

#### AUGER HOLE 2 (~RL9.3) – AH2 (Photo 2)

Depth (m)	Material Encountered
0.0 to 0.4	SAND, brown, fine to coarse grained, dry.
0.4 to 0.8	SAND, light brown, medium grained, dry.
0.8 to 2.0	SAND, yellow, medium grained, dry.

End of Hole @ 2.0m in sand. No water table encountered.

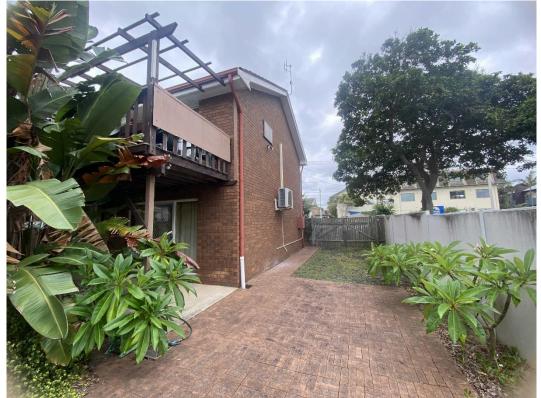
Photo 3

#### AUGER HOLE 3 (~RL9.5) – AH3 (Photo 3)

0.0 to 0.7	SAND, brown, fine to coarse grained, dry.
0.7 to 1.4	SAND, light brown, medium grained, dry.
1.4 to 2.0	SAND, yellow, medium grained, dry.

End of Hole @ 2.0m in sand. No water table encountered.

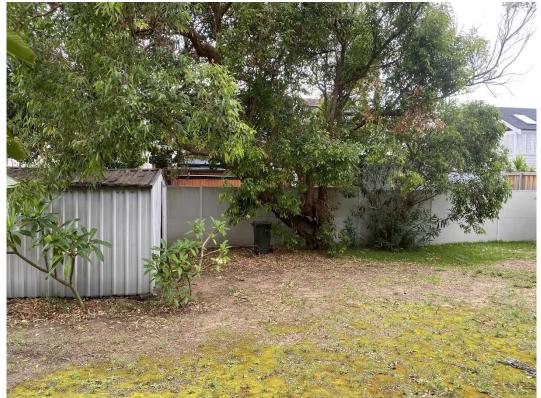
Photo 4

#### AUGER HOLE 4 (~RL9.5) – AH4 (Photo 4)

Depth (m)	Material Encountered
0.0 to 0.3	<b>TOPSOIL</b> , dark brown, sandy, dry, fine to medium grained.
0.3 to 2.0	<b>SAND</b> , orange, dry, fine to medium grained.

End of hole @ 2.0m in sand. No water table encountered.

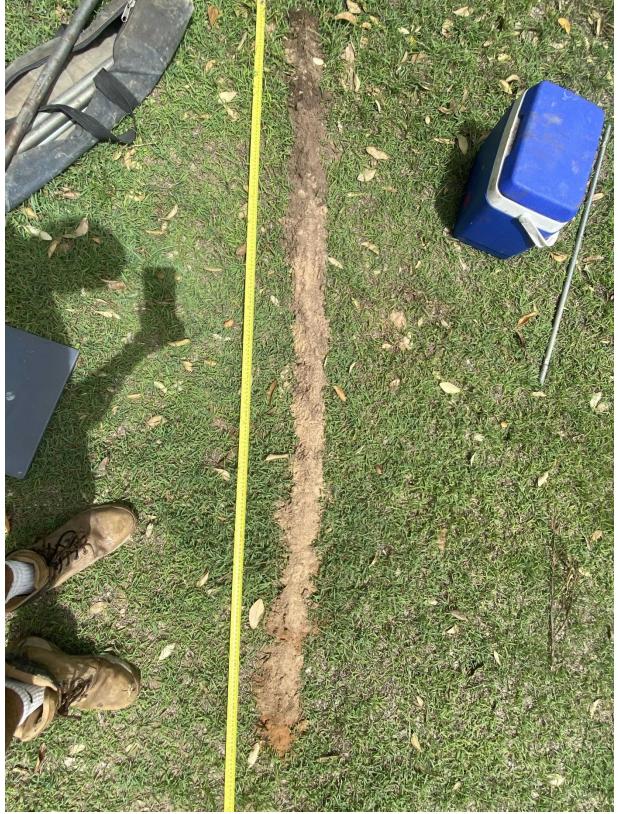
Photo 7 - top to bottom

#### AUGER HOLE 1 (~RL9.3) – AH1 (Photo 7)

Depth (m)	Material Encountered
0.0 to 0.4	SAND, brown, fine to coarse grained, dry.
0.4 to 0.8	SAND, light brown, medium grained, dry.
0.8 to 1.2	SAND, yellow, medium grained, dry.
1.2 to 2.5	SAND, orange, medium grained, dry.
2.5 to 5.0	SAND, yellow and orange, medium grained, dry.

End of Hole @ 5.0m in sand. No water table encountered

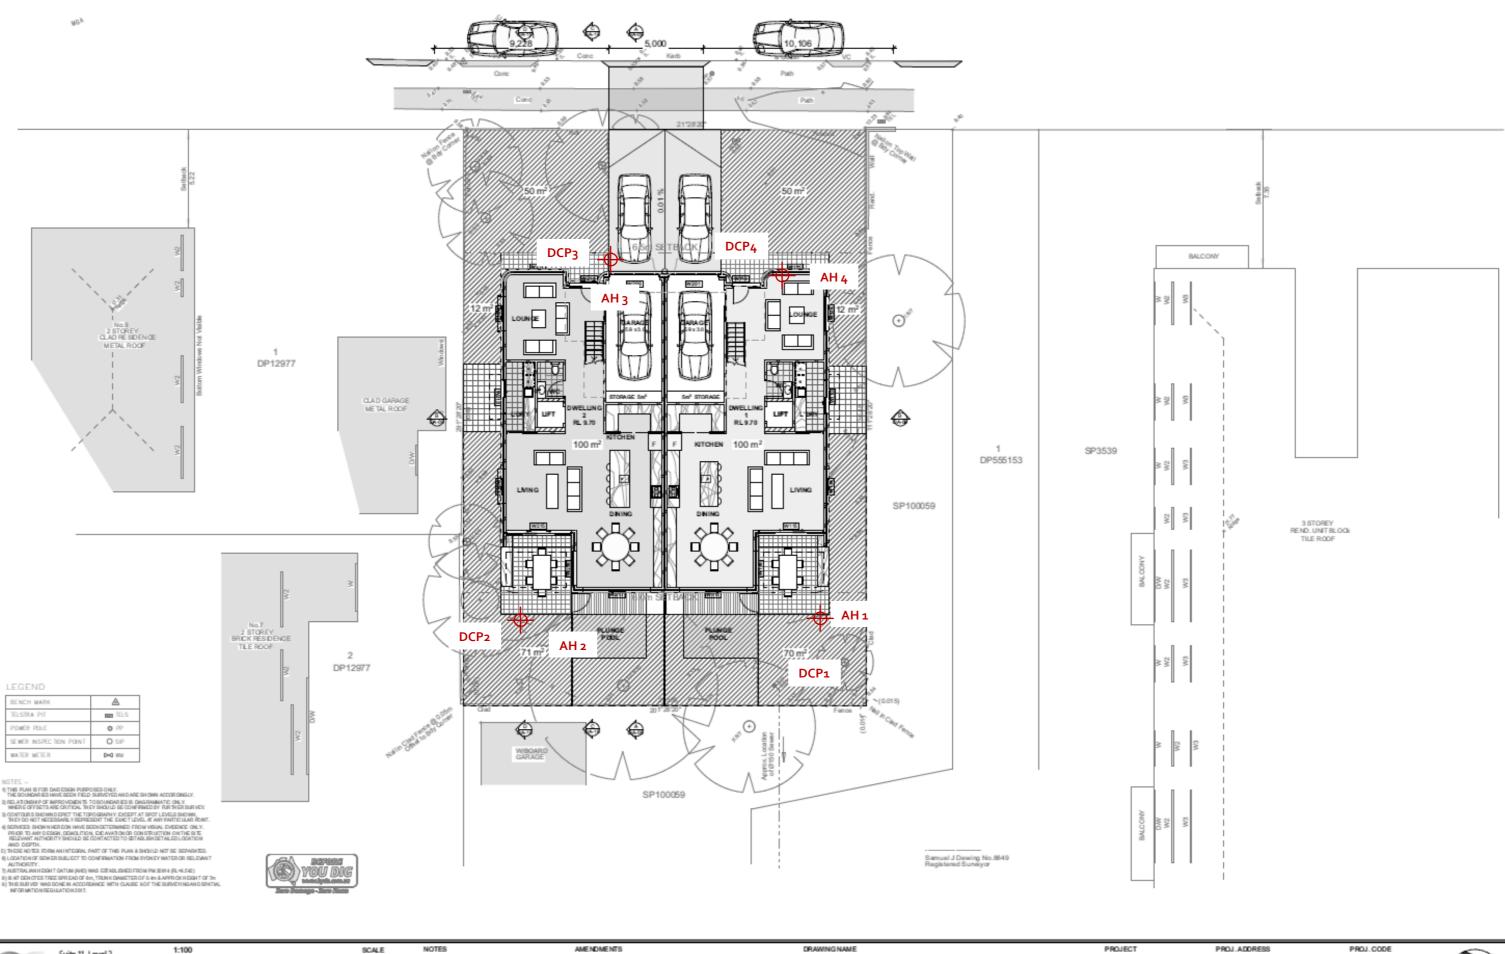
#### SITE PLAN – showing test locations and minimum extent of required shoring

Four hand Auger Holes (AH) were put down to identify the soil materials. Four Dynamic Cone Penetrometer (DCP) tests were put down to determine the relative densities of the sands through the profile. The locations of the tests are shown on the site plan attached. It should be noted that a level of caution should be applied when interpreting DCP test results. The test will not pass through hard buried objects so in some instances it can be difficult to determine whether refusal has occurred on an obstruction in the profile or on the natural rock surface. This is not expected to be an issue for the testing on this site. However, excavation and foundation budgets should always allow for the possibility that the interpreted ground conditions in this report vary from those encountered during excavations. See the appended "Important information about your report" for a more comprehensive explanation. The results are as follows:

The sides of the proposed pool excavations are expected to stand at near-vertical angles for short periods of time until the pool structure is installed, provided the cut batters are kept from becoming saturated. If the cut batters remain unsupported for more than a day before pool construction commences, they are to be supported with typical pool shoring until the pool structure is in place.

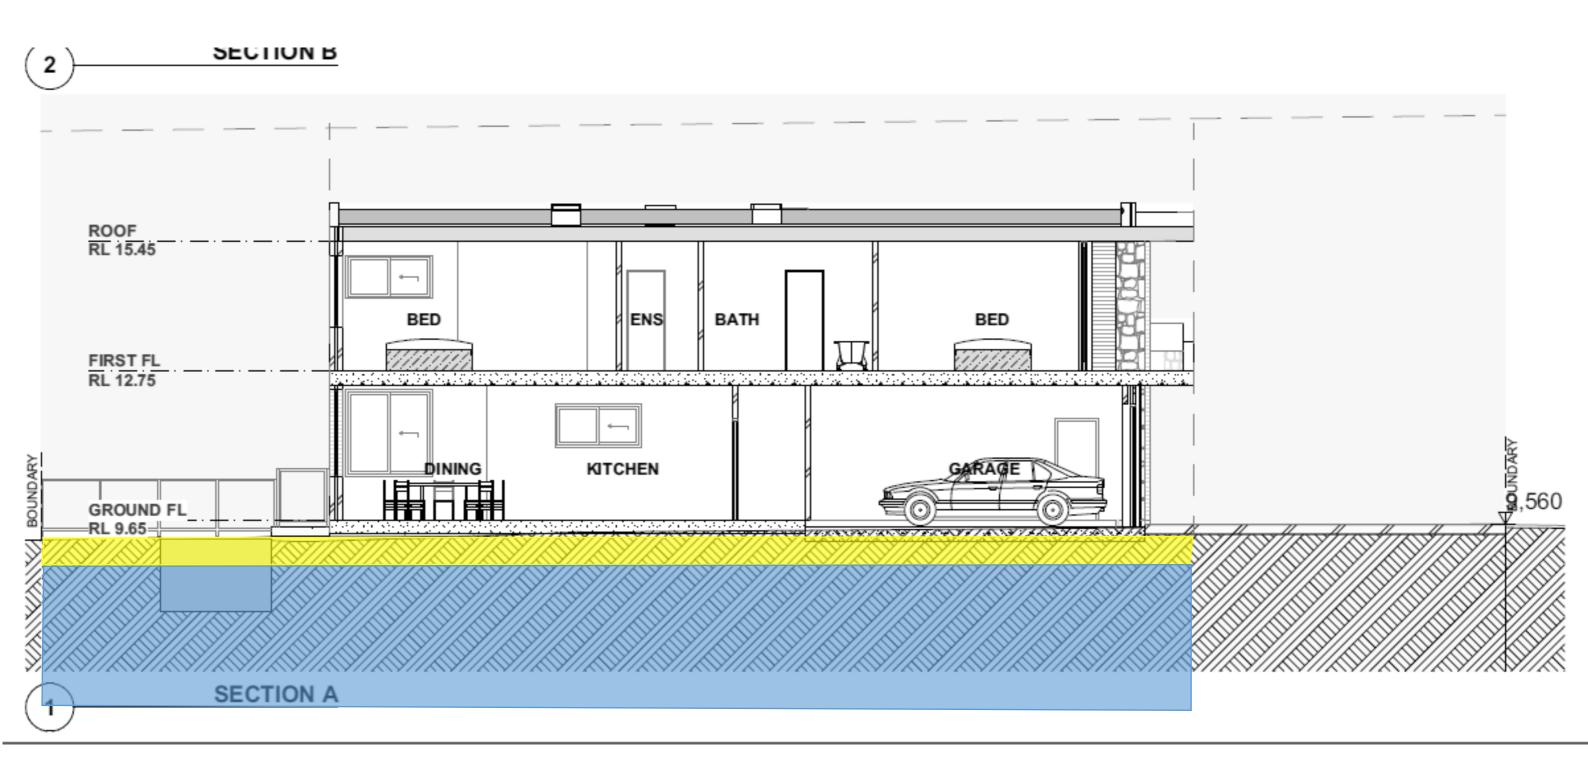
### **Expected Ground Materials**

the extent of the tests at 5.0m. See the Type Section attached for a diagrammatical representation of the expected ground materials.

- Sand Loose
- Sand Medium Dense to Dense

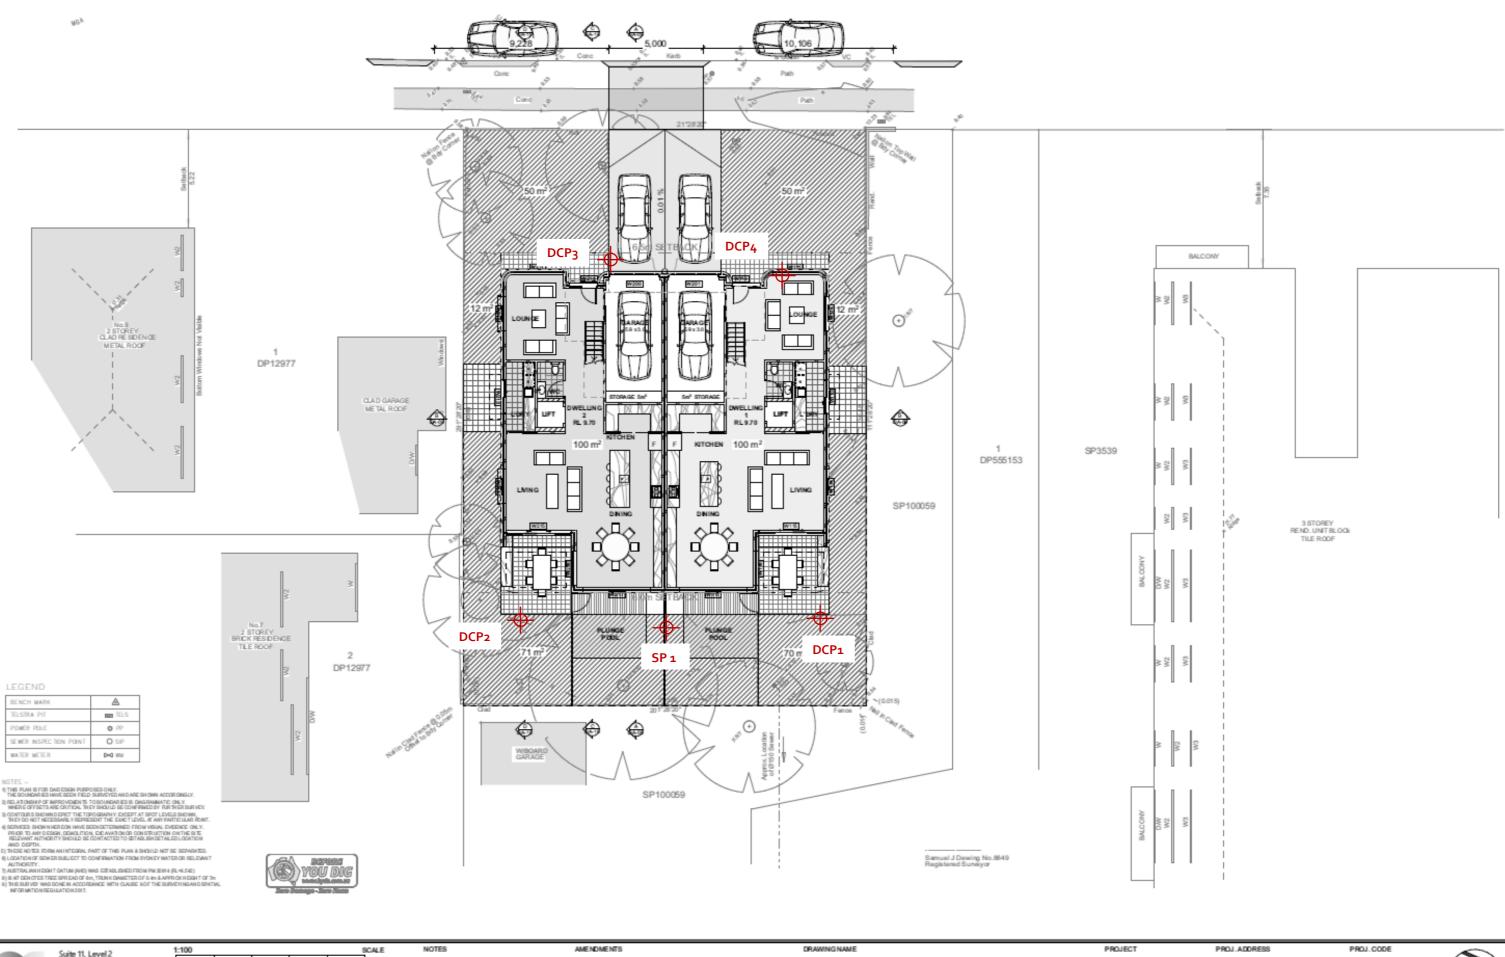
#### SITE PLAN – showing test locations and minimum extent of required shoring

One Hand Auger Hole (SP1) was put down for the stand pipe used in the infiltration testing. Four Dynamic Cone Penetrometer (DCP) test was put down to determine the relative density of the overlying soil and depth to rock. The locations of the tests are shown on the site plan and the logs and results are as follows:

Trenches should follow the natural slope contours (i.e., run perpendicular to the slope direction) and be at least 3.0m from downhill structures and downslope common boundaries.
