PRELIMINARY GEOTECHNICAL ASSESSMENT:

12 Collaroy Street, Collaroy

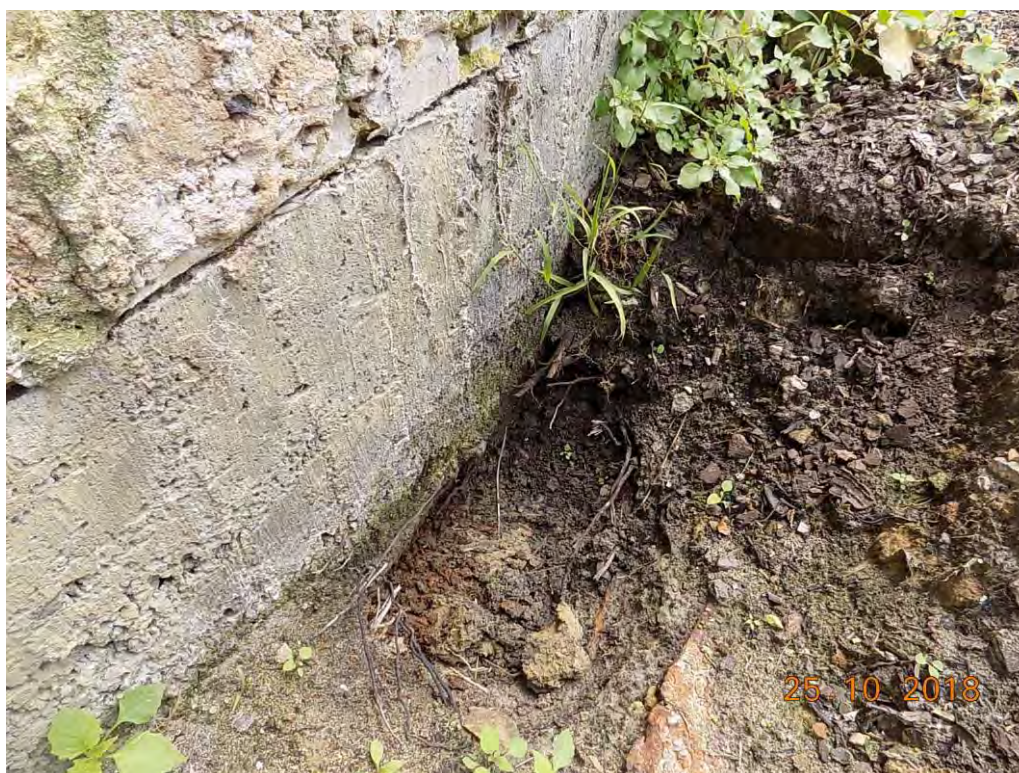
Photo 2: PIT 1

PIT 1 (~RL11.0) - (Photo 2)

| Depth (m) | Material Encountered |
|---|--|
| 0.0 to 0.2 | TOPSOIL , sandy soil, dark brown, fine to coarse grained with fine trace organic matter. |
| 0.2 to 0.4 | CLAY , grey and brown, soft, very wet, fine to coarse grained with fine trace organic matter. |

Base of pit @ 0.4m in wet clay. Existing foundations of the brick retaining wall taken to a depth of 0.25m onto the underlying clay.

On the basis of the ground testing, we expect the brick retaining wall on the boundary will be undercut by the proposed excavation. As such the wall will need to be propped and underpinned to rock prior to the commencement of the excavation. A new engineered retaining wall will then need to be constructed in front of the existing wall. The new wall is to be designed to support the loads on the existing wall.

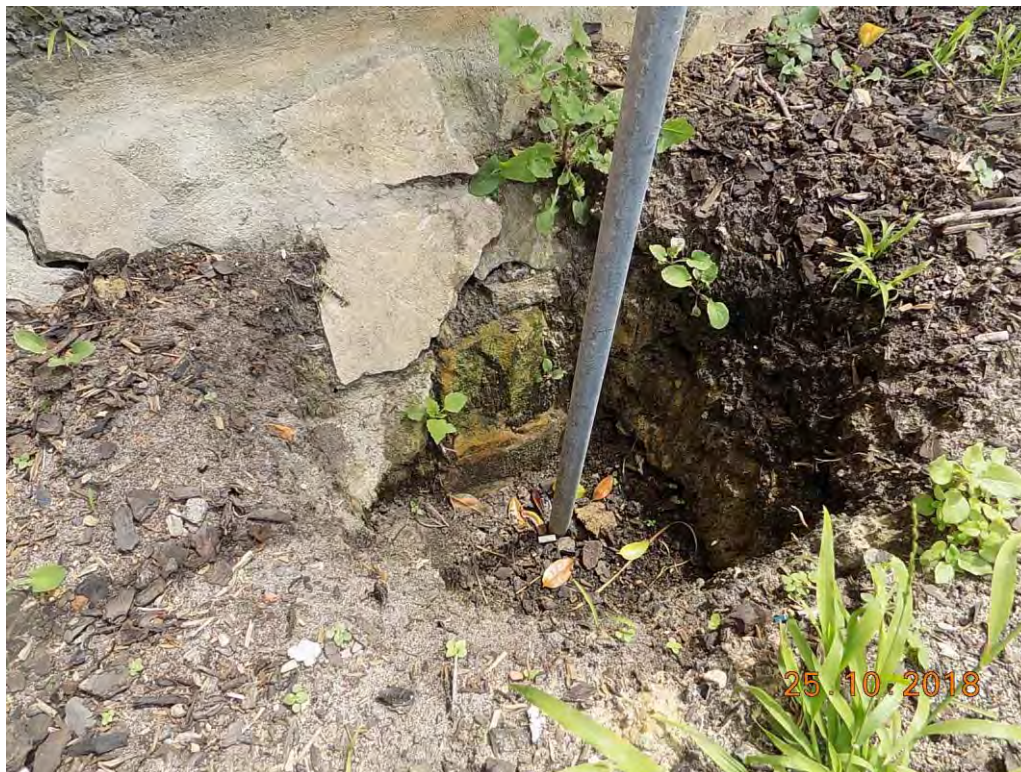
Photo 3: PIT 2

PIT 2 (~RL11.3) - (Photo 3)

| Depth (m) | Material Encountered |
|---|--|
| 0.0 to 0.25 | TOPSOIL , sandy soil, dark brown, fine to coarse grained with fine trace organic matter. |
| 0.25 to 0.5 | CLAY , grey and brown, soft, very wet, fine to coarse grained with fine trace organic matter. |

Base of pit @ 0.5m in wet clay. Existing foundations of the brick retaining wall not visible.

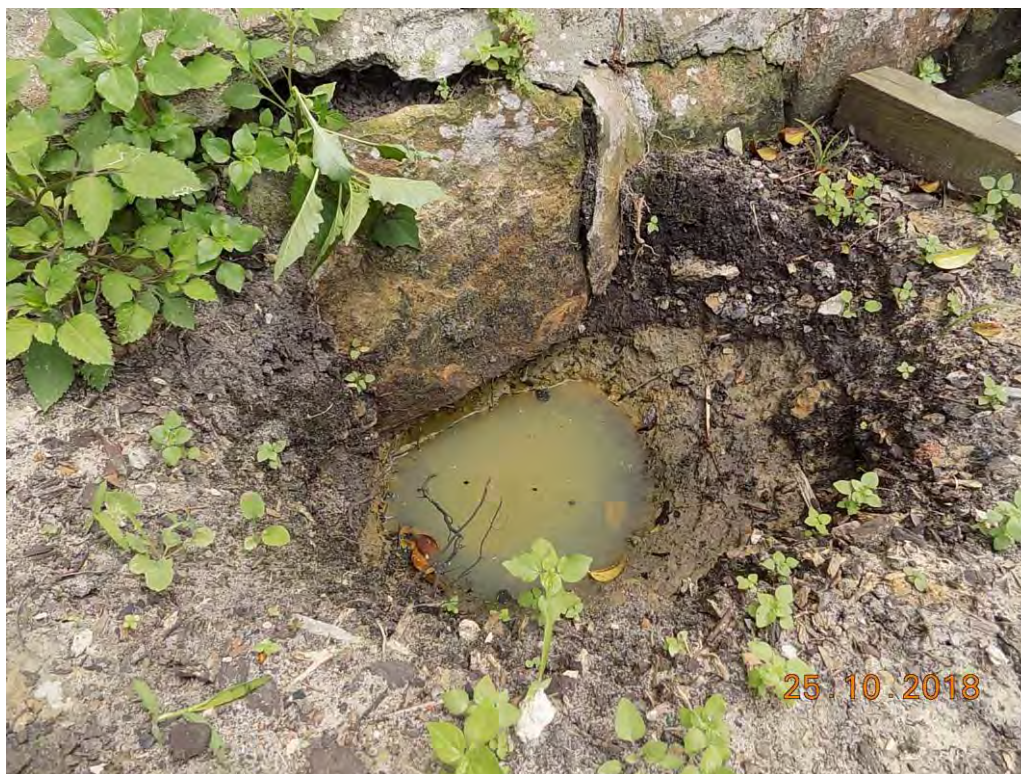
Photo 4: PIT 3

PIT 3 (~RL11.3) - (Photo 4)

| Depth (m) | Material Encountered |
|---|--|
| 0.0 to 0.3 | TOPSOIL , sandy soil, dark brown, fine to coarse grained with fine trace organic matter. |
| 0.3 to 0.5 | CLAY , grey and brown, soft, very wet, fine to coarse grained with fine trace organic matter. |

Base of pit @ 0.5m in wet clay. Existing foundations of the brick retaining wall not visible.
Water pooling from 0.4m.

cut up by excavation equipment. The water that was observed to be pooling in the pits likely originates from standard groundwater that flows over the buried surface of the clays. See Type Section attached for a diagrammatical representation of the expected ground materials.

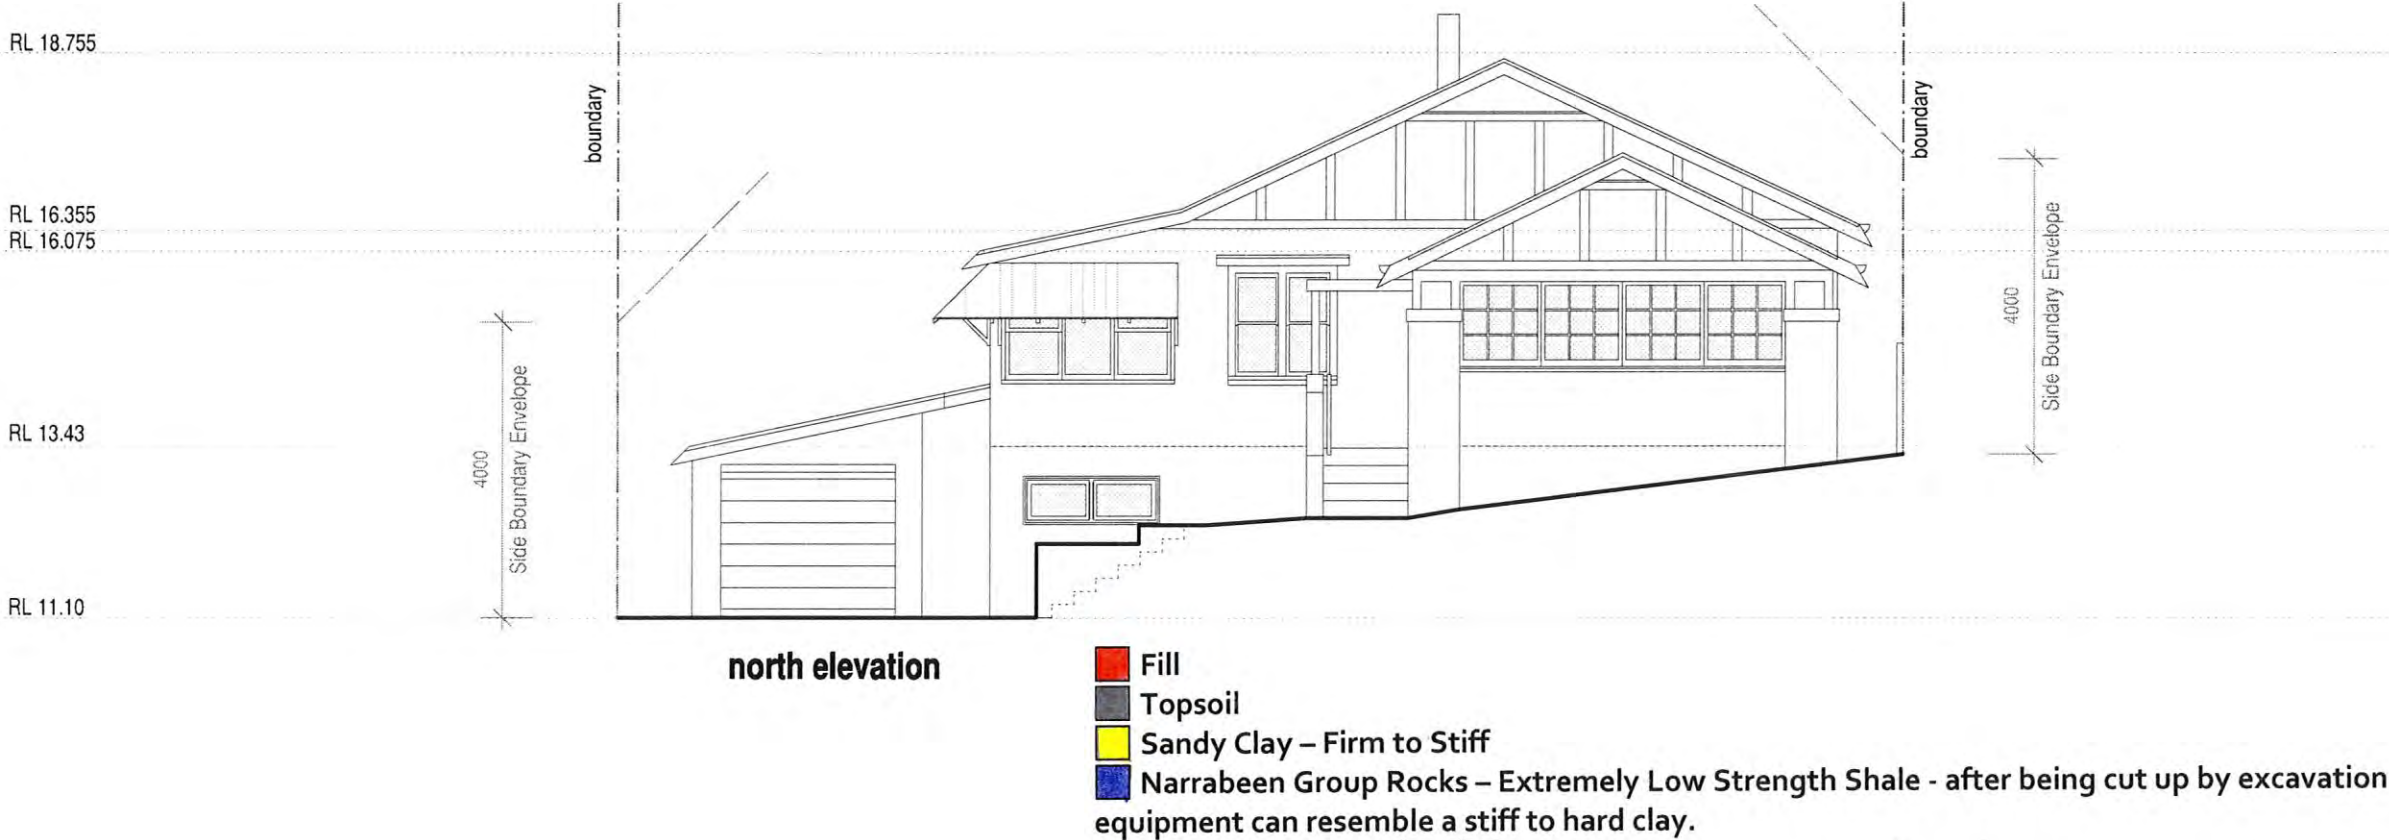
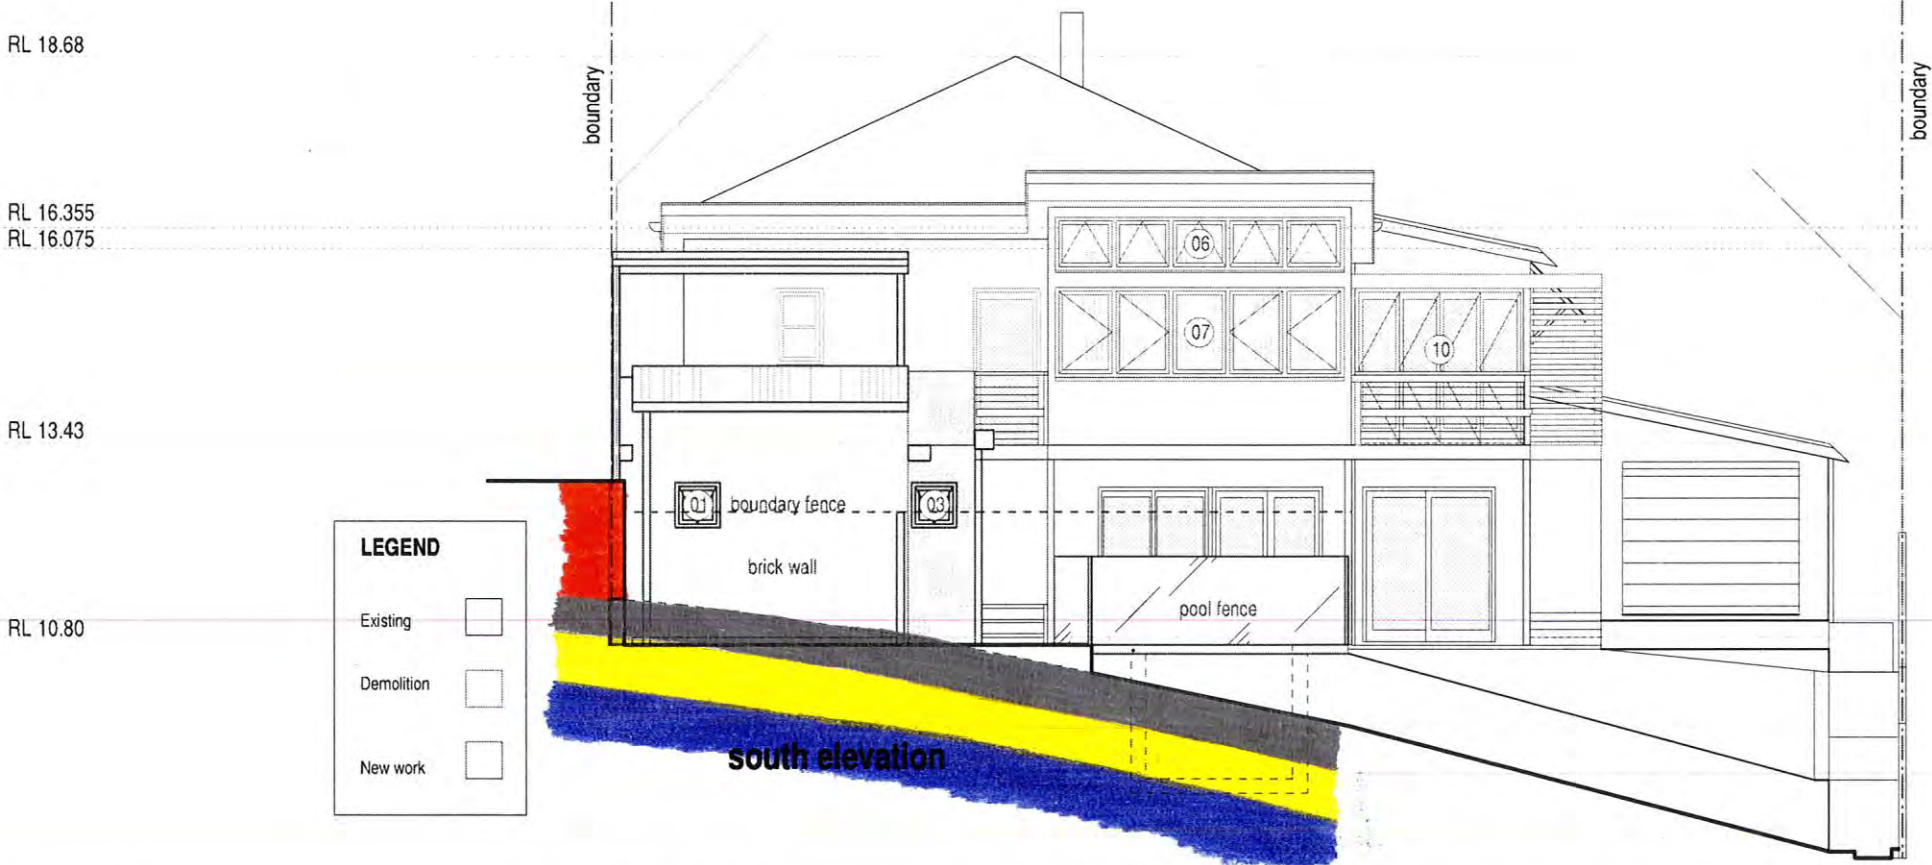
TYPE SECTION – Diagrammatical Interpretation of expected Ground Materials

The slope materials are colluvial at the near surface and residual at depth. They consist of a manmade fill over sandy topsoil and silty clays and clays. In the test locations, the silty clays and clays merge into the weathered zone of the under lying shale at an average depth of ~1.2m below the current surface. The weathered zone is interpreted as Extremely Low Strength Shale. It is to be noted that this material can appear as a mottled stiff clay when it is
