90 Alameda Way, Warriewood NSW

Geotechnical Assessment

Prepared for:
Shae Knights
90 Alameda Way
Warriewood, NSW 2102

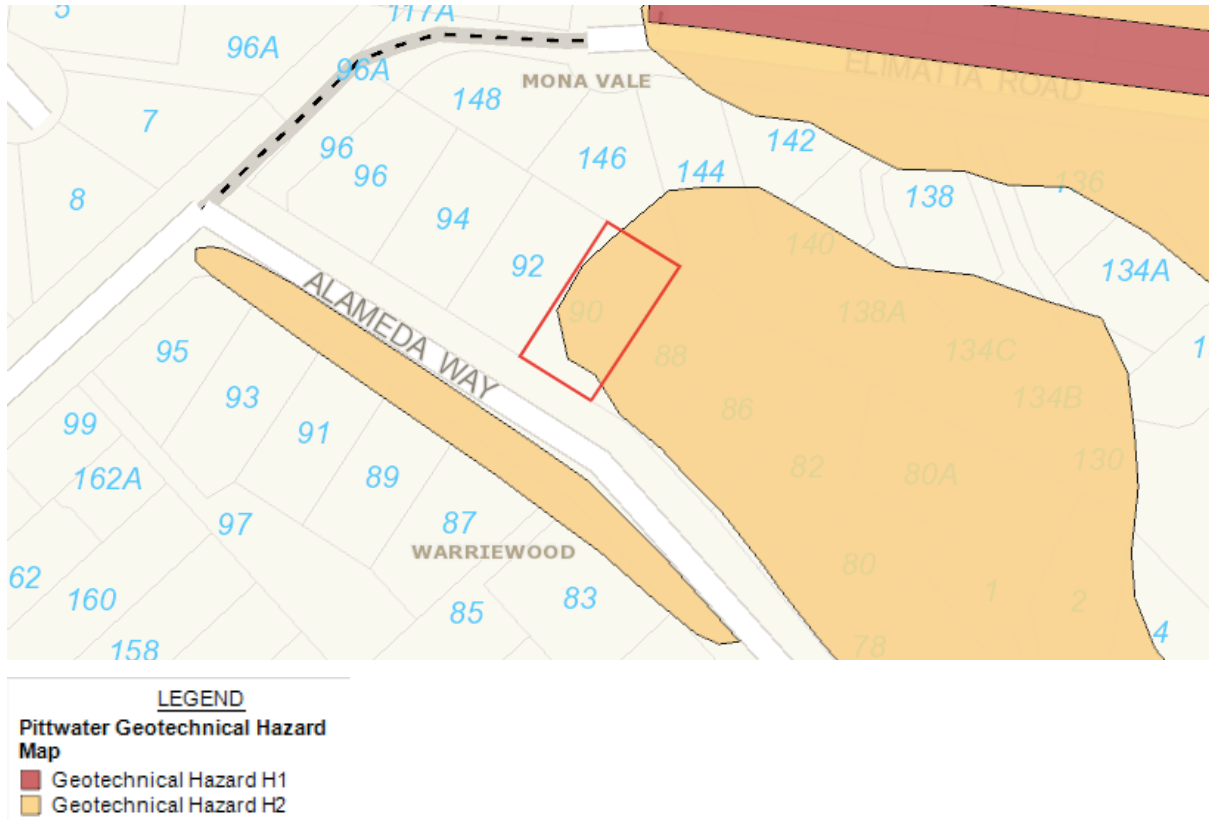
- The cuts exposed in the rear of the property show some minor destabilisation along tension cracks in the clay layer, likely as a result of having been exposed for roughly six months.
- No other evidence of significant soil creep, tension cracks, unstable outcrops, or other indicators of slope instability were identified outside of the exposed cuts at the time of our inspection.
- The existing structures displayed minor evidence of settlement restricted to pavements most likely due to inadequate compaction of supporting fill at the time of construction.
- The property is classified as ‘**Geotechnical Hazard H2**’ zone, with reference to Northern Beaches Council PLEP Geotechnical Hazard Map (PLEP Geotechnical Hazard Map **Image 2** below).
