## **GEOTECHNICAL INVESTIGATION:**

### **Alterations and Additions at 13 Carolyn Avenue, Beacon Hill**

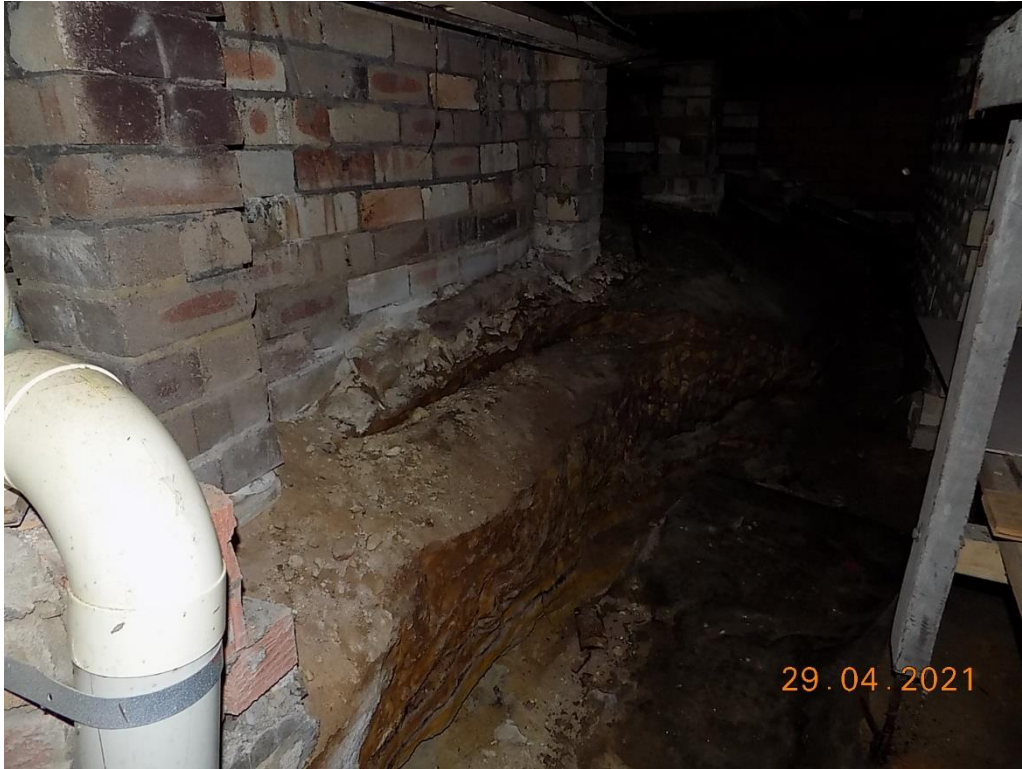
Photo 5

brick piers (Photo 4). The supporting walls display no significant signs of movement and the supporting piers stand vertical. Many of the walls and piers were observed to be supported directly off competent Medium Strength Sandstone bedrock within the foundation space of the house (Photo 5). A gently sloping lawn extends off the uphill side of the house to the base of a terraced slope (Photo 6). The slope is terraced with a series of stable brick retaining walls reaching ~1.0m high (Photo 7). Many of these walls were observed to be supported directly onto outcropping sandstone bedrock. An outcrop in the SW corner of the property was observed to be undercut to ~1.0m (Photo 8). The undercut joint block has a relatively thick cantilever arm compared to its overhang length and displays no signs of cracking as viewed from below. The undercut is considered stable.

HAZARDS	Hazard Three	Hazard Four
TYPE	A loose boulder, wedge, or similar geological defect toppling onto the work site during the excavation process.	The proposed excavations undercutting the footings of the house causing failure (Photo 5).
LIKELIHOOD	'Possible' ( $10^{-3}$ )	'Possible' ( $10^{-3}$ )
CONSEQUENCES TO PROPERTY	'Medium' (20%)	'Medium' (35%)
RISK TO PROPERTY	'Moderate' ( $2 \times 10^{-4}$ )	'Moderate' ( $2 \times 10^{-4}$ )
RISK TO LIFE	$5.4 \times 10^{-5}$ /annum	$5.3 \times 10^{-5}$ /annum
COMMENTS	This level of risk to life and property is 'UNACCEPTABLE'. To move risk to 'ACCEPTABLE' levels, the recommendations in <b>Section 13</b> are to be followed.	This level of risk to life and property is 'UNACCEPTABLE'. To move risk to 'ACCEPTABLE' levels, the recommendations in <b>Section 13</b> are to be followed.

The excavations will come close to flush with the supporting brick walls of the subject house (Photo 5). However, apart from a thin layer of soil over the rock, the excavations will be taken almost entirely through Medium Strength Sandstone and any nearby structures are already supported on the rock so no structures or boundaries will be within the zone of influence of the excavations.

If any supporting walls and/or piers are required to be removed, the house is to be propped and supported with beams prior to the excavation through rock commencing.

During the excavation process, the geotechnical consultant is to inspect the excavations as they approach to within a horizontal distance of not less than 0.7m from the supporting posts and piers of the house to confirm the stability of the cut to go flush with the footings.

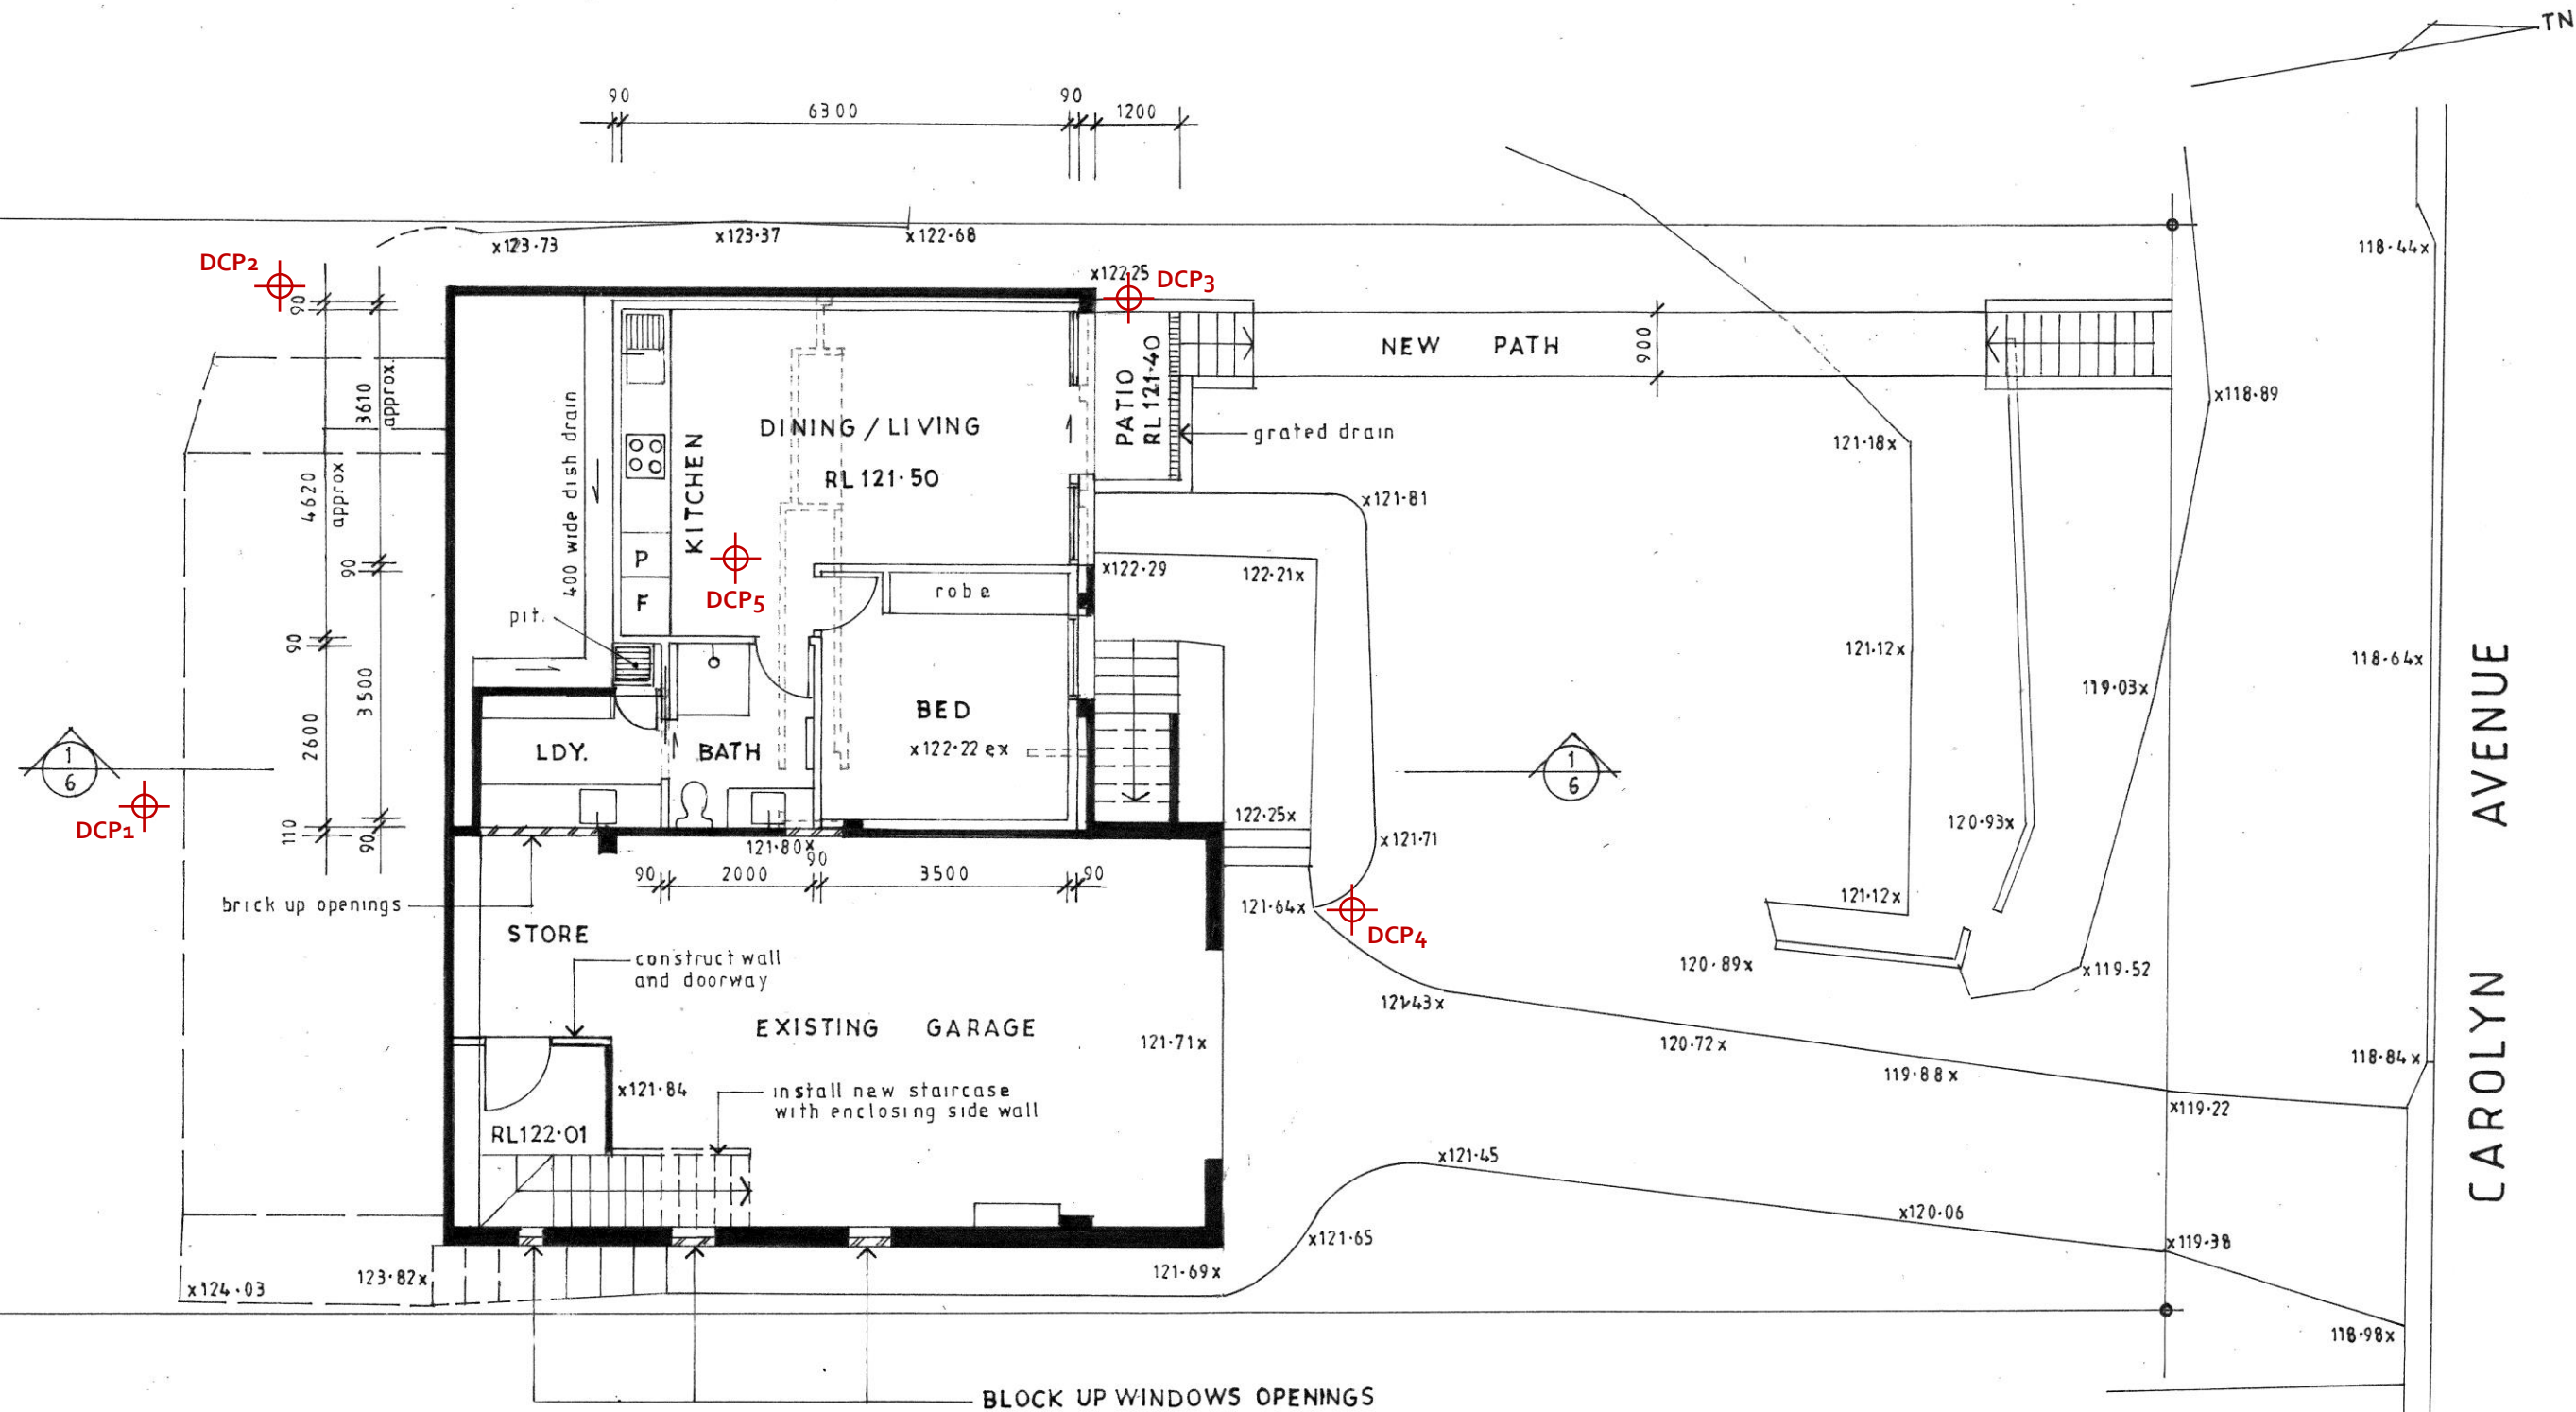
SITE PLAN – showing test locations

Five DCP (Dynamic Cone Penetrometer) tests were carried out to determine the relative density of the overlying soil and the depth to bedrock. The locations of the tests are shown on the site plan attached. It should be noted that a level of caution should be applied when interpreting DCP test results. The test will not pass through hard buried objects so in some instances it can be difficult to determine whether refusal has occurred on an obstruction in the profile or on the natural rock surface. This is not expected to be an issue for the testing on this site. However, excavation and foundation budgets should always allow for the possibility that the interpreted ground conditions in this report vary from those encountered during excavations. See the appended "Important information about your report" for a more comprehensive explanation. The results are as follows:

DCP TEST RESULTS – Dynamic Cone Penetrometer					
Equipment: 9kg hammer, 510mm drop, conical tip.			Standard: AS1289.6.3.2 - 1997		
Depth(m) Blows/0.3m	DCP 1 (~RL124.1)	DCP 2 (~RL124.1)	DCP 3 (~RL122.2)	DCP 4 (~RL121.6)	DCP 5 (~RL121.8)
0.0 to 0.3	4	Rock Exposed at Surface	6	12	Rock Exposed at Surface
0.3 to 0.6	2		9	6	
0.6 to 0.9	#		#	3	
0.9 to 1.2				10	
1.2 to 1.5				#	
	Refusal on Rock @ 0.4m		Refusal on Rock @ 0.6m	Refusal on Rock @ 1.0m

DCP1 – Refusal on rock @ 0.4m, DCP bouncing off rock surface, orange sandstone fragments on dry tip.

DCP2 – Rock exposed at surface.

DCP3 – Refusal on rock @ 0.6m, DCP bouncing off rock surface, white impact dust and brown sand on damp tip.

DCP4 – Refusal on rock @ 1.0m, DCP bouncing off rock surface, light brown clay on dry tip.

DCP5 – Rock exposed at surface.
