## **GEOTECHNICAL INVESTIGATION:**

New House, Granny Flat & Studio at **4 Southern Cross Way, Allambie Heights**

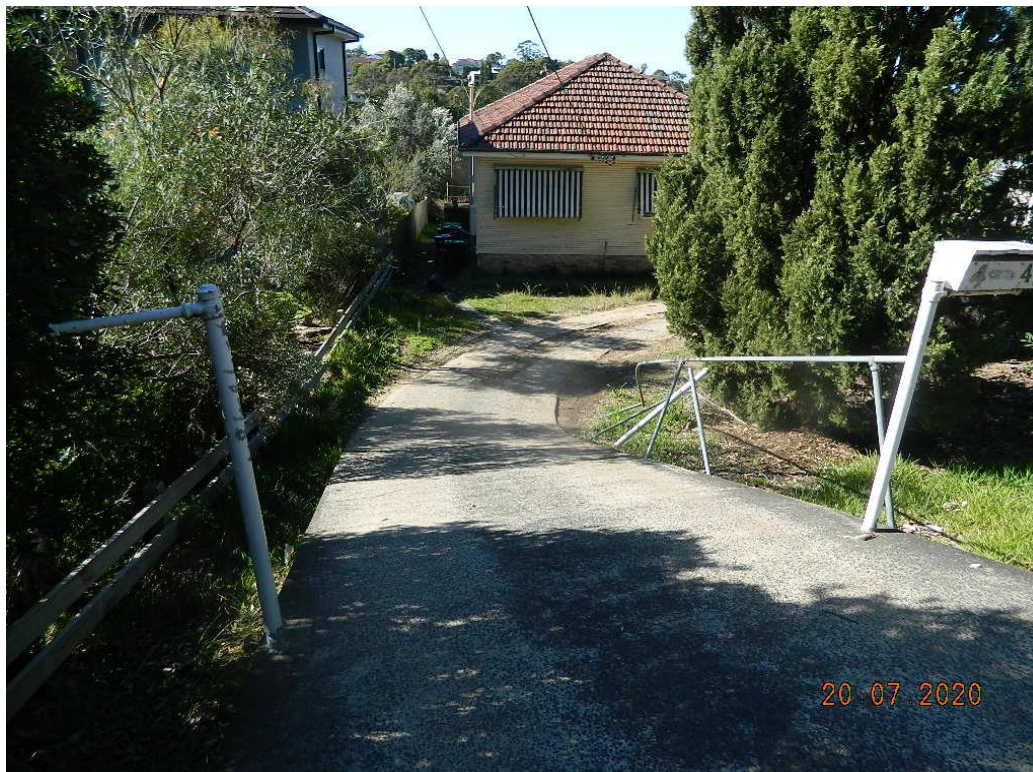
Photo 1

- 2.1** The site was inspected on the 20<sup>th</sup> of July, 2020.
- 2.2** This residential property is on the low side of the road and has an E aspect. It is located on the gentle to moderately graded upper reaches of a hillslope. The natural slope falls at an average angle of ~8° from the uphill boundary of the property to the downhill side of the existing house. The rocky slope below the existing house falls at an angle of ~15°. The slope above and below the property continues at similar angles.
- 2.3** At the road frontage a concrete and concrete stripped driveway runs down the slope to a carport beside the house (Photos 1 & 2). Sandstone is exposed at the surface

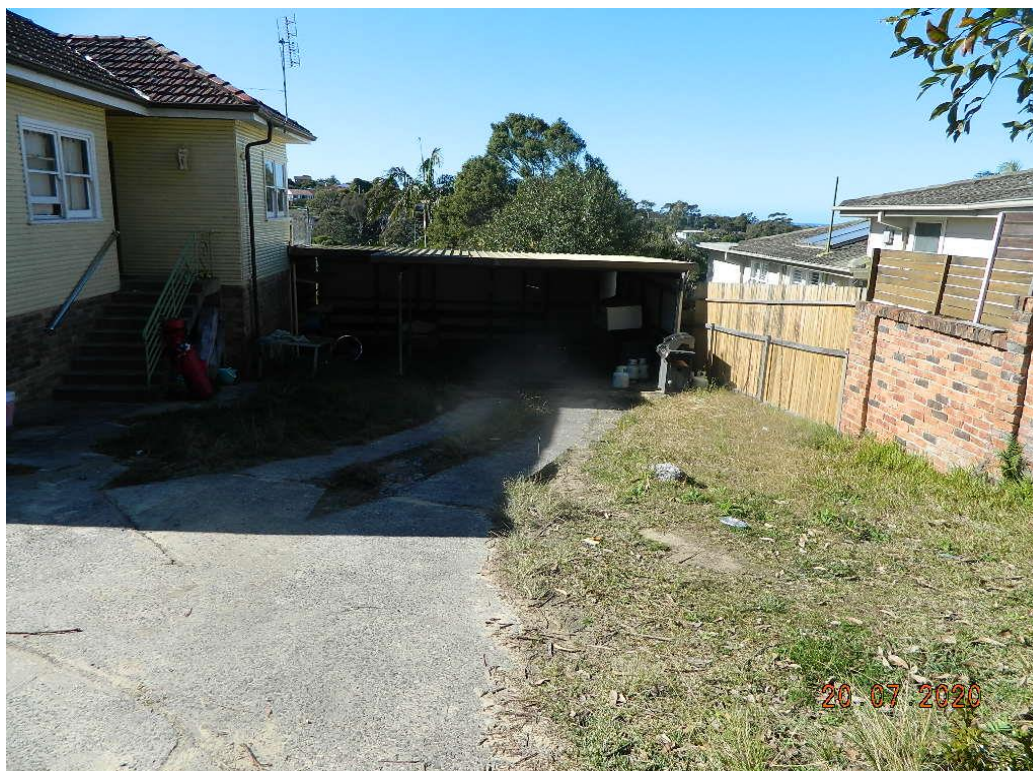
Photo 2

Given the exposed bedrock and depth to rock shown by the test results, the S common boundary brick wall (Photo 2) is expected to be supported on rock. However, to be sure, exploration pits along the wall will need to be put down by the builder to determine the foundation depth and material. These are to be inspected by the geotechnical consultant.

If the foundations are confirmed to be supported on Medium Strength Rock, the excavation may commence. If they are not, the wall will need to be underpinned prior to the excavation commencing. Underpinning requires permission of the neighbour. The extent of the area of the required exploration pits/underpinning are shown in orange on the attached site plan.

Underpinning is to follow the underpinning sequence 'hit one miss two'. Under no circumstances is the bulk excavation to be taken to the edge of the wall and then underpinned. Underpins are to be constructed from drives that should not exceed 0.6m in width along strip footings and should be proportioned according to footing size for other foundation types. Allowances are to be made for drainage through the underpinning to prevent a build-up of hydrostatic pressure. Underpins that are not designed as retaining walls are to be supported by retaining walls. The void between the retaining walls and the underpinning is to be filled with free-draining material such as gravel.

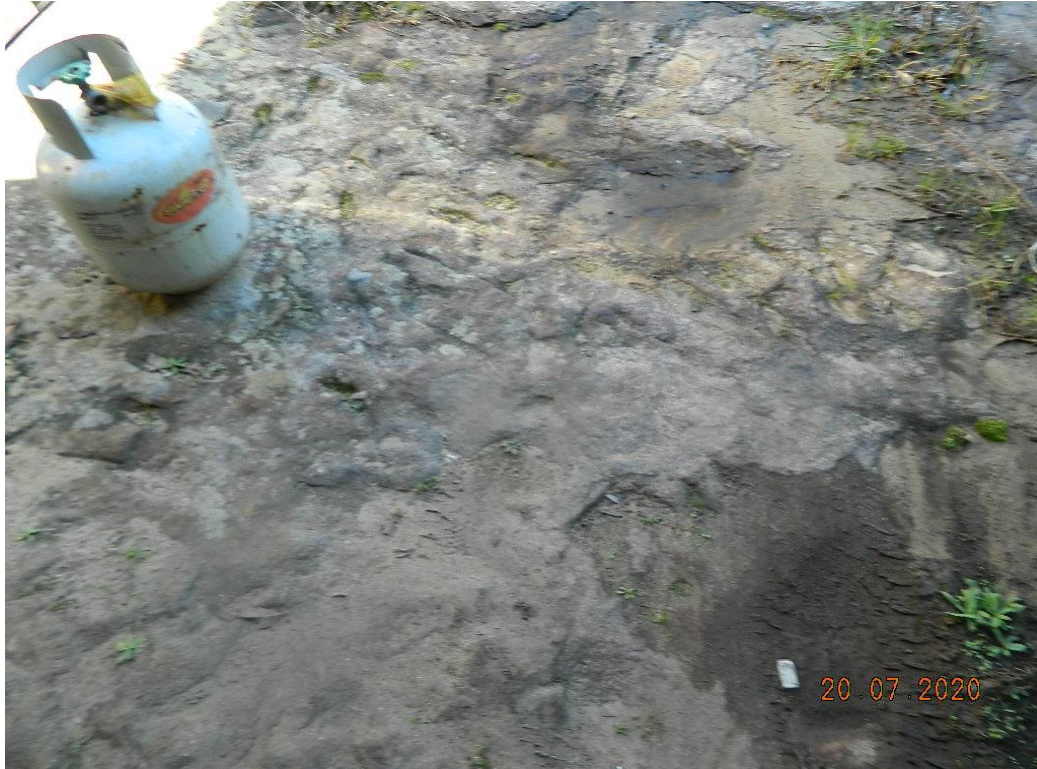
Photo 3

under the carport at the uphill side (Photo 3). The part two storey brick and weatherboard clad house is supported on brick walls and brick (Photos 4 & 5). The supporting walls show no significant signs of movement and the supporting piers stand vertical (Photo 6). Competent Medium Strength Sandstone bedrock outcrops across the slope on the downhill side of the property (Photo 7). Stable low sandstone block retaining walls support fill on the downhill side of the house and carport (Photo 8). No signs of slope instability were observed on the property that could have occurred since the property was developed. The adjoining neighbouring properties were observed to be in good order as seen from the street and subject property

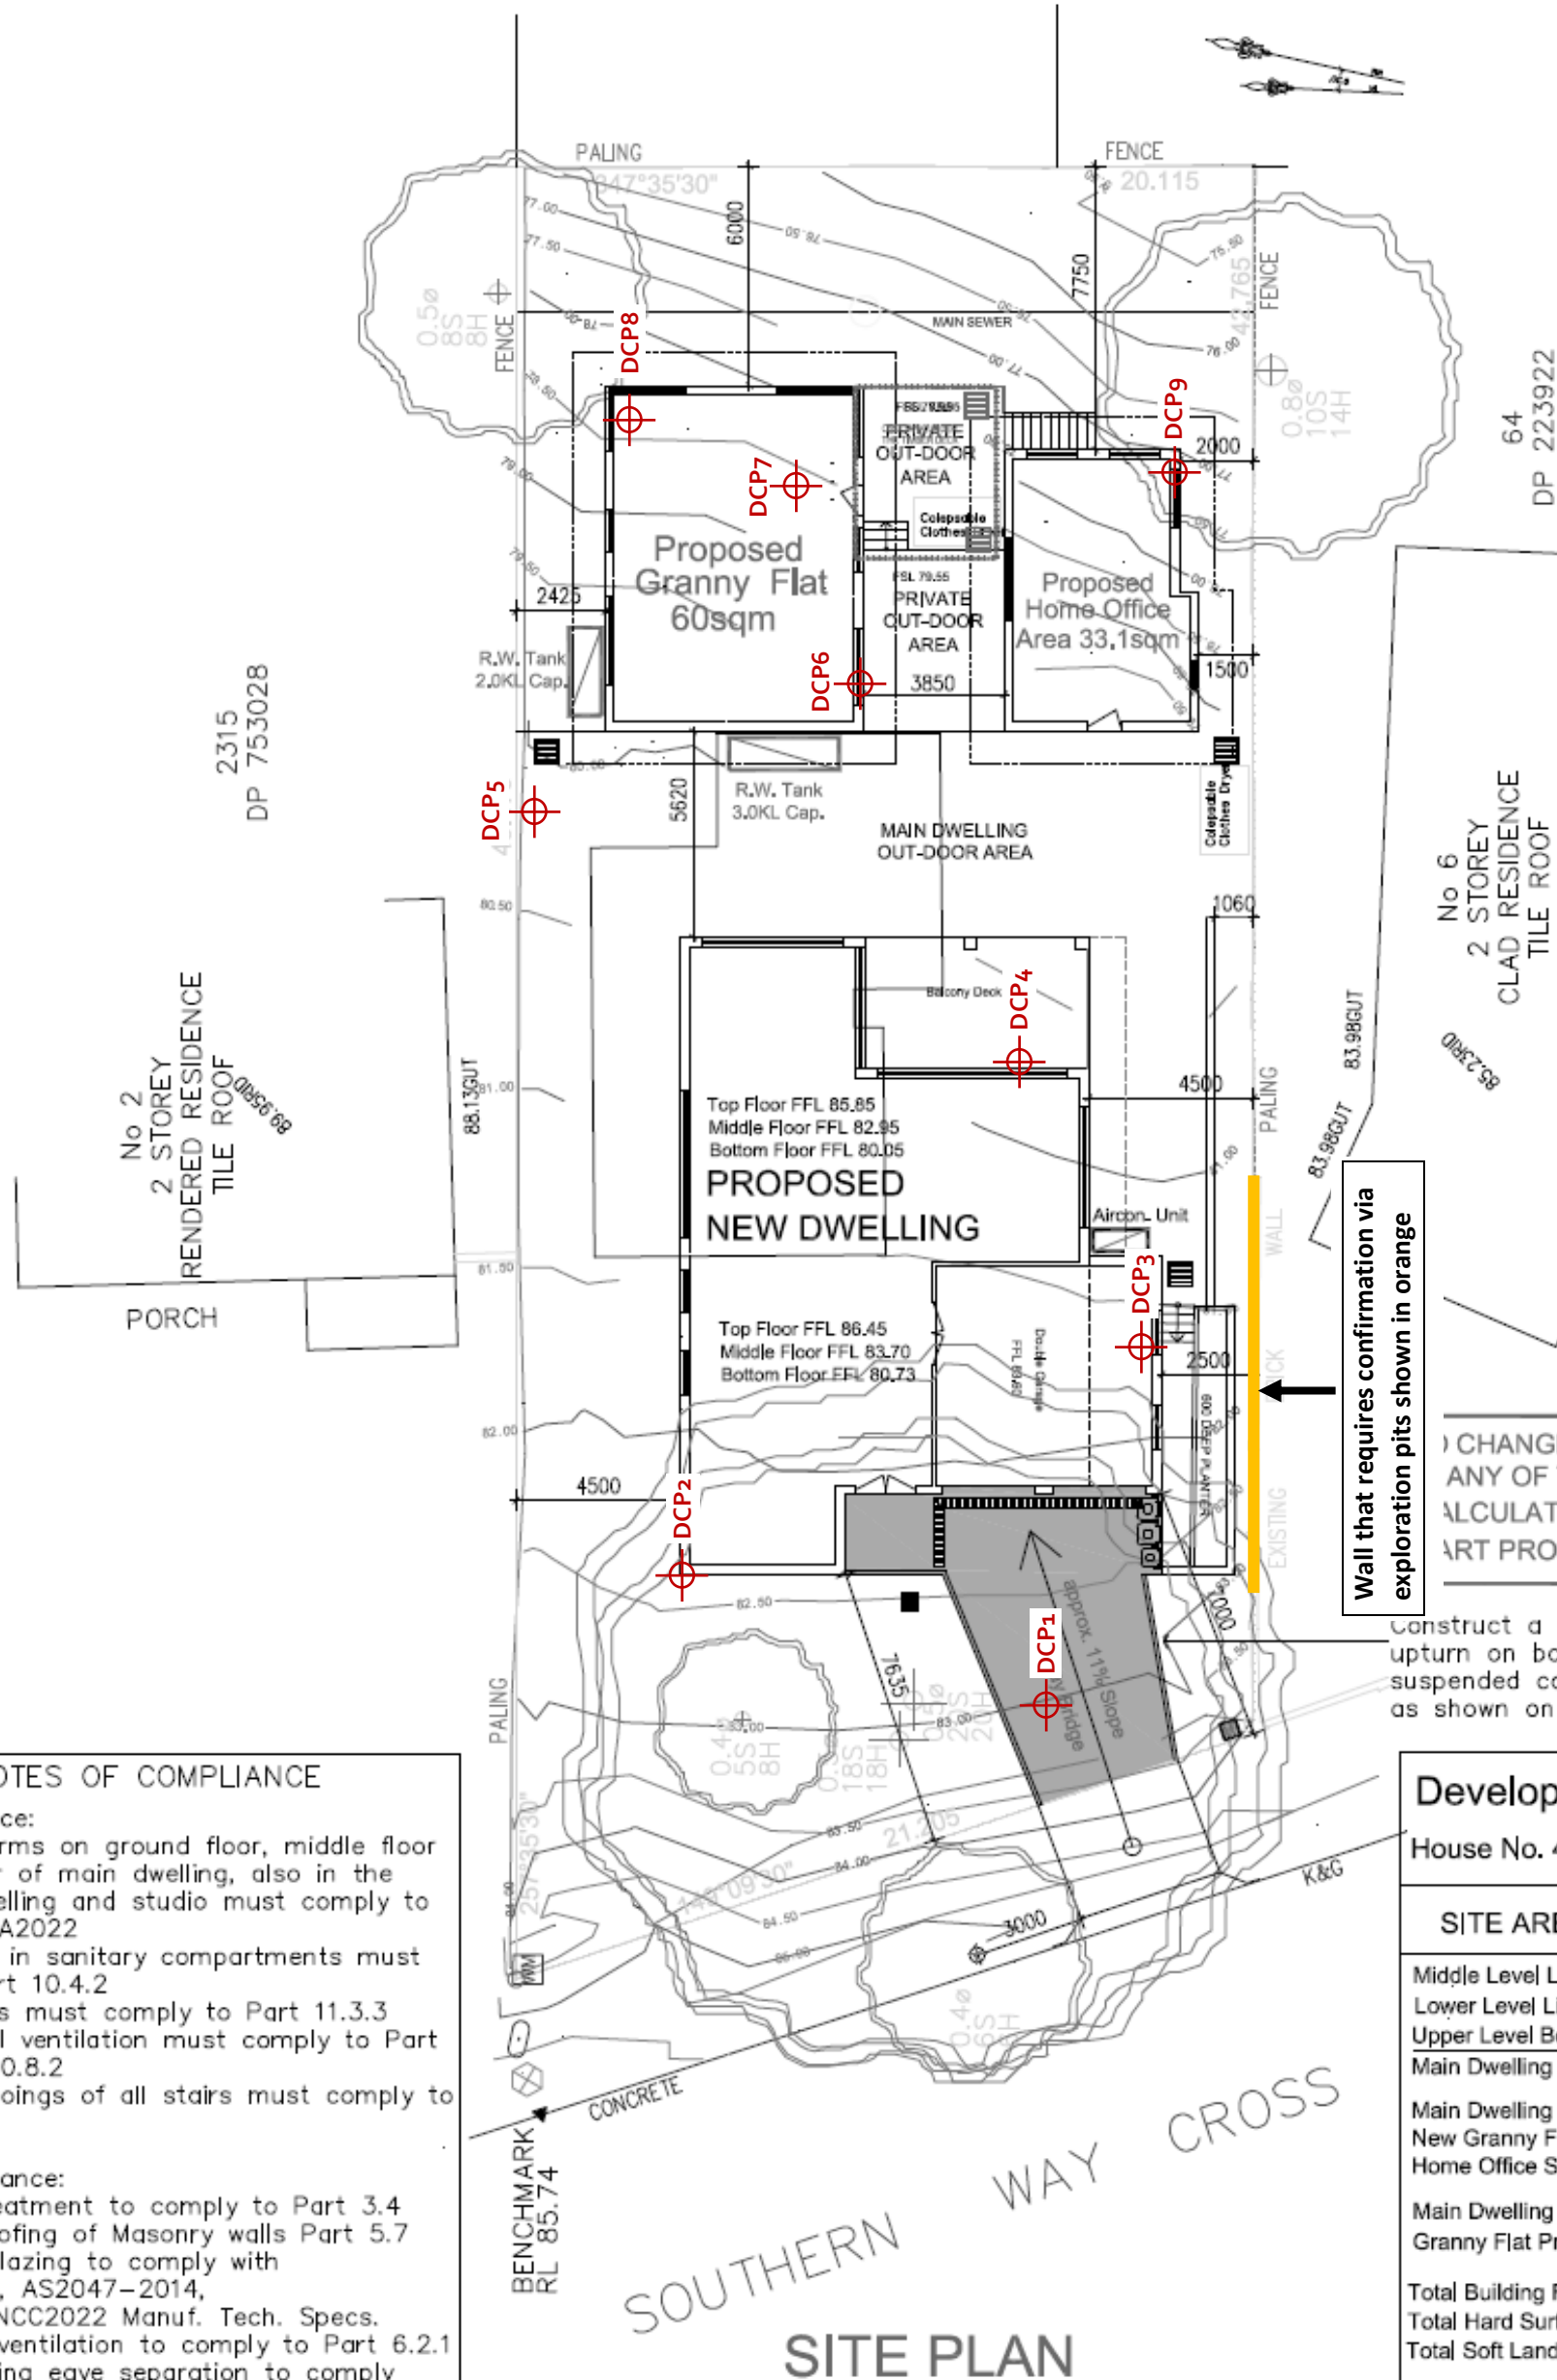
# SITE PLAN – showing test locations

Wall that requires confirmation via exploration pits shown in orange

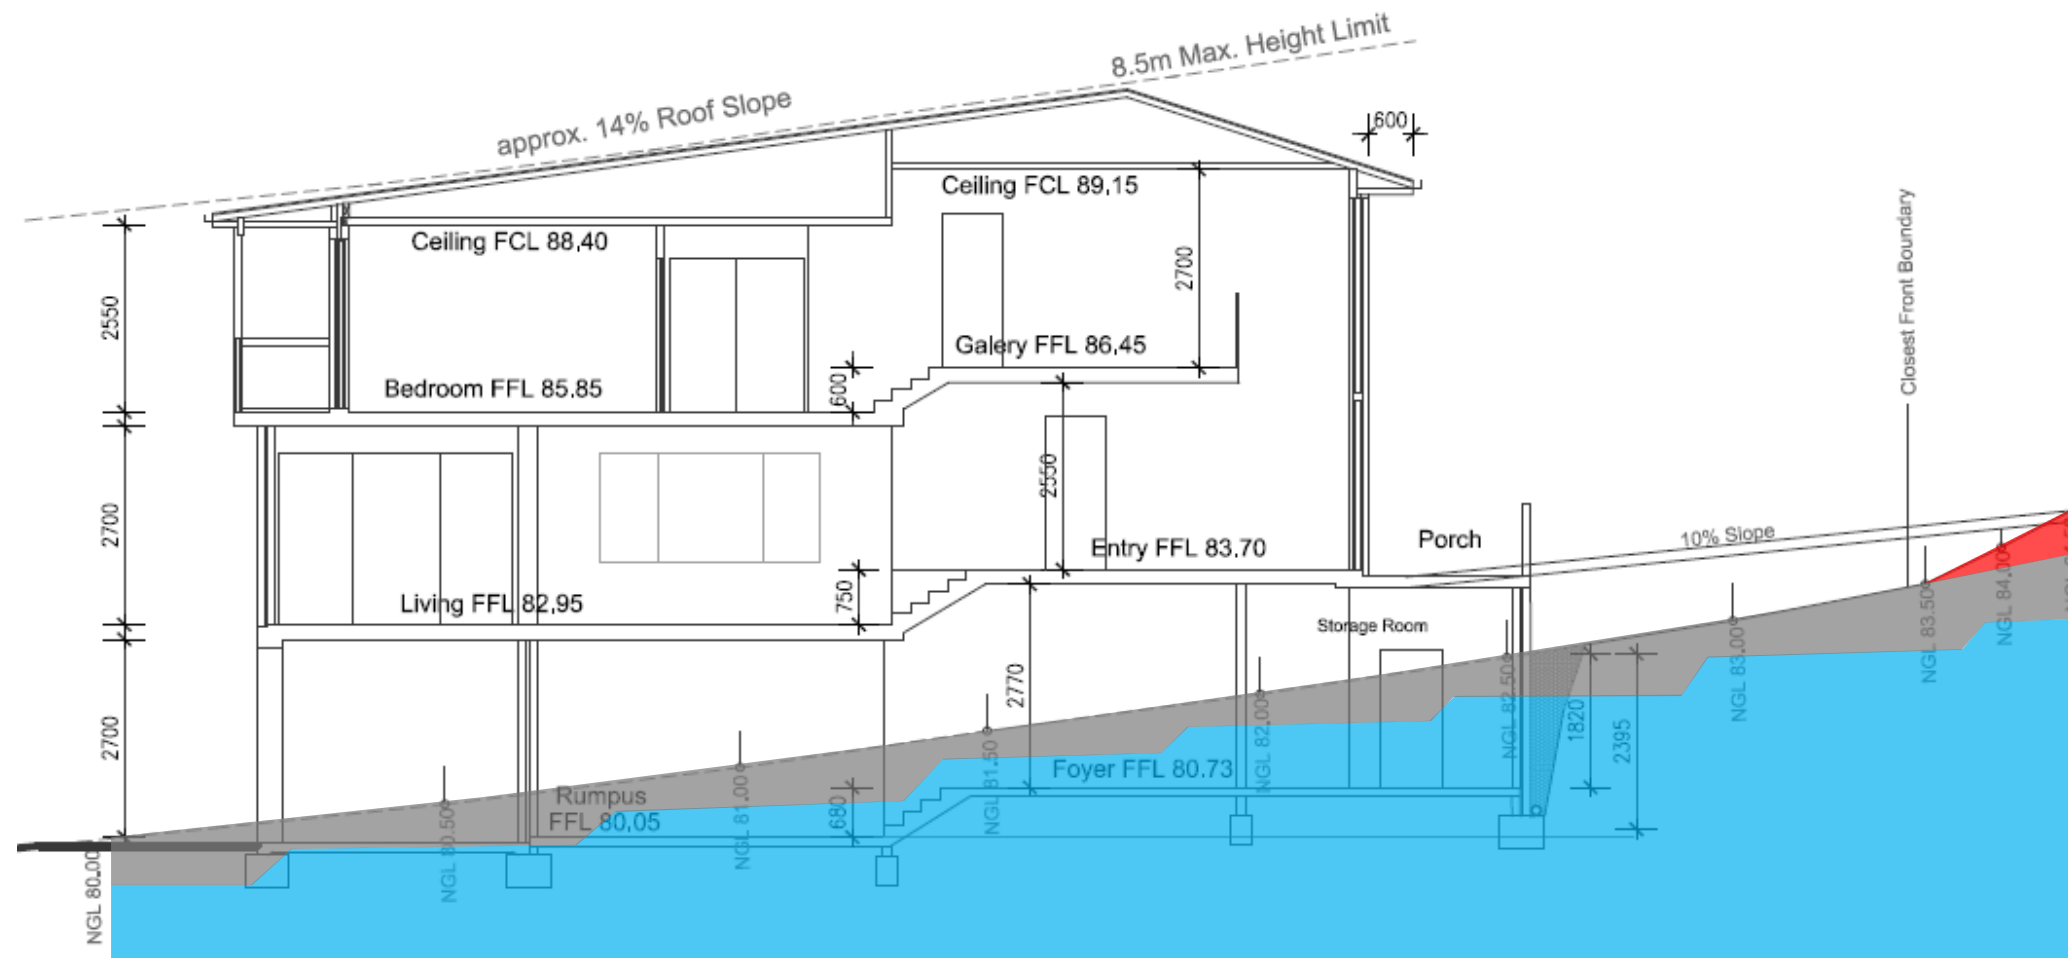
# TYPE SECTION – Diagrammatical Interpretation of expected Ground Materials

test locations, where rock was not exposed, it was encountered at depths of between ~0.4 to ~1.4m below the current surface, being deeper in the filled areas and slightly variable due to the stepped nature of the rock. The sandstone exposed across the property is estimated to be Medium Strength or better and similar strength rock is expected to underlie the entire site. See Type Section attached for a diagrammatical representation of the expected ground materials.
