GEOTECHNICAL INVESTIGATION:

New Pool and Decks at 135 Seaforth Crescent, Seaforth

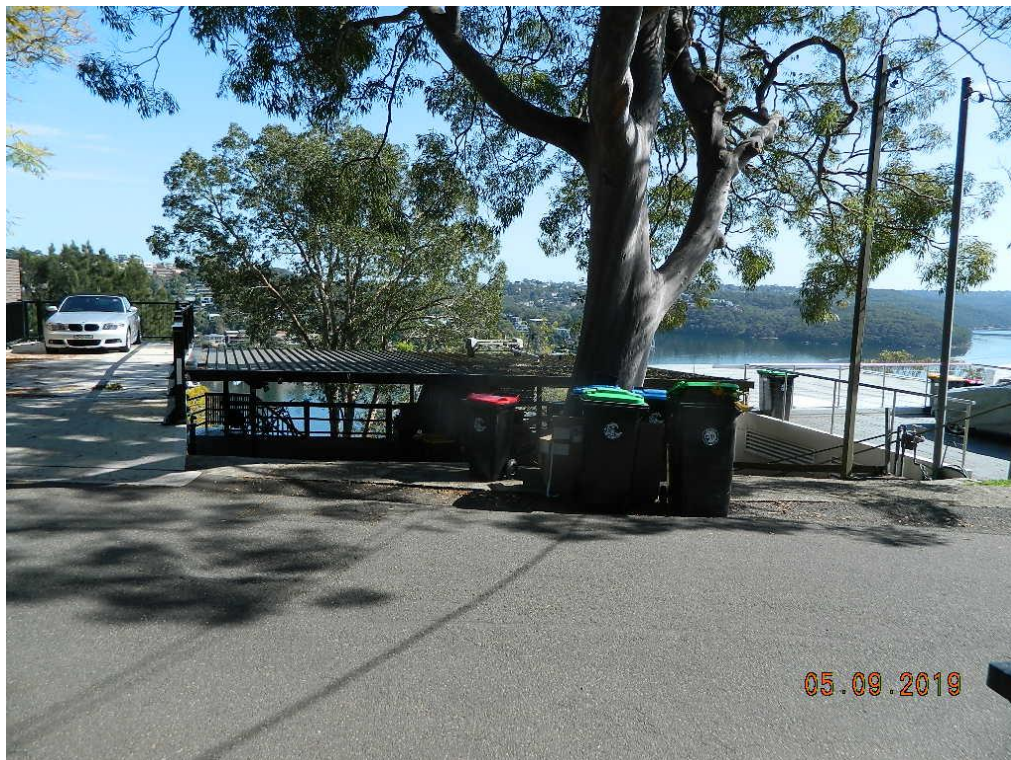
Photo 1

- 2.3** At the road frontage, a concrete driveway runs to a suspended carport on the uphill side of the property (Photo 1). A timber and steel stair case runs downslope from the carport to the house (Photo 2). Outcropping sandstone was observed across the entire site. The three storey timber framed and clad house continues downslope. The house is partially suspended and is supported by steel beams and concrete footings on sandstone (Photo 3). All visible footings showed no signs of movement and are considered stable. An inclined lift runs along the S boundary and rough sandstone block set of stairs along the E side of the property (Photo 4). A $\sim 3.0\text{m}$ high sloped and jointed sandstone rock face extends downslope of the house (Photo 5). The rock face is considered stable. The footprint of the suspended pool will fall over this portion of the slope. A timber stair case has been cut into the sandstone rock face

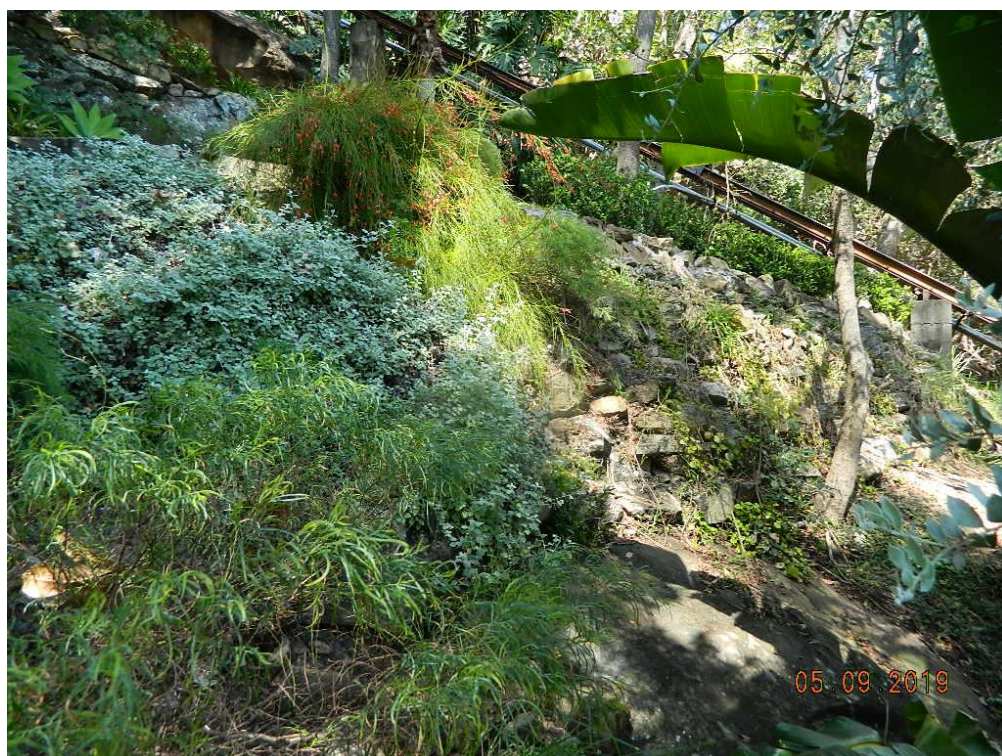
Photo 6

and provides access to narrow lawn covered terraces. Sandstone stack rock retaining walls founded on outcropping sandstone have been used to support the fills that form these terraces. The retaining walls range in height from 0.4m to 2.0m and are considered stable (Photo 6). Where terraces don't exist the slope is covered in native and exotic shrubs and trees. The steep slope continues to the downhill property boundary.

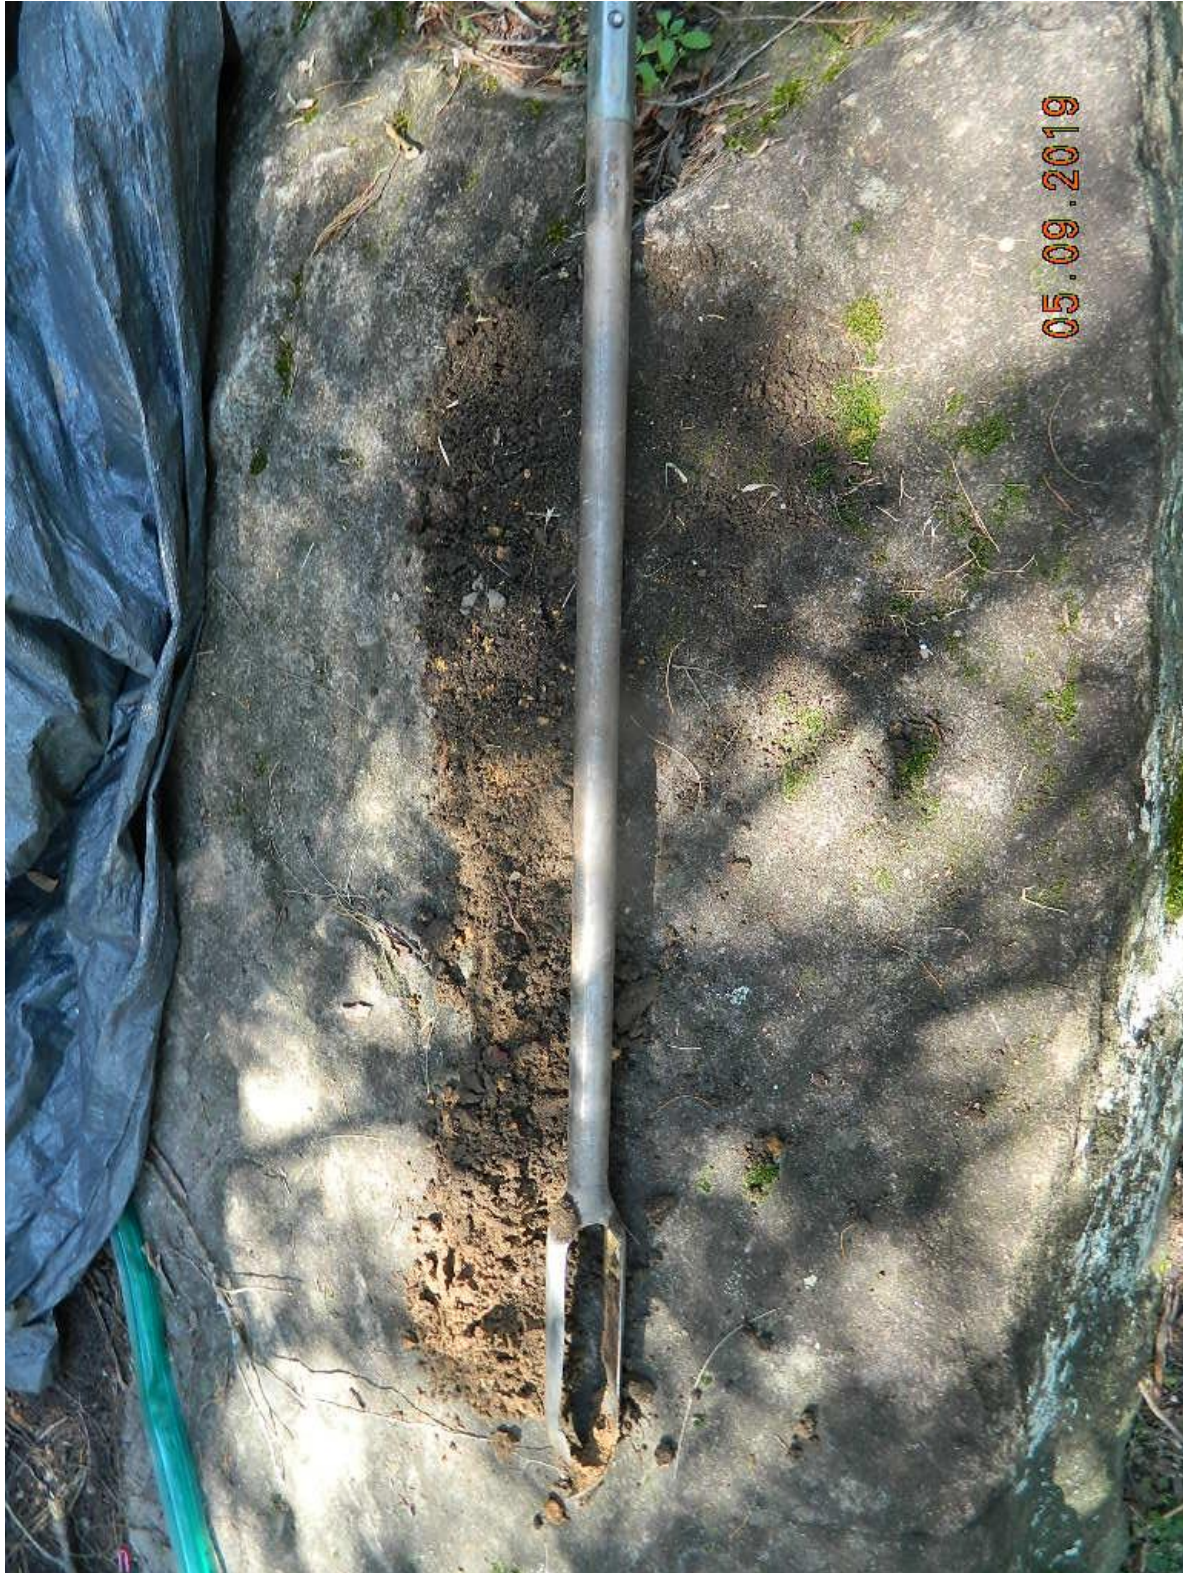
Photo 7 – AH1

AUGER HOLE 1 (~RL33.8) – AH1 (Photo 7)

Depth (m)	Material Encountered
0.0 to 1.0	Sandy Soil , brown, medium grained with sandstone fragments

Refusal @ 1.0m grinding on rock. No watertable encountered.

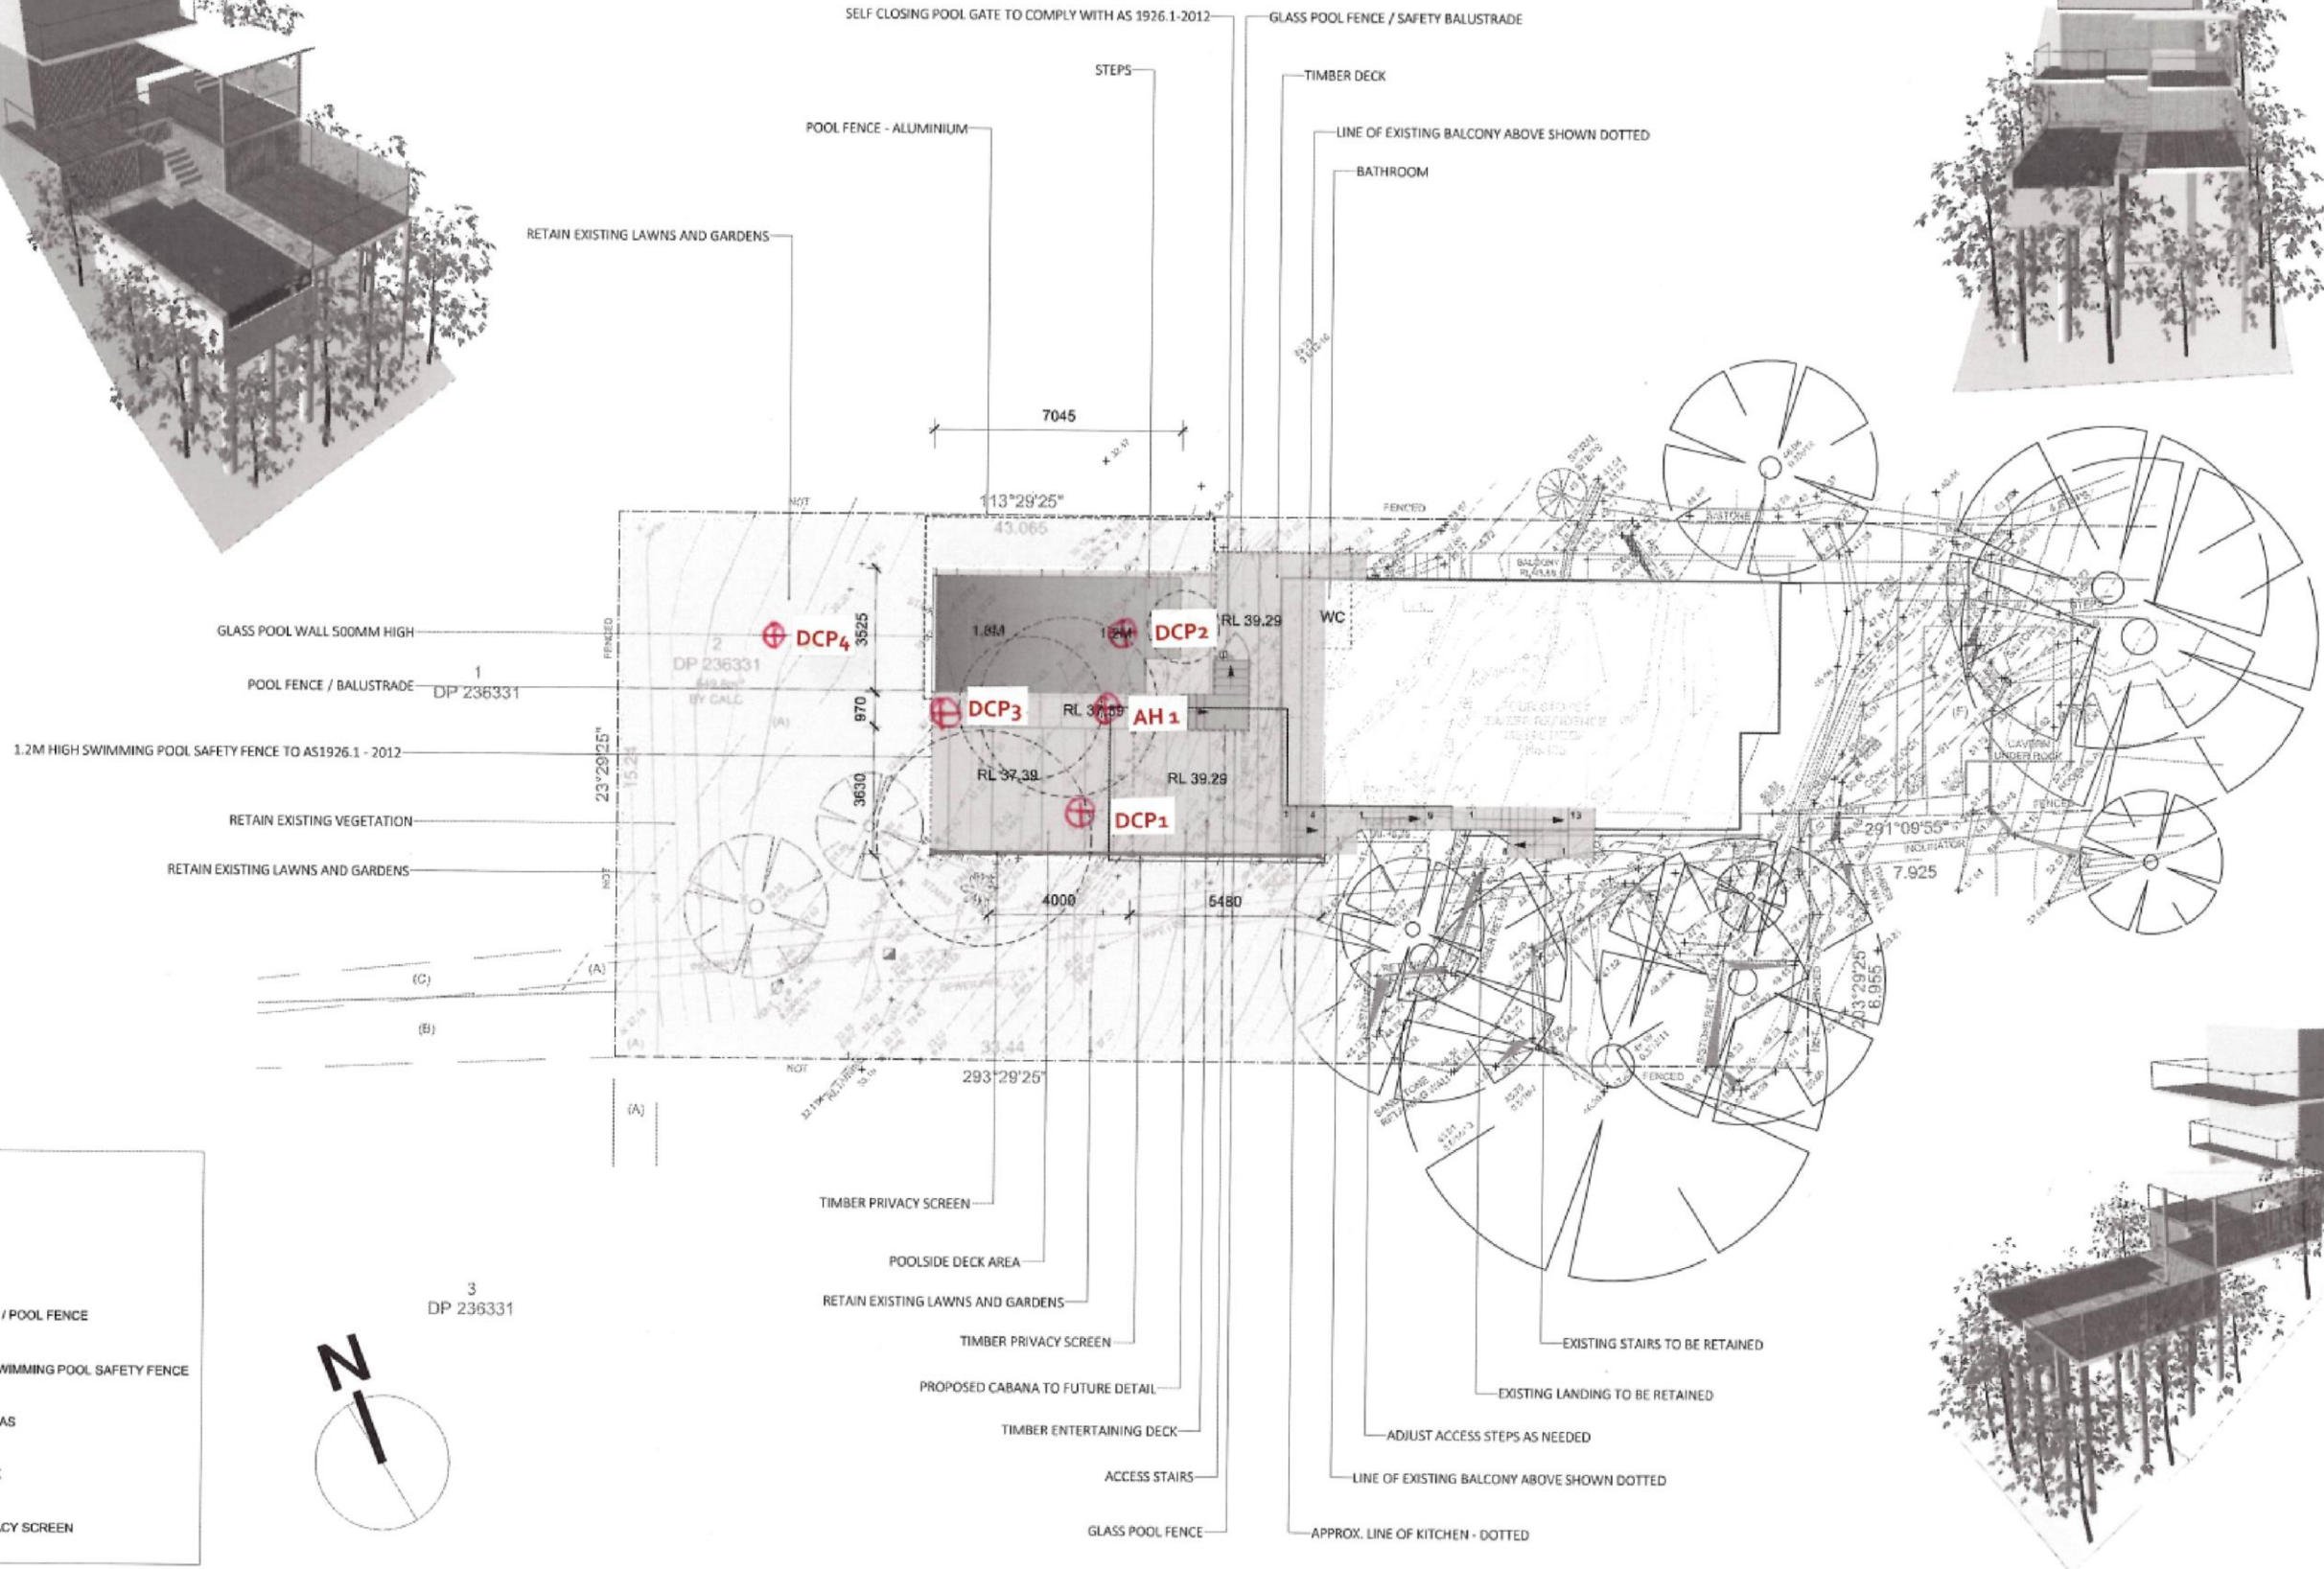
SITE PLAN – showing test locations

One auger hole was put down to identify the soil materials. Four Dynamic Cone Penetrometer (DCP) tests were put down to determine the relative density of the overlying soil and the depth to bedrock. The locations of the tests are shown on the site plan. It should be noted that a level of caution should be applied when interpreting DCP test results. The test will not pass through hard buried objects so in some instances it can be difficult to determine whether refusal has occurred on an obstruction in the profile or on the natural rock surface. This is not expected to be an issue for the testing on this site and the results are as follows:
