42 Beacon Hill Road, Beacon Hill

Geotechnical Comments for Section 4.55 (Formerly Section 96).

PRELIMINARY GEOTECHNICAL ASSESSMENT:

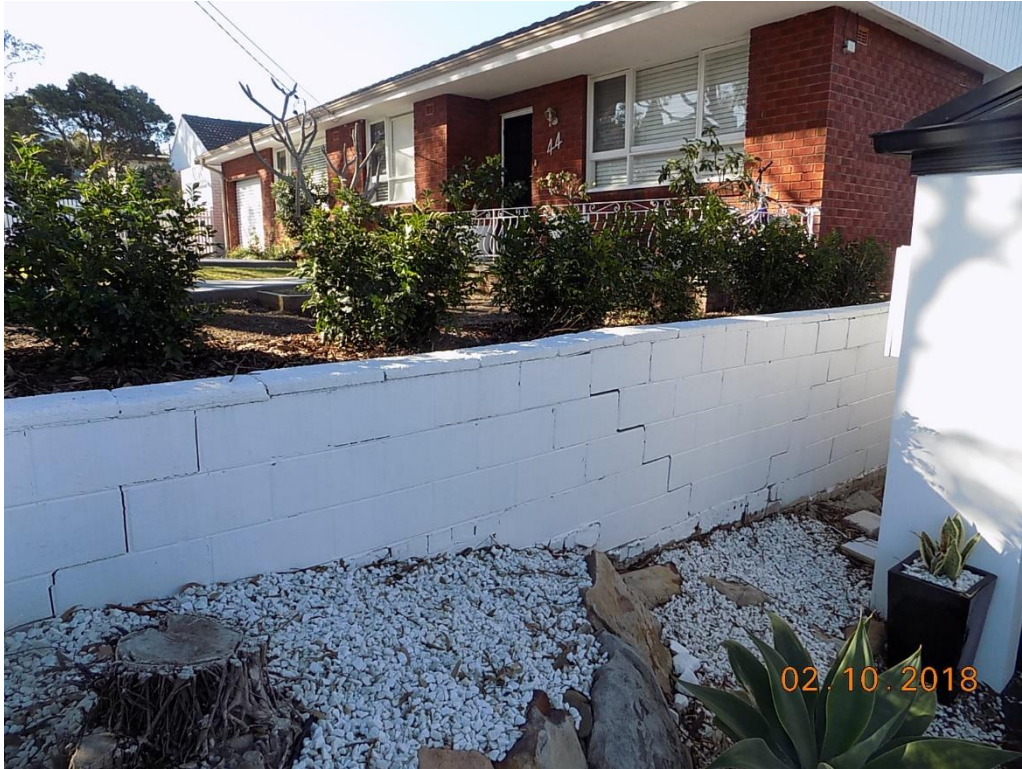
Photo 1

The concrete block retaining wall supporting the fill on the NW neighbouring property is cracked and shows minor settlement (Photo 1). To be prudent, we recommend the retaining wall be inspected by the owners on an annual basis or after heavy prolonged rainfall, whichever occurs first, keeping a photographic record of the inspections. We can carry out these inspections upon request. Should any new movement be observed, the geotechnical consultant is to be engaged to assess the movement and provide remedial advice if necessary.
