ARBORICULTURAL
IMPACT
ASSESSMENT OF
TREES ADJOINING
29 CURRONG
CIRCUIT, TERREY
HILLS

1.2 The subject site was inspected on 21/5/2021;

1.3 This report was prepared for Clarendon Homes.

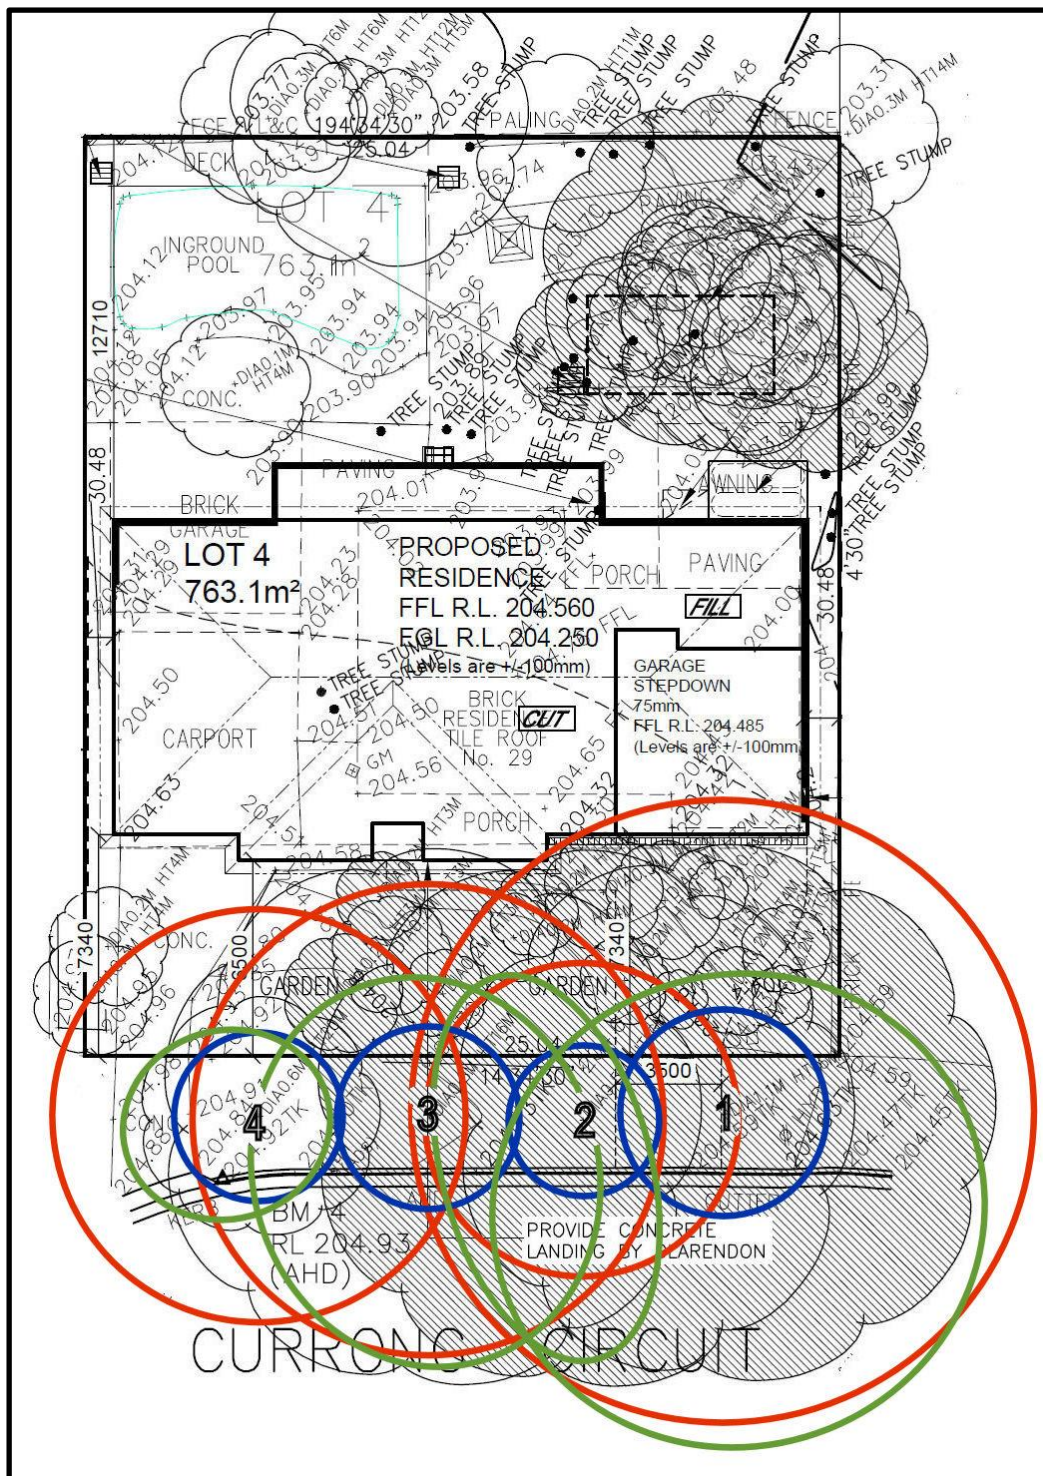
Figure 3: Position of the trees with calculated Tree Protection Zones outlined in red, the calculated Structural Root Zones outlined in blue and the crown limits in green. Scale 1:250. From Site Plan of 29 Currong Circuit, Terrey Hills, by Clarendon Homes. Dated 29/3/2021

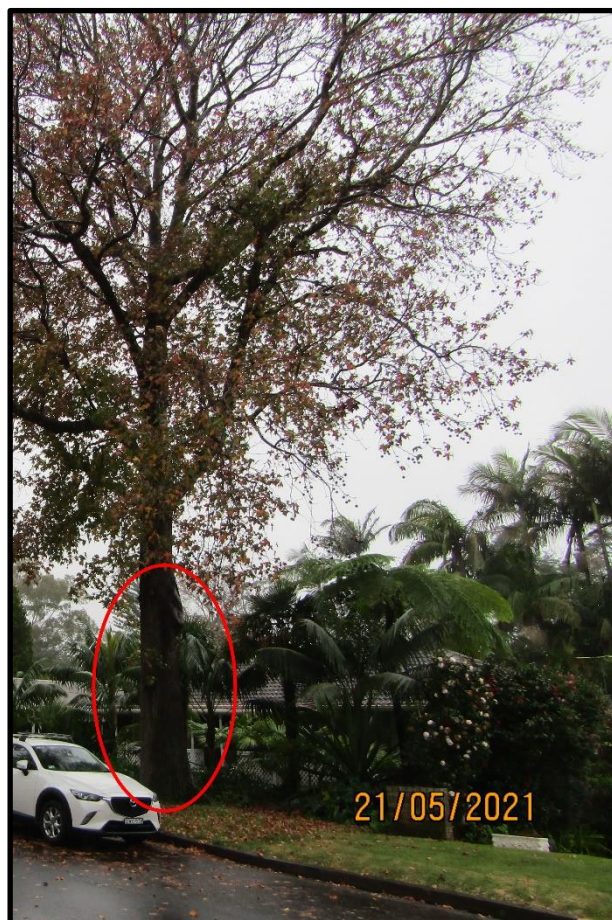
- 5.1 Tree 1 is a mature *Liquidambar styraciflua* (Sweet Gum). (See Figure 5) Tree 1 is growing on the road verge of Currong Circuit. Tree 1 has been crown lifted of several years by removing the majority of the lower and mid-trunk first order branches. (See Figure 6) This has resulted in a tree typified by Mattheck (2007) P. 67, where he describes a tree “*which will put on less and less radial increment from the top down*”. Mattheck, also, implies that the loss of the lower first order branches will reduce root growth, resulting in a smaller root plate. The mid trunk’s reduced growth is such that the lower trunk has developed an expanded form, similar to “Bottle Butt”. (See Figure 5) Gilman and Eisner (2007) suggest that trees that have been heavily trunk pruned can developed decay, from the excessive pruning, and can be at risk of failing, resulting from too much weight at the top of the tree. This tree does appear to have decay in the poorly sealed over branch stubs. (See Figure 6 and Figure 7) However, Tree 1 has developed a buttressed root system and does appear

Figure 5: Tree 1 showing the developing bottle butt

- 6.1 Trees 1 to 3 should be removed as these trees all have structural issues. Trees 1 and 2 are in conflict with the proposed driveway and tree 1 is going in too close proximity to the water main and hydrant;
- 6.2 Tree 4 should be retained.

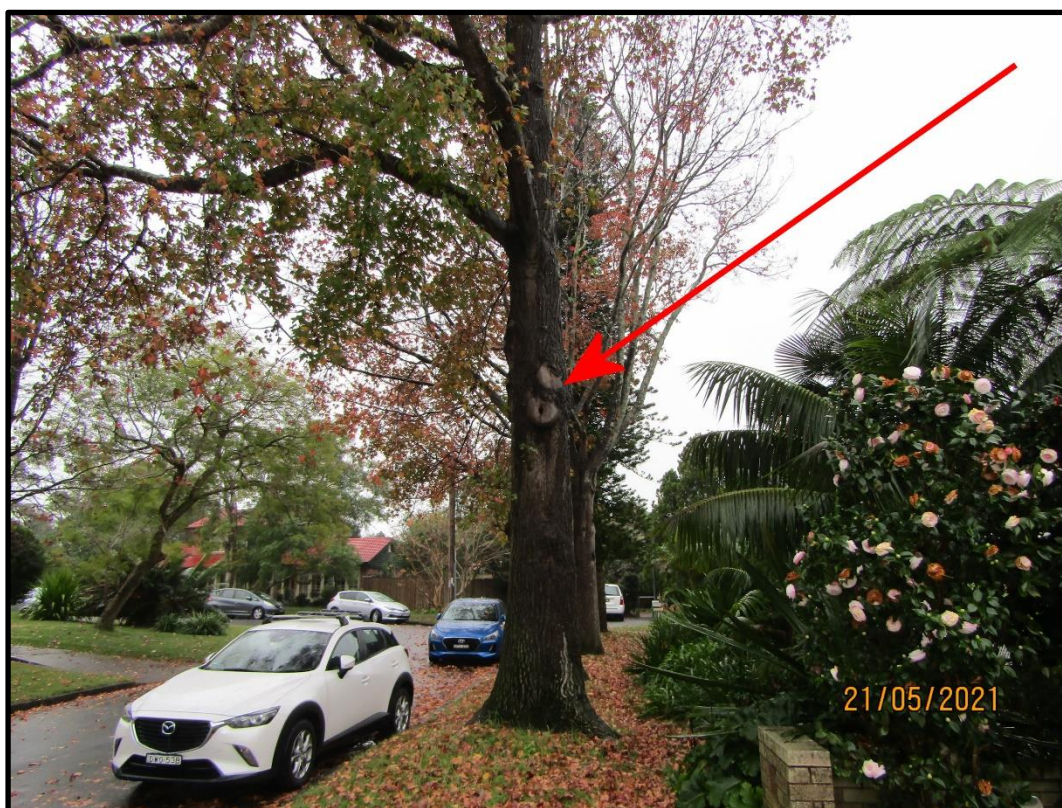
Figure 6: Showing the crown lifted trunk on Tree 1 with partially decaying branch stubs

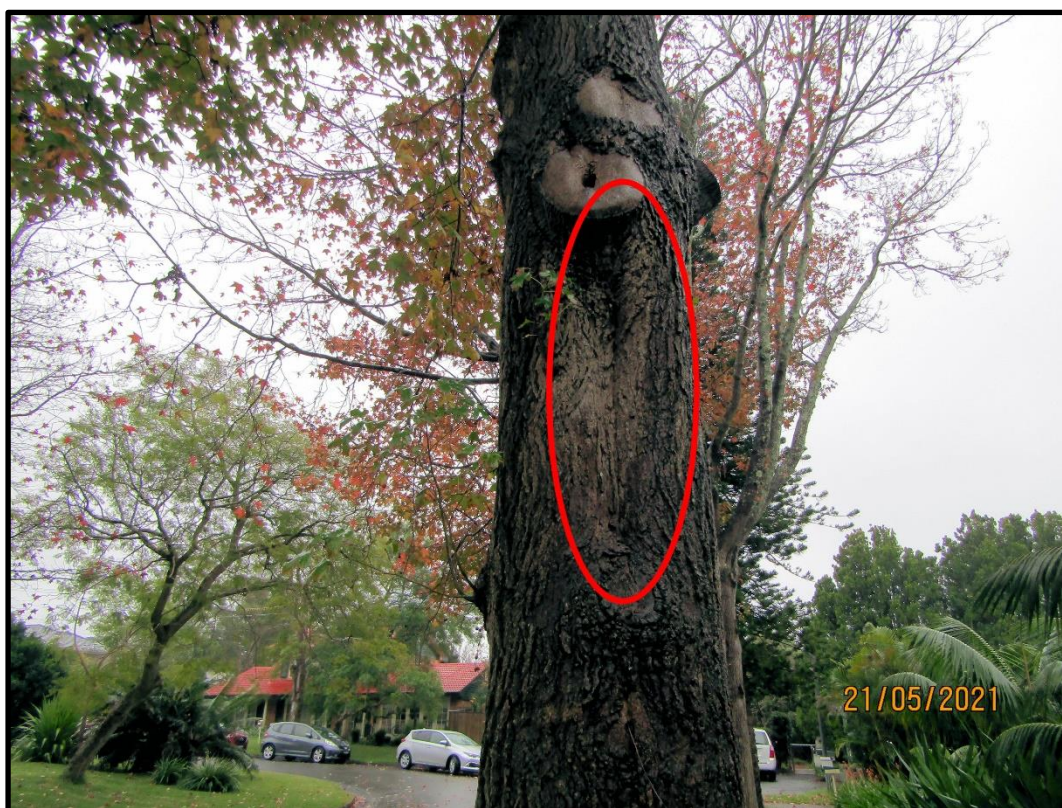
to be relatively stable. Although the root plate may be stable Tree 1 does appear to have a partially sealed over shear crack on the lower trunk, which may be related to the less formed trunk from the crown lifting. (See Figure 7) Mattheck (2007) P. 19 states that shear cracks *often start at bark inclusions and do not lead to total failure, but they do reduce the safety reserves with bending loads*. Further, Tree 1 is growing 1.63 metres from a hydrant. (See Figure 8) Considering the expansive and fast growing root system attributed to *Liquidambar styraciflua*, the tree is too close to the hydrant and water main. Council should consider removing Tree 1, due to the crown lifting, the shear crack and the proximity to the water main and hydrant. Further, the current proposal, including the driveway would require that Tree 1 is removed, as the driveway passes through the location for Tree 1;

Figure 7: Shear crack on Tree 1 with decaying stubs above

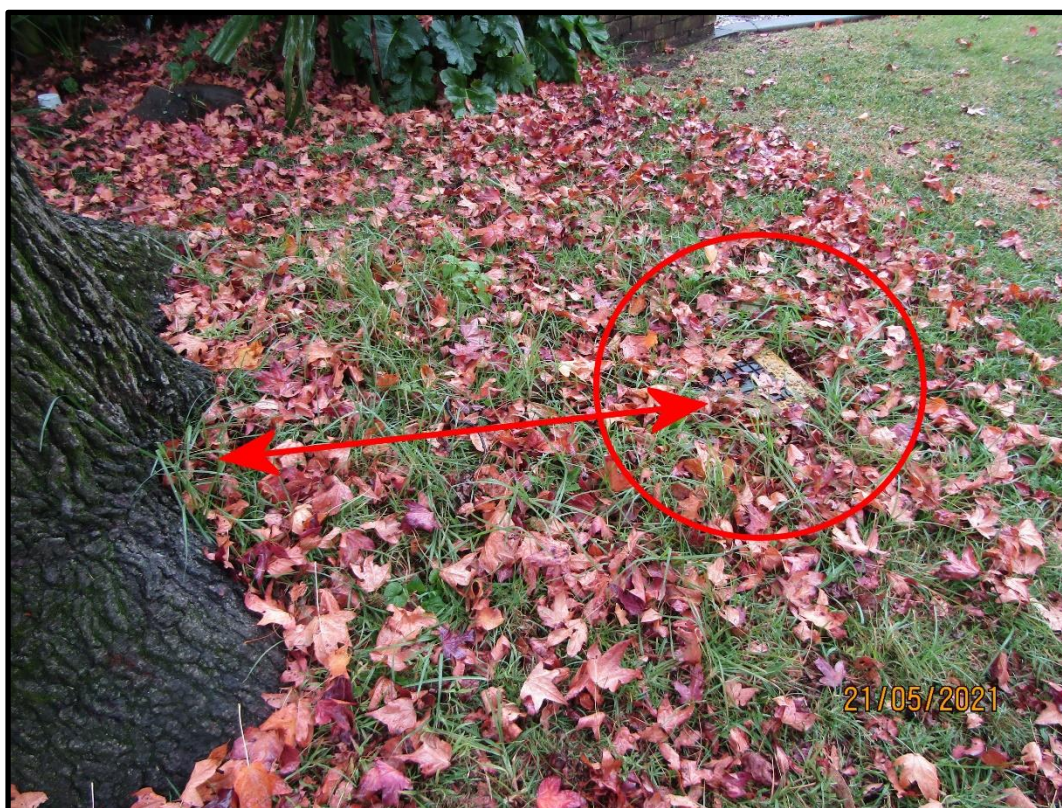
Figure 8: Showing Tree 1's position in relation to the hydrant

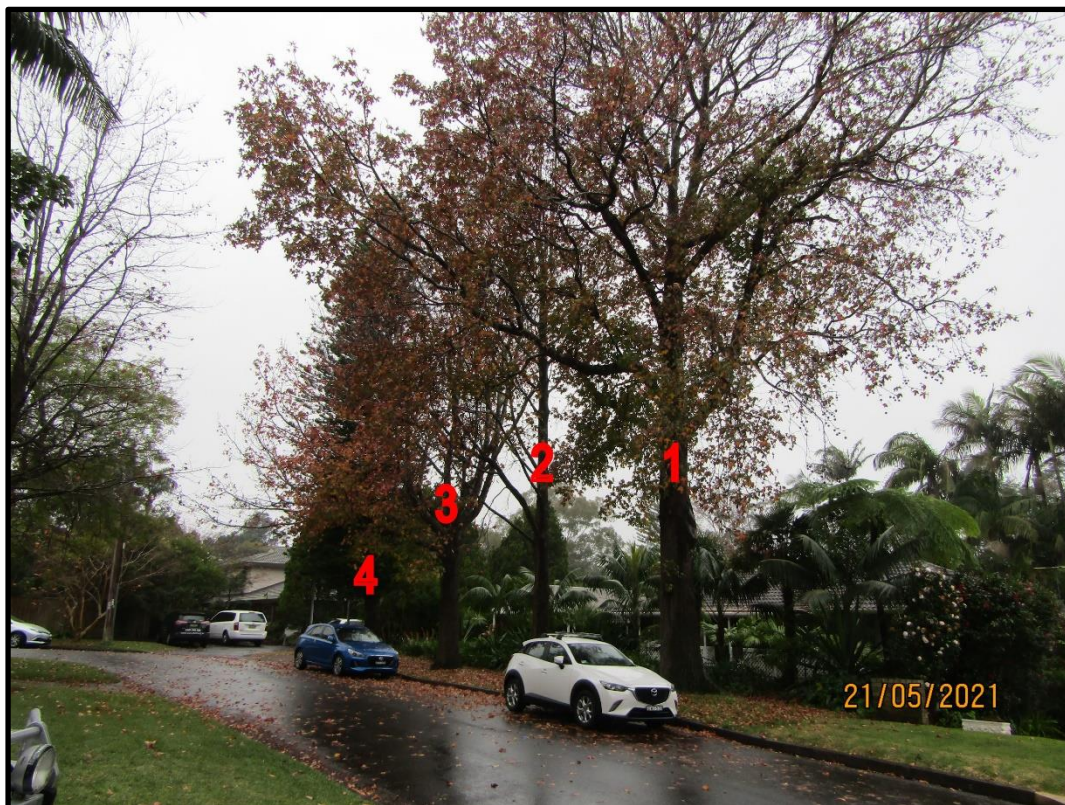
- 5.2 Tree 2 is a partially suppressed *Liquidambar styraciflua* (Sweet Gum). This tree is also growing on the road verge, in front of 29 Currong. Tree 2's growth has been suppressed by Trees 1 and 3 with a much compressed crown and narrower trunk. (See Figure 3 and Figure 9) Tree 2's lower and mid trunk has been subjected to side stubbing which has been described by Lee R., F. and Wolowicz R., S. in Kuser ed (2013) as undesirable. (See Figure 10) The proposed driveway will impact on 28.7% of Tree 2's Tree Protection Zone (TPZ). (See Figure 3) This is major encroachment under Part 3.3.3 of the Australian Standard 4970 of 2007. Council should consider removing Tree 2;

Figure 9: Showing Tree 2 surrounded by Tree 1 and 3 with reduced trunk size.

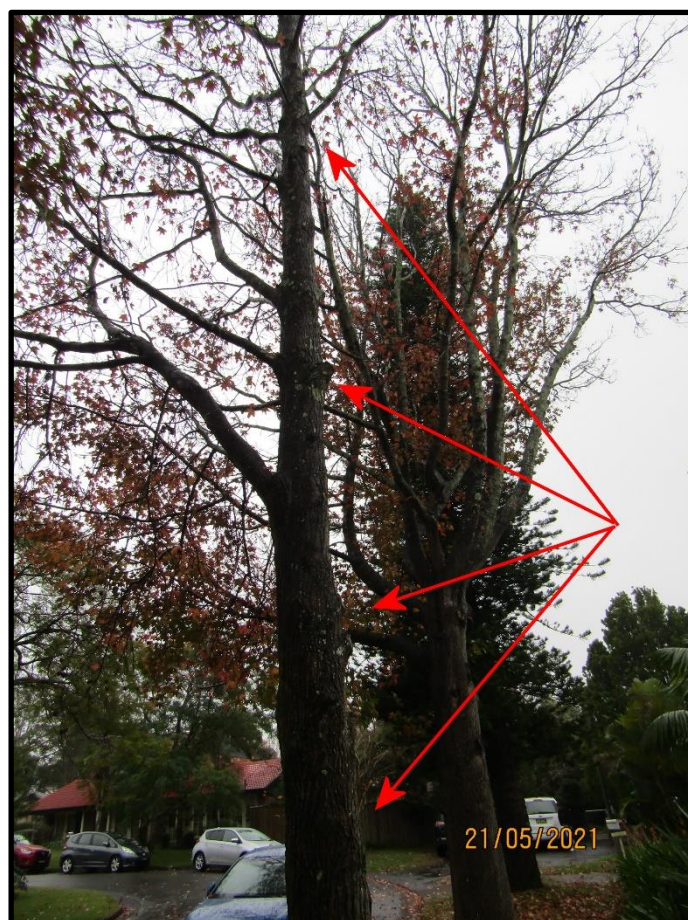
Figure 10: Showing side stubbing on Tree 2

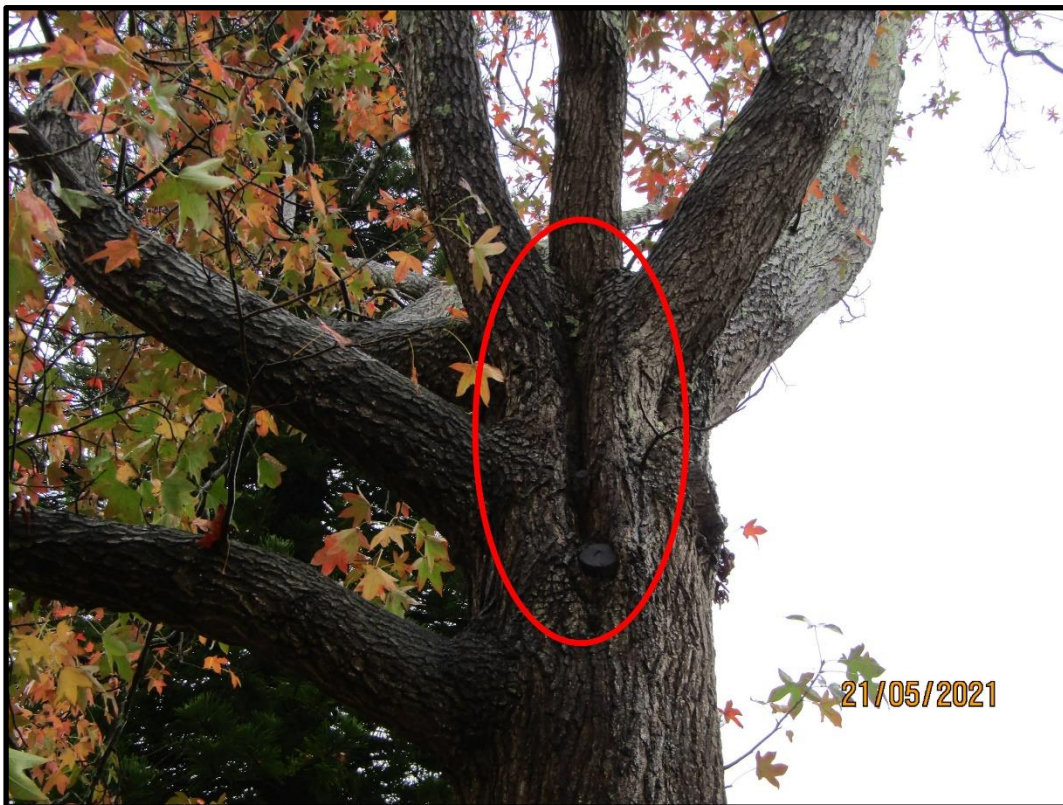
- 5.3 Tree 3 is a mature *Liquidambar styraciflua* (Sweet Gum). (See Figure 11) Tree 3 has had a damaged crown, resulting in the development of a multi-branched crown, derived from epicormic shoots. (See Figure 11 and Figure 12) Regarding epicormic shoots, Burges (2005) states: - *"They are usually crowded and not strongly attached to the tree. Unlike normal branches that develop in a "socket" of overlapping wood tissues, these new shoots are anchored only in the outermost layers of the parent branches. Consequently, they are likely to break as they mature."* Further, Gillman (2012) states *"When sprouts with adjacent points of origin enlarge, they physically push against each other, sometimes resulting in bark inclusions and failure."* There are several bark inclusions in the branch junction. Mattheck (2007) P.21 regards compression forks, particularly those with longitudinal cracks, as dangerous. Lonsdale (2000) P. 20, supports Mattheck stating *"unions with included bark are most likely to fail in trees on exposed sites (especially if exposure has increased, as when surrounding trees are removed), or in dominant trees whose height makes them rather exposed. Gusts blowing between the forks are most likely to cause failure "*. Tree 3 should be removed;

Figure 11: Tree 3 showing compression fork among epicormic derived branches

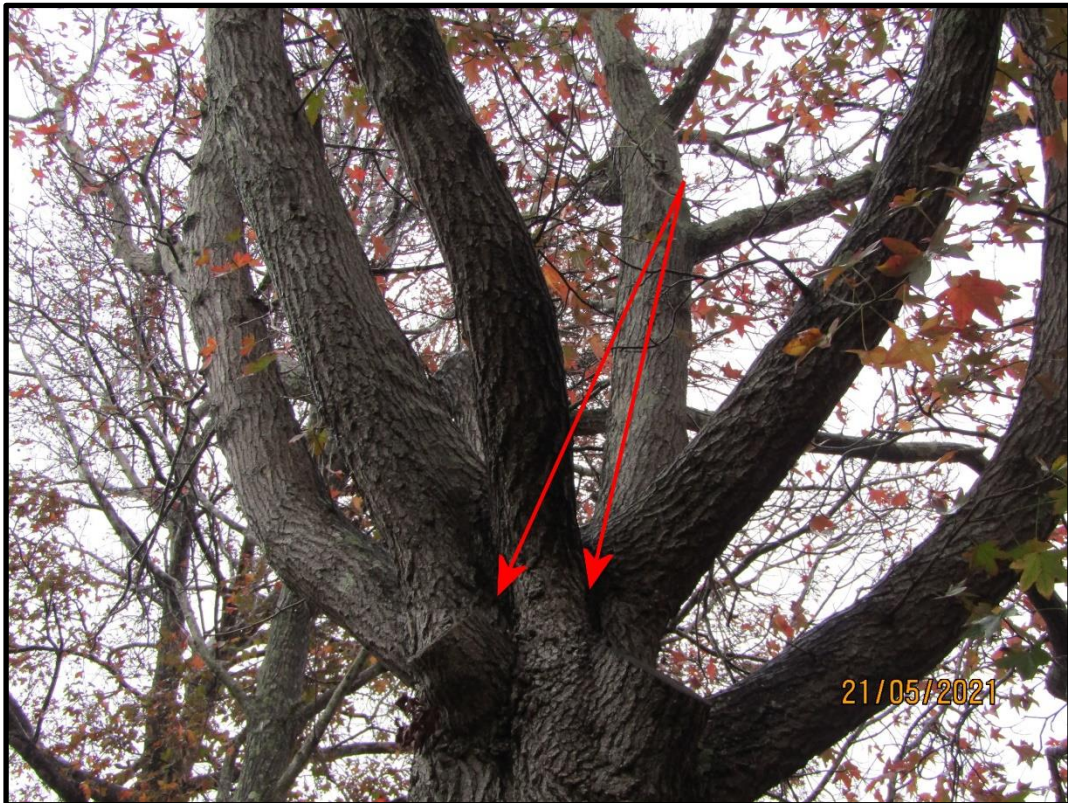
Figure 12: Tree 3 showing more compression fork among epicormic derived branches
