## ***Construction Impact & Management Statement***

**May 2020**

<b>Site:</b>	<b>Lot 55 in DP 11462 61 Dress Circle Road AVALON BEACH, NSW</b>
<b>Client:</b>	<b>Haidee &amp; Simon Keegan c61 Dress Circle Road AVALON BEACH, NSW 2107</b>
<b>Author:</b>	<b>Kyle A Hill Registered (Arb Aus #1884) Practising &amp; Consulting Arborist Post Graduate Certificate in Arboriculture, Uni of Melb Diploma of Horticulture–Arboriculture TAFE, Grow SA Certificate of Horticulture, TAFE Certificate Advanced Tree Care TAFE Founder -Growing My Way Tree Services (1977) Member of International Society of Arboriculture Member of Arboriculture Australia</b>

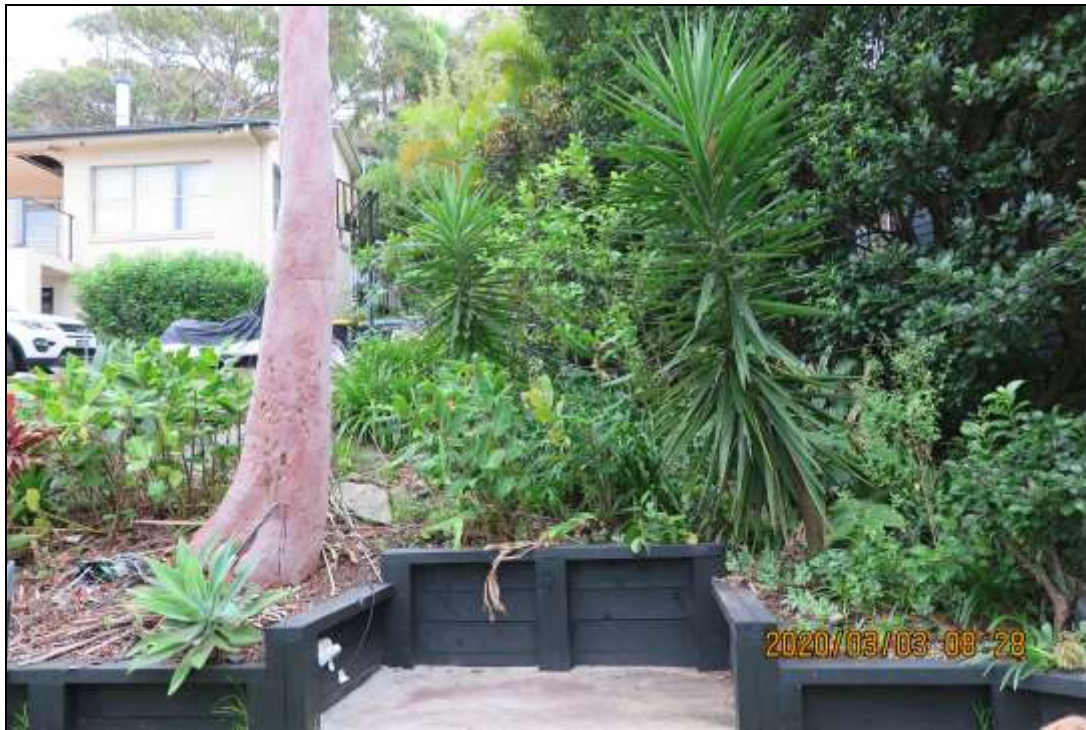
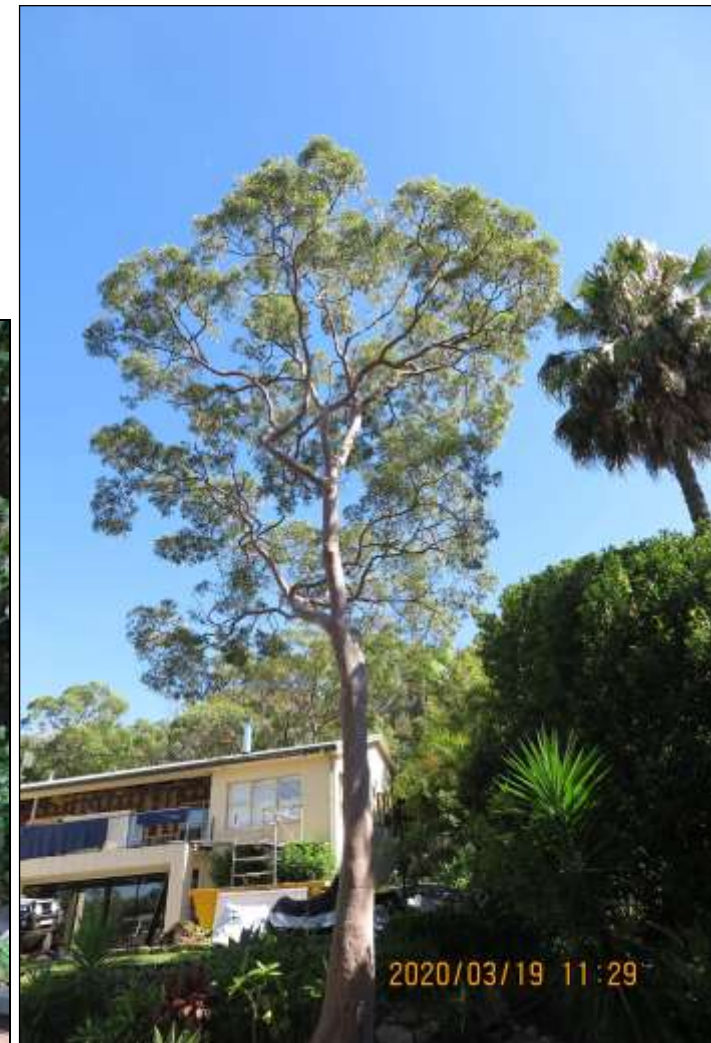
Figure 5: Illustrates the location & condition of Tree #1.

**Tree #1** is acknowledged as being of High Significance & High Retention value by size, species, condition &/or presence. However, by actual specimen these ratings are significantly exaggerated by virtue of the 'body language' of its trunk base. The southern side of the trunk base is quite deformed. Only two trunk base points of origin for 'Structural Supporting Roots' were able to be obviously confirmed. (See below photograph red arrows.) This observation plus the fact the tree trunk on its northern side displayed no likely able to be located 'Structural Supporting Roots' as well as having been subjected to both increased (i.e. infill) & reduced (i.e. excavated) soil levels prompted an earlier exploratory 'root location' excavation. This was undertaken to determine the location of any northern side of tree trunk 'Structural Supporting Roots', none were found. (See page ?? photograph.)

Identification	Height (m)	Crown (m)	DBH (m)	TPZ (m)	SRZ (m)	Age	Health/Vigour	Structure	Significance/Retention Values	Comments
1	<i>Angophora costata</i> Sydney Red Gum	<18.00	<13.00	0.55	6.60	2.80	Mature	Good & Good	Trunk base displays atypical 'butt form' & 'supporting root pattern'	High/High	<b><u>Remove &amp; Replace:</u></b> Tree TPZ/SRZ radial distances are significantly compromised by the as proposed new driveway/driveway infrastructure & new retaining wall.
2	<i>Syagrus</i> spp. (3 x trunks) Closely related but not Cocos Palm	<7.00	<6.00	0.30	3.60	N/A	Mature	Good & Good	Typical	Low/Low	<b><u>Remove &amp; Replace:</u></b> Tree is within the proposed new driveway crossover within the Bellevue Road road reserve.

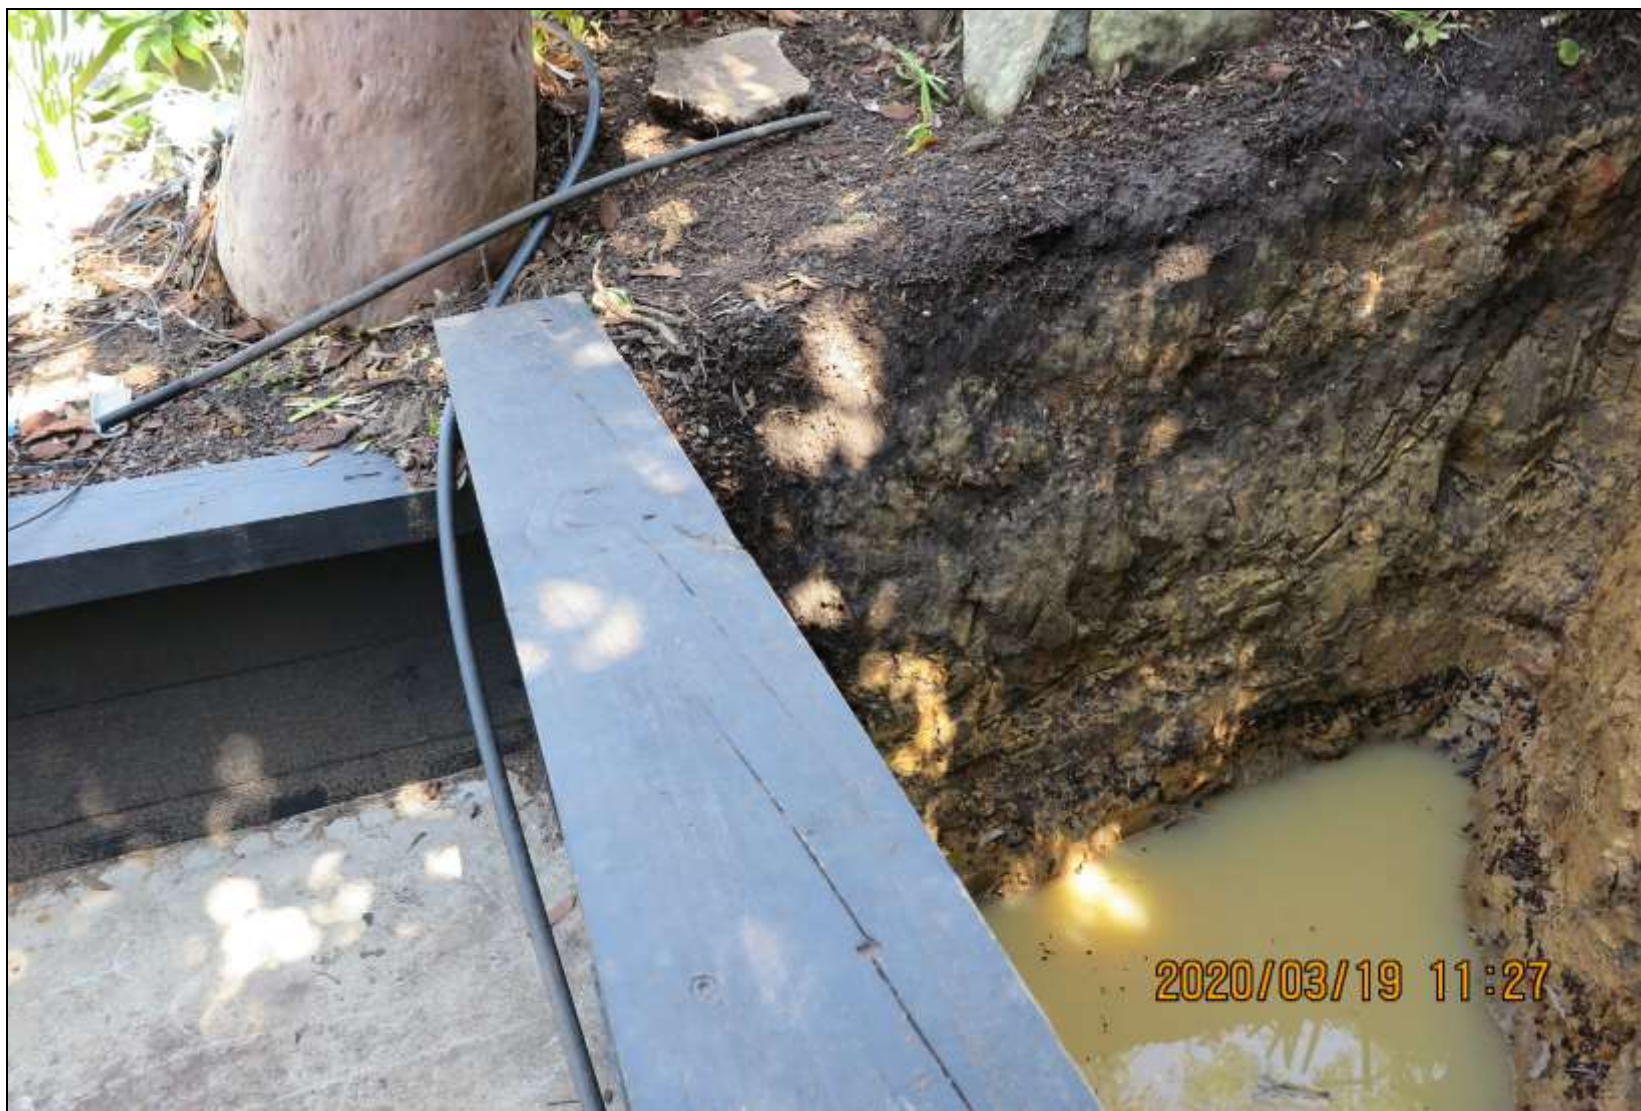
Figure 6: Confirms predictable 'atypical root system'.

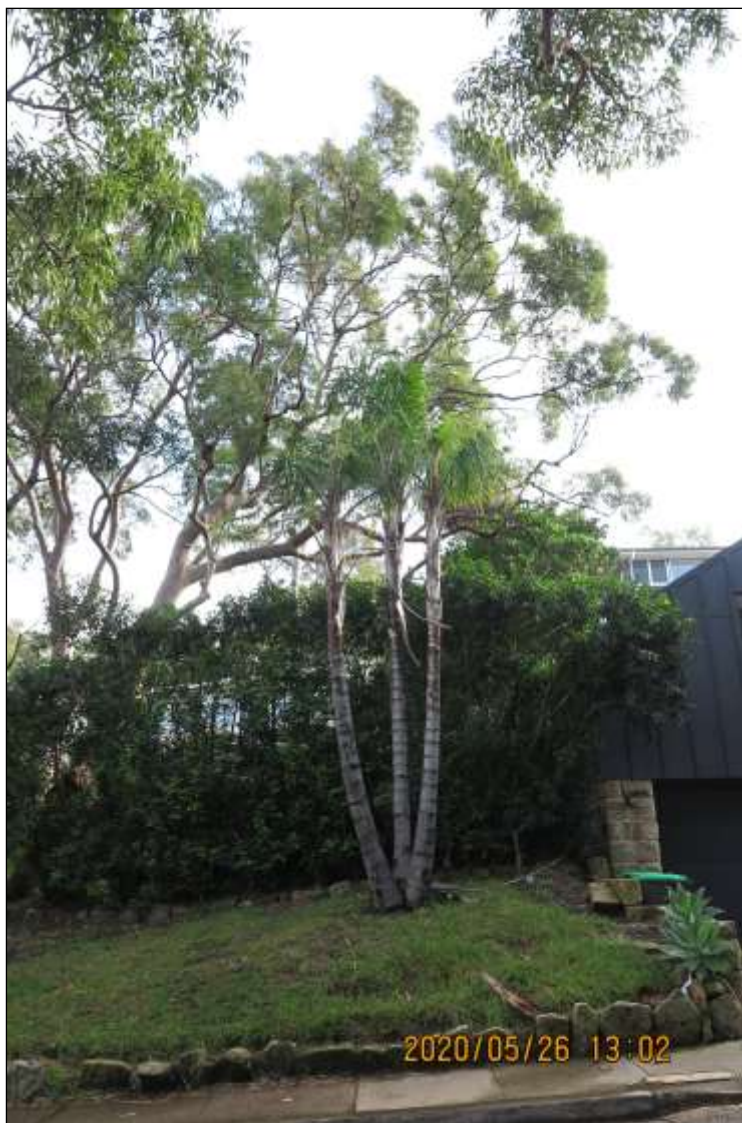
**Figure 7: Illustrates location of the discussed Tree #2.**

Tree #2 as an exotic planted tree not protected by the old *Pittwater Council* & now *NBC* “*Tree Management Provisions*” plus the new *SEPP* “*Vegetation in non-rural Areas, August 2017*” has been given Low Retention & Significance values. At the very least, it is incompatibly with the local floral plant community as well as the concept of the subject site existing & proposed to be enhanced landscape concept.

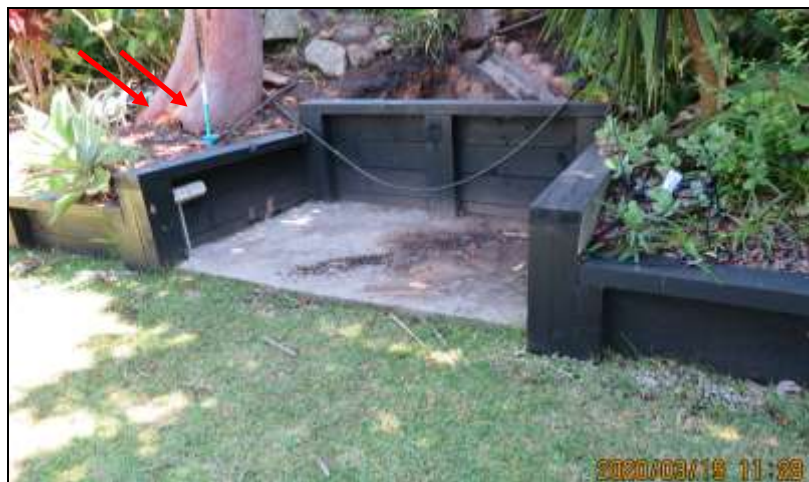
Based on these findings, it would be easy to support the total removal of this tree regardless of any development proposal.

**Figure 8: Illustrates & confirms the description of the tree trunk body language causing concern about total tree stability regardless of any proposal for development.**
