Project name	8-10 Bate Avenue, Allambie Heights
Project date	6/08/2021
Job End Date	6/08/2021

Section No.	US MH	DS MH	Date of Inspection	Address/Location	Material	Inspected Length	Pipe Asset ID
1	SPP 20559	SPP 07744	6/08/2021	Bate Avenue	Concrete reinforced	79.52	SPC 00317

Section Inspection - 6/08/2021 - SPC 00317

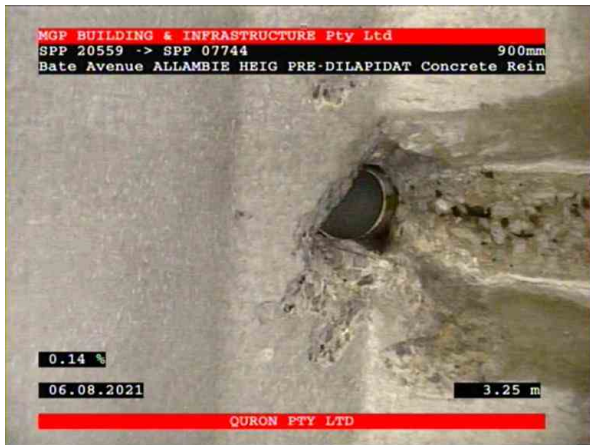
1, 00:00:48, 3.25
Connection, poor workmanship, connection appears to be open, height: 100mm at 2 o'clock

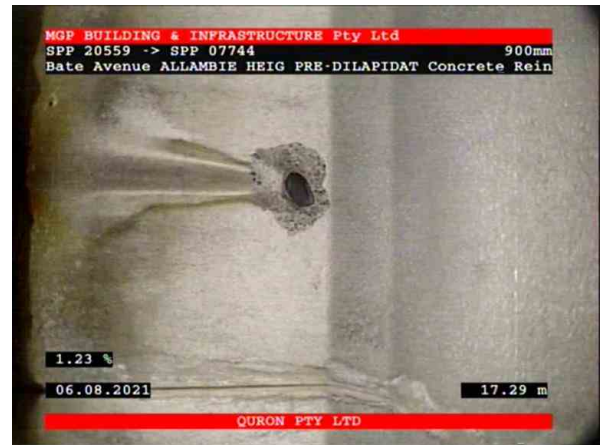
2, 00:04:45, 17.29
Connection, good workmanship, connection appears to be open, height: 100mm at 10 o'clock

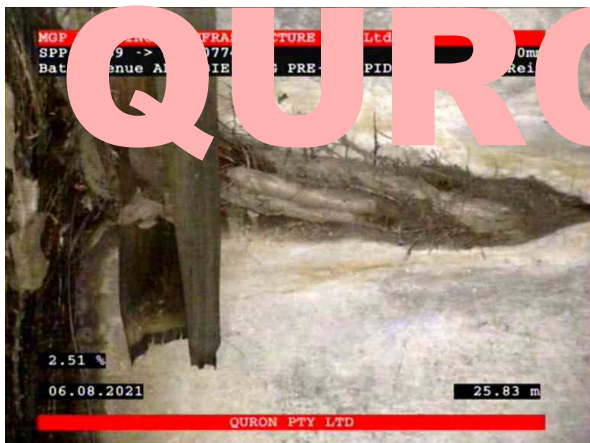
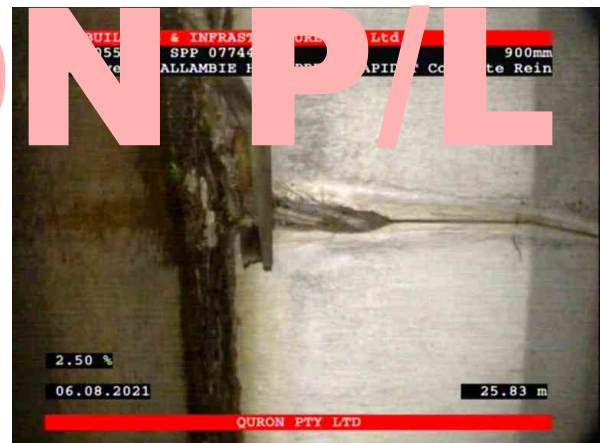
3, 00:07:04, 25.83
Tap roots--a small number of major roots (10mm or greater) without a significant mass of fine root, at joint, Obstruction: <5% at 8 o'clock

4, 00:07:04, 25.83
Tap roots--a small number of major roots (10mm or greater) without a significant mass of fine root, at joint, Obstruction: <5% at 8 o'clock

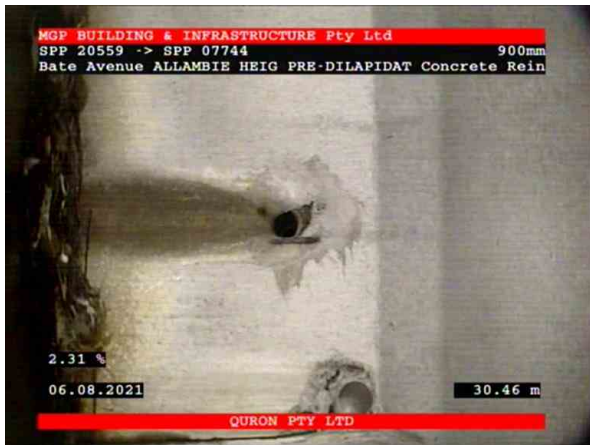
5, 00:09:16, 30.46
Connection, poor workmanship, connection appears to be open, height: 100mm at 9 o'clock

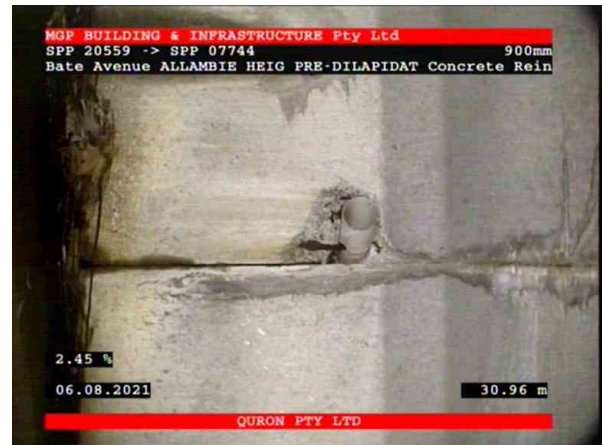
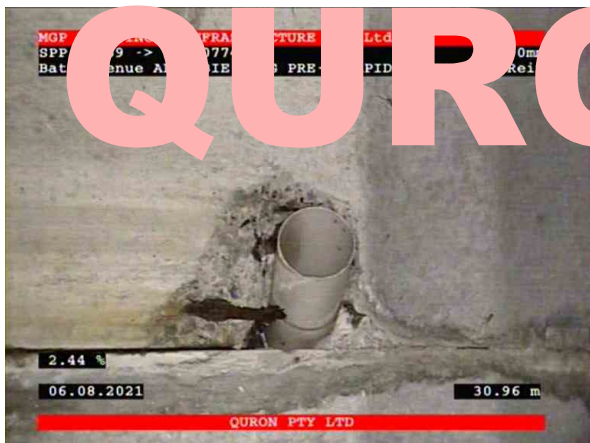
6, 00:09:30, 30.96
Connection, poor workmanship, connection appears to be open, height: 100mm at 10 o'clock

7, 00:09:30, 30.96
Connection, poor workmanship, connection appears to be open, height: 100mm at 10 o'clock

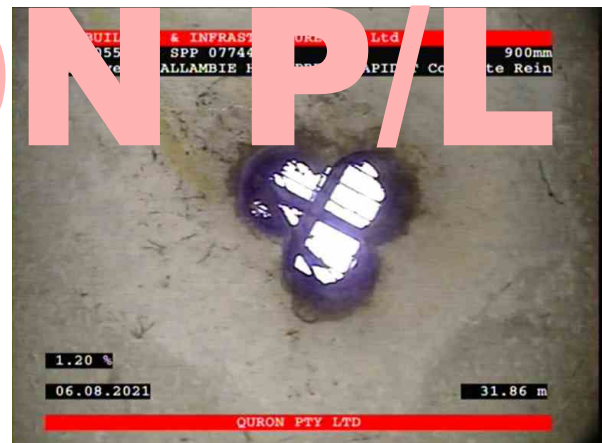
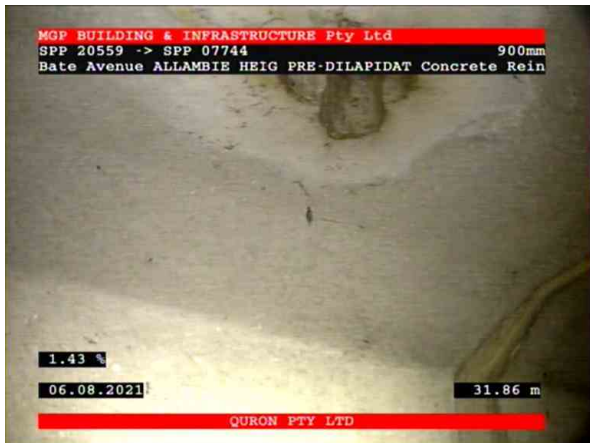
8, 00:10:42, 31.86
Connection, poor workmanship, connection appears to be open, height: 200mm at 12 o'clock

9, 00:10:42, 31.86
Connection, poor workmanship, connection appears to be open, height: 200mm at 12 o'clock

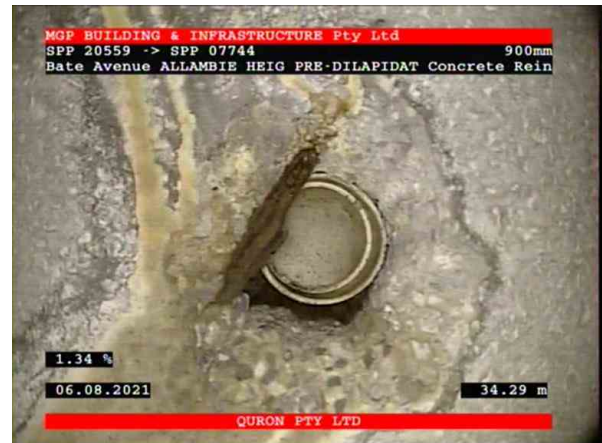
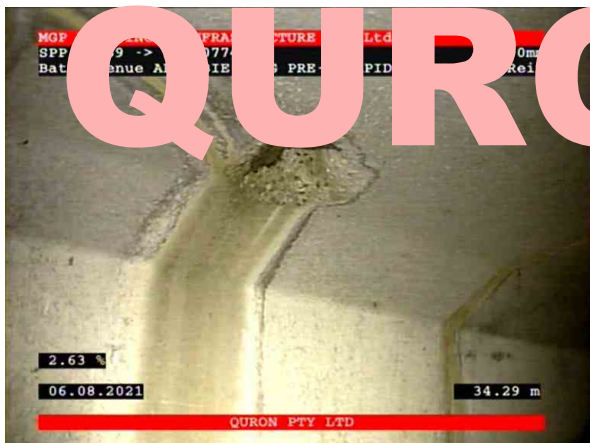
10, 00:13:35, 34.30
Connection, poor workmanship, connection appears to be open, height: 100mm at 12 o'clock

11, 00:13:35, 34.30
Connection, poor workmanship, connection appears to be open, height: 100mm at 12 o'clock

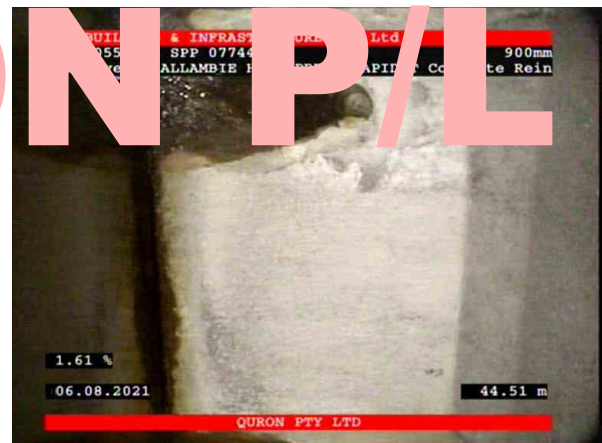
12, 00:16:03, 44.51
Connection, good workmanship, connection appears to be open, height: 100mm at 9 o'clock

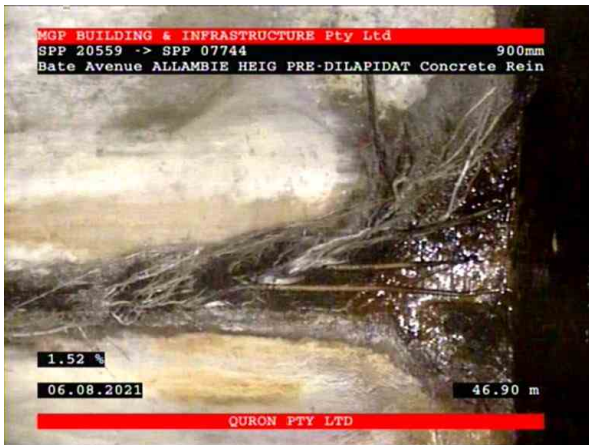
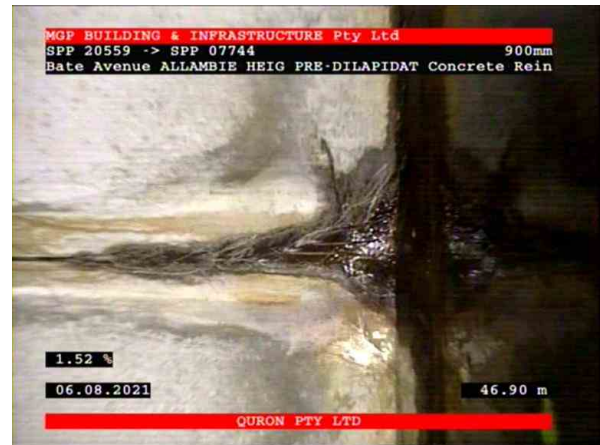
13, 00:16:38, 46.90
Fine roots--a relatively small number of flexible minor roots, at joint, Obstruction: <5% from 3 o'clock to 4 o'clock

14, 00:16:38, 46.90
Fine roots--a relatively small number of flexible minor roots, at joint, Obstruction: <5% from 3 o'clock to 4 o'clock

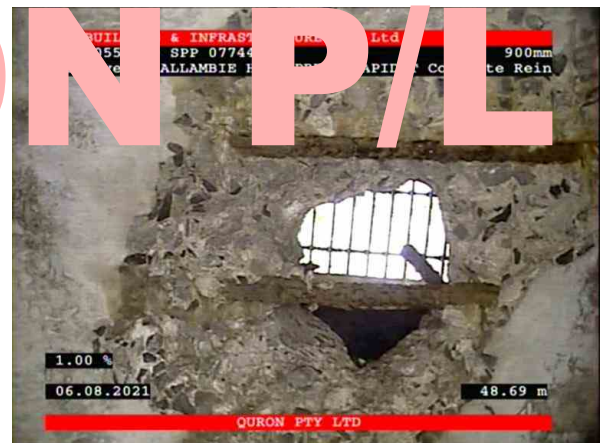
48.69	SRC	Reinforcement is exposed and corroded at 12 o'clock	00:17:11	16	5
	49.65	GC	General comment / APPROX BOUNDARY BETWEEN No.10 & 8	00:17:58		
	52.87	CNPO	Connection, poor workmanship, connection appears to be open, height: 100mm at 10 o'clock	00:19:28

16, 00:17:11, 48.69
Reinforcement is exposed and corroded at 12 o'clock

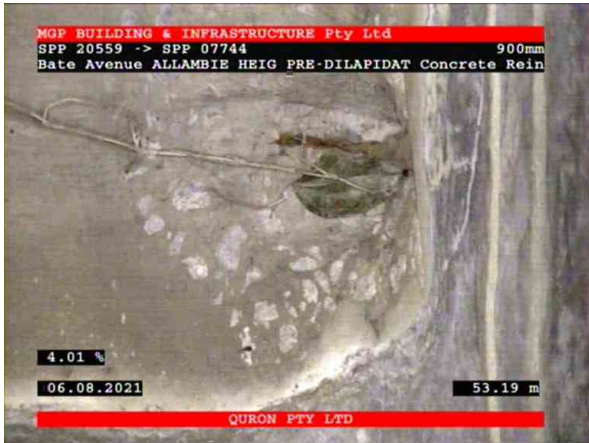
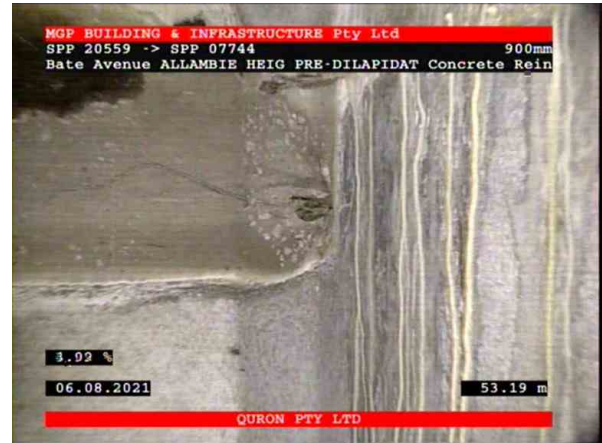
17, 00:19:41, 53.19
Connection, poor workmanship, connection appears to be open, height: 150mm at 12 o'clock

18, 00:19:41, 53.19
Connection, poor workmanship, connection appears to be open, height: 150mm at 12 o'clock

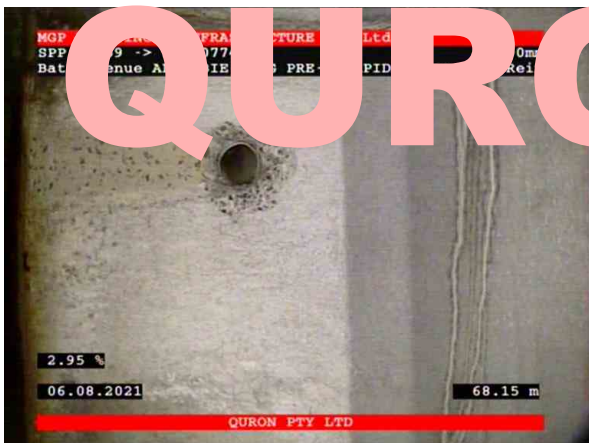
19, 00:24:37, 68.15
Connection, good workmanship, connection appears to be open, height: 100mm at 9 o'clock

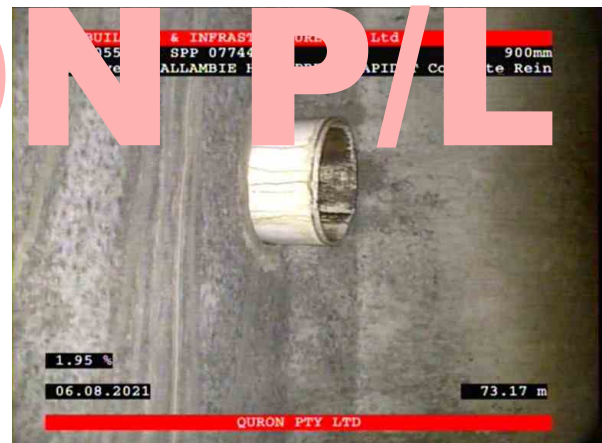
20, 00:30:12, 73.17
Intruding connection, magnitude of intrusion: <5% at 12 o'clock

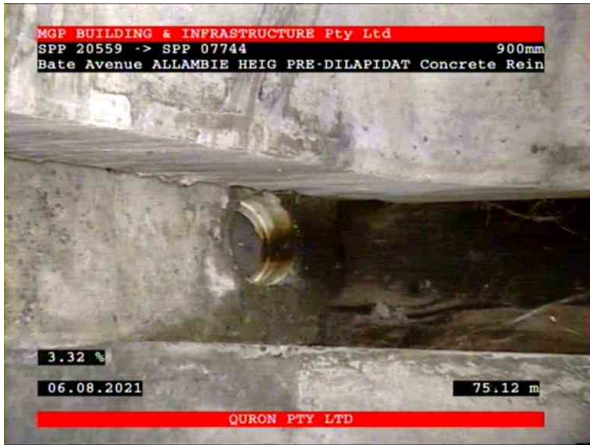
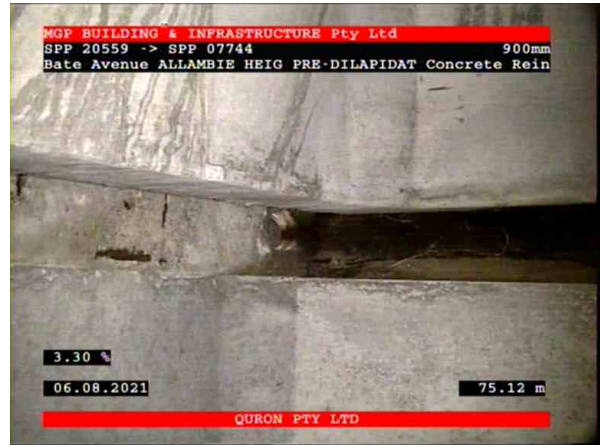
21, 00:30:51, 75.12
Connection, good workmanship, connection appears to be open, height: 100mm at 2 o'clock

22, 00:30:51, 75.12
Connection, good workmanship, connection appears to be open, height: 100mm at 2 o'clock
