11 July 2024  
Our Ref: 220643

## REVIEW OF ACCESSIBILITY MATTERS PILU RESTAURANT, 80 UNDERCLIFF ROAD, FRESHWATER NSW

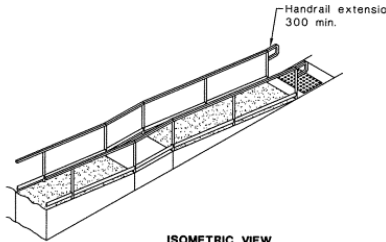
<p style="text-align: center;">ISOMETRIC VIEW</p>	<p>Council to review</p>

<p>The path of travel to the kiosk is understood to be relatively recent and does not comply with the requirements of AS1428.1-2009. Issues identified include:-</p> <p>a. Crossfall is more than 1:40; and b. Gradient is more than 1:20 and does not contain handrails to both sides and does not have tactile indicators at top/bottom.</p> <p>The access report does not recommend upgrade except where major building works are proposed within the complex.</p> <p>It is considered that the proposed works are sufficiently major, and due to the fact that the accessway was constructed on Council land by Pilu, the upgrade of the walkway should be included as part of the Development Consent Conditions.</p>	<p>Partially agreed.</p> <p>The complete upgrade of the walkway is considered to be unreasonable. Only minor works are required to ensure compliant access to the Pilu Baretto, as outlined below.</p> <p>The existing Council path between the walkway may remain given that AS1428.1 permits a crossfall of 1 in 33.</p>

<p>We have no objection to the provision of handrails and tactiles should Council require it. The proposed works will ensure a compliant walkway in accordance with AS1428.1.</p>

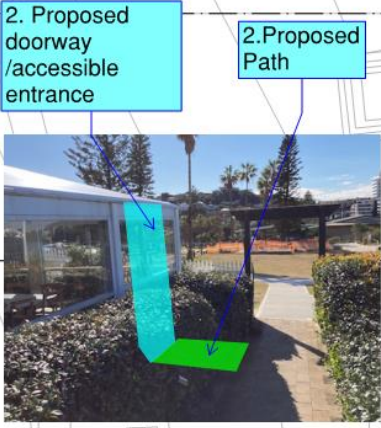
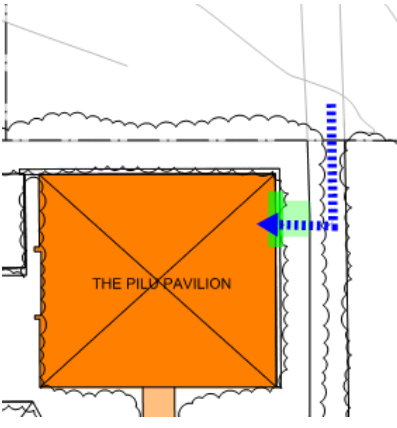
<p>The access report recommends an accessible path of travel be provided to the eastern side of the wedding pavilion in accordance with AS1428.1-2009. This recommendation is accepted. And the accessible path of travel should commence at the property boundary and the existing pathway gradient modified as necessary to ensure gradient as per AS1428.1-2009</p>	<p>We do not agree.</p> <p>Following a reassessment as part of the recent site inspections, it was identified that compliant access can be provided with relatively minor works.</p> <p>The markup below identifies the proposed minor works that involve provision of a landing and new</p>	<p>Council to Review</p>

<p>accessible door opening to the Pilu Pavilion within the lot boundary. The relatively new Council footpath to this entrance is compliant</p>

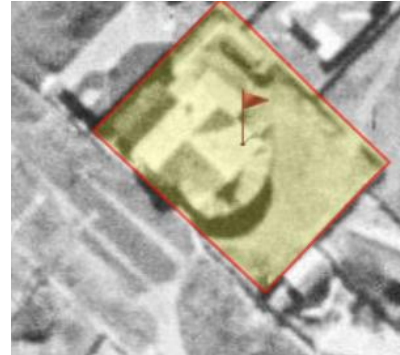
**Proposal 2** – This proposal outlines a deck connection to Undercliff Road and an external unroofed platform lift to provide an accessway to the Garden Room.

It is understood that the current arrangement is to limit and/or prevent access from the Undercliff Road side. And due to the primary access being from the Moore Road elevation, the provision of access from Undercliff Road would only serve a small population when compared to an accessway from Moore Road entrance.

It is alternatively recommended that an accessway is provided from the Moore Road entrance which provides access to the wedding pavilion, the current main entrance and to an external platform lift. An unroofed low rise external platform lift could be provided to the eastern side of the restaurant and connected to a new principle pedestrian entrance to the Garden Room.

When compared to the Cityplan Proposal 2, the alternative recommendation outlined below would only include additional landscaping works to connect the lift to the Garden Room entrance doorway and this is readily achievable within the existing terraced seating area without substantial visual appearance due to the ability for unroofed platform lift to be concealed within existing landscaping.

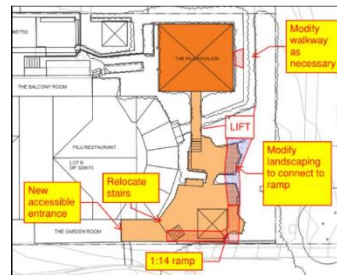
We note the access is not strictly compliant with current provisions of the BCA/ AS1428.1.

The works suggested by JH in their figure below is considered to be unreasonable, extremely cost prohibitive, and damaging to the building curtilage, biodiversity and physical built form/aspects of the existing development.
