Geotechnical Assessment

Project: Alterations & Additions
137 Whale Beach Road, Avalon Beach NSW

Prepared for:
Arclab

Ref: AG 24485
8 November 2024

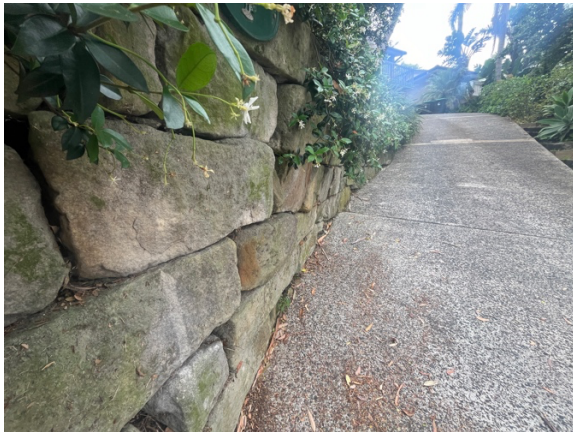
Photo 1: Sandstone block wall and driveway at site frontage

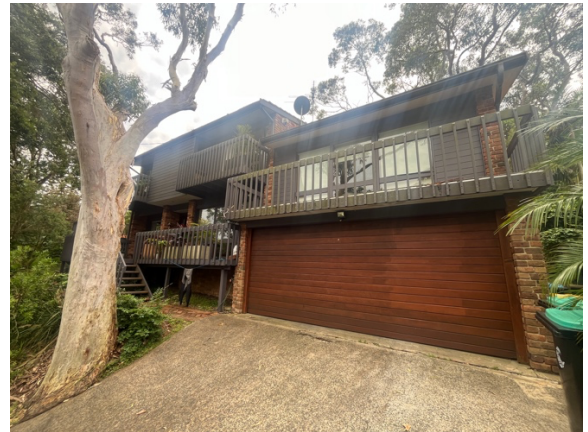
Photo 2: Residence frontage

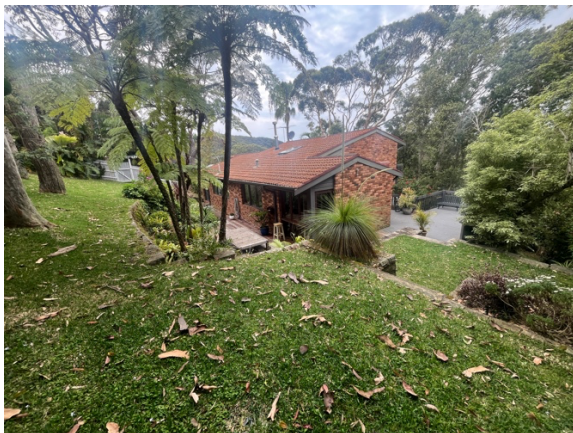
Photo 3: Residence rear and rear yard

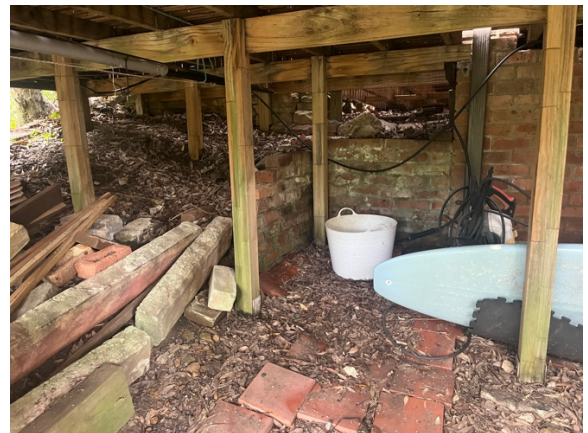
Photo 4: Under deck area at the south-western corner of the residence
