REPORT ON GEOTECHNICAL INVESTIGATION AND RISK ASSESSMENT

PROPOSED NEW RESIDENTIAL BUILDING

5 LAUDERDALE AVENUE, FAIRLIGHT, NSW

Project No.: 2024-109

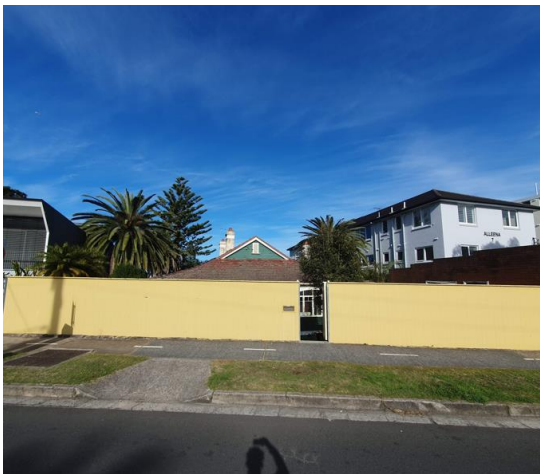
Photograph 2 – Front view of the property and brick-rendered fence, looking south from the roadway.

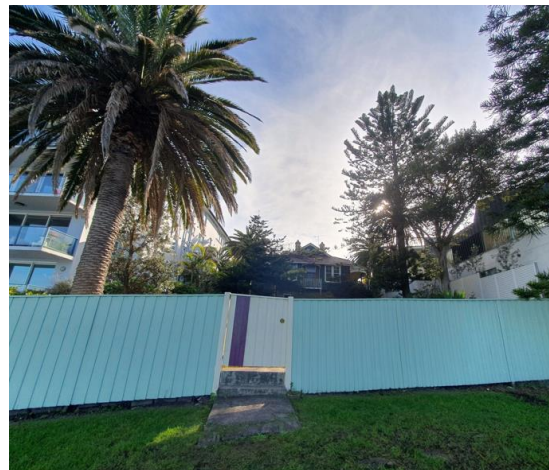
Photograph 3 – Rear view of the property with a rear colorbond fence, looking north from Fairlight Beach area.

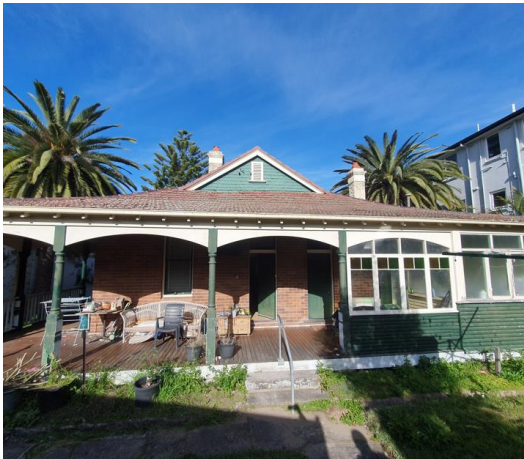
Photograph 4 – Front view of the main dwelling, looking south from the front yard.

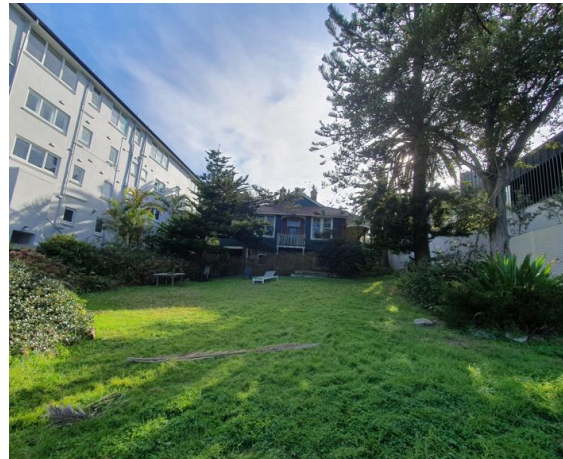
Photograph 5 – Rear view of the main dwelling, looking north from the rear yard.

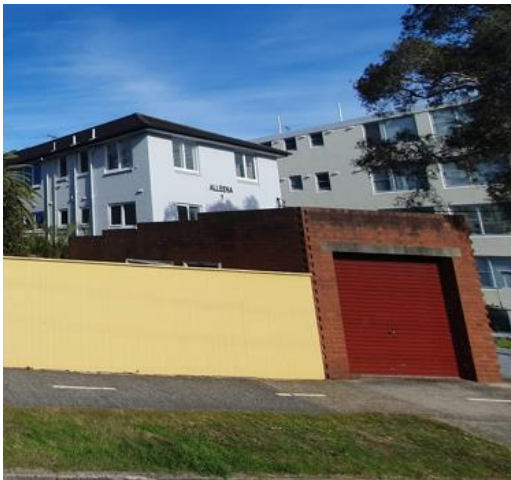
Photograph 6 – View of the front brick garage, looking south from the roadway.

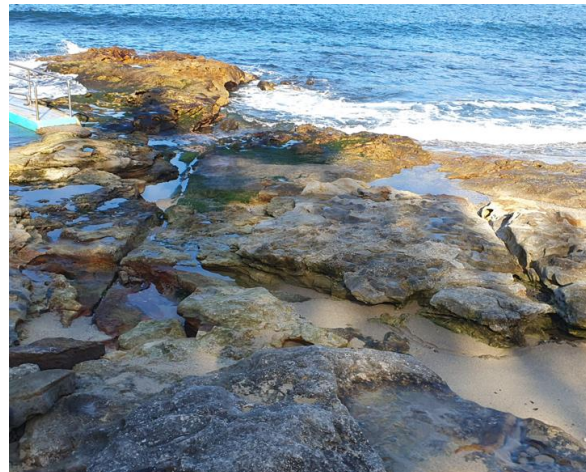
Outcropping sandstone was observed within Fairlight Beach area to the southern site boundary (Photograph 7). No indications of significant distress were observed within the structures within the site.

Photograph 7 – View of sandstone outcrops within Fairlight Beach, looking low south from the southern site boundary.
