## **Arboricutural Impact Assessment Statement**

**Prepared for:** Mr Mathew Linney

Date: March 2019

Prepared by: Vicki Beecher

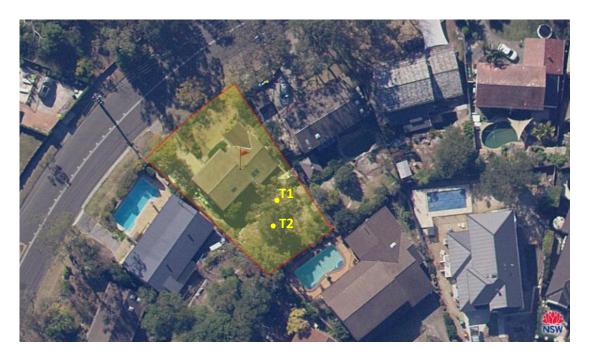
Fig 2: Aerial image (SIX Maps, accessed -20/03/18) illustrating tree locations within site

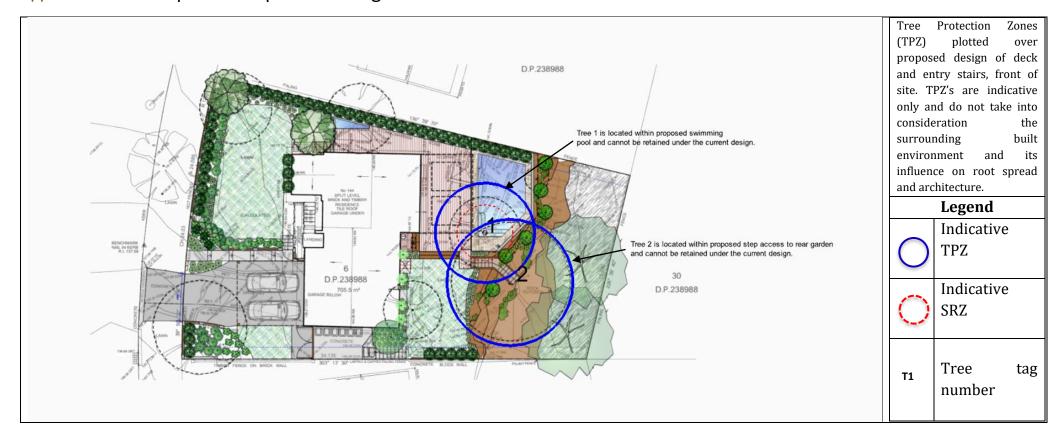
## Appendix 2 Landscape Masterplan Showing Tree Protection Zones and Structural Root Zones

- 4.1 Tree 1, a *Eucalyptus haemastoma* (Scribbly Gum), is located within the proposed development footprint, being the location of the swimming pool, as indicated within Landscape Masterplan Issue D refer Appendix 2, as such the tree cannot be retained under the current plan.
- 4.2 Tree 2, a *Eucalyptus robusta* (Swamp Mahogany), is located within the proposed development footprint, being the location of the proposed stair access, as indicated within Landscape Masterplan Issue D refer Appendix 2, as such the tree cannot be retained under the current plan.
