GEOTECHNICAL INVESTIGATION REPORT

PROPOSED NEW DEVELOPMENT

32 GOLF AVENUE, MONA VALE, NSW

Project No.: 2024-004.2

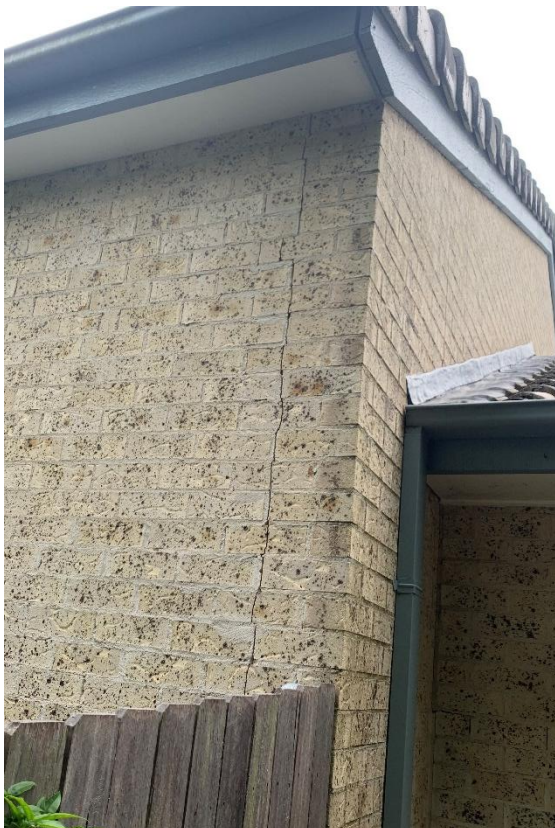
The main structures appeared in reasonable condition with several large vertical cracks observed on all-townhouse exterior walls presumed to be a result of thermal expansion and deterioration over time, shown in Photograph 3. Cracking and settlement was observed on the concrete driveway and concrete floor slab of the

Photograph 3: Vertical crack within rear external wall

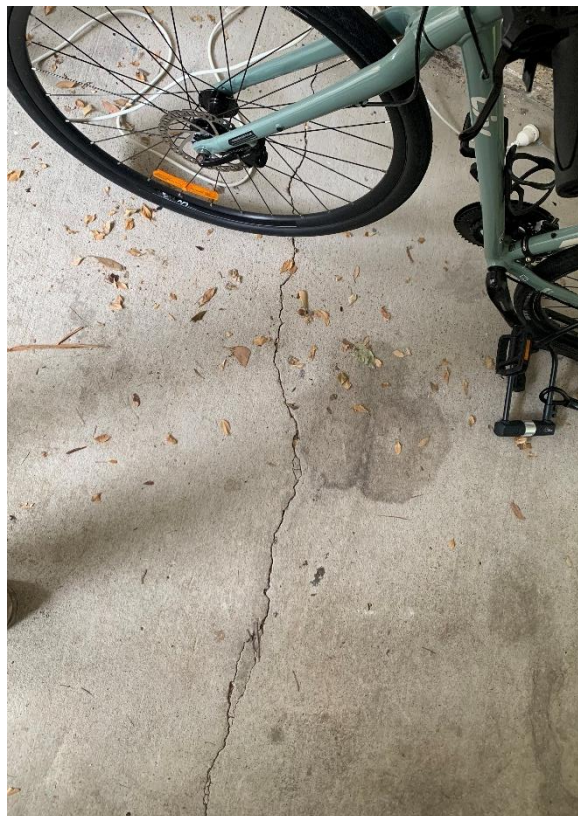
garage, shown in Photograph 4. These cracks are presumed to be a result of differential settlement and deterioration over time.

Photograph 4: Crack within concrete floor slab of garage
