| Tree Data Summary - 3 Berith St, Wheeler Heights - Assessed 13/02/2018 | | | | | | | | | | | | | | | | | | | |

Tree Identification Map  
Date: 14/02/2018  
Plotted: G. Blues  
Drawing not to scale.

| DRAWING NOTES | PLAN BY | CLIENT | REVISION | DESCRIPTION | DATE | PROJECT LOCATION | PLAN TYPE | LEVEL DATUM |
|---|---|---|---|---|---|---|---|---|
| 1. CONTOURS SHOWN HAVE BEEN INTERPOLATED FROM SPOT LEVELS TAKEN ON-SITE AND ARE A REPRESENTATION OF THE TOPOGRAPHY ONLY. | | | | | | LOT A DP 411784 | CONTOUR PLAN | AUSTRALIAN HEIGHT DATUM |

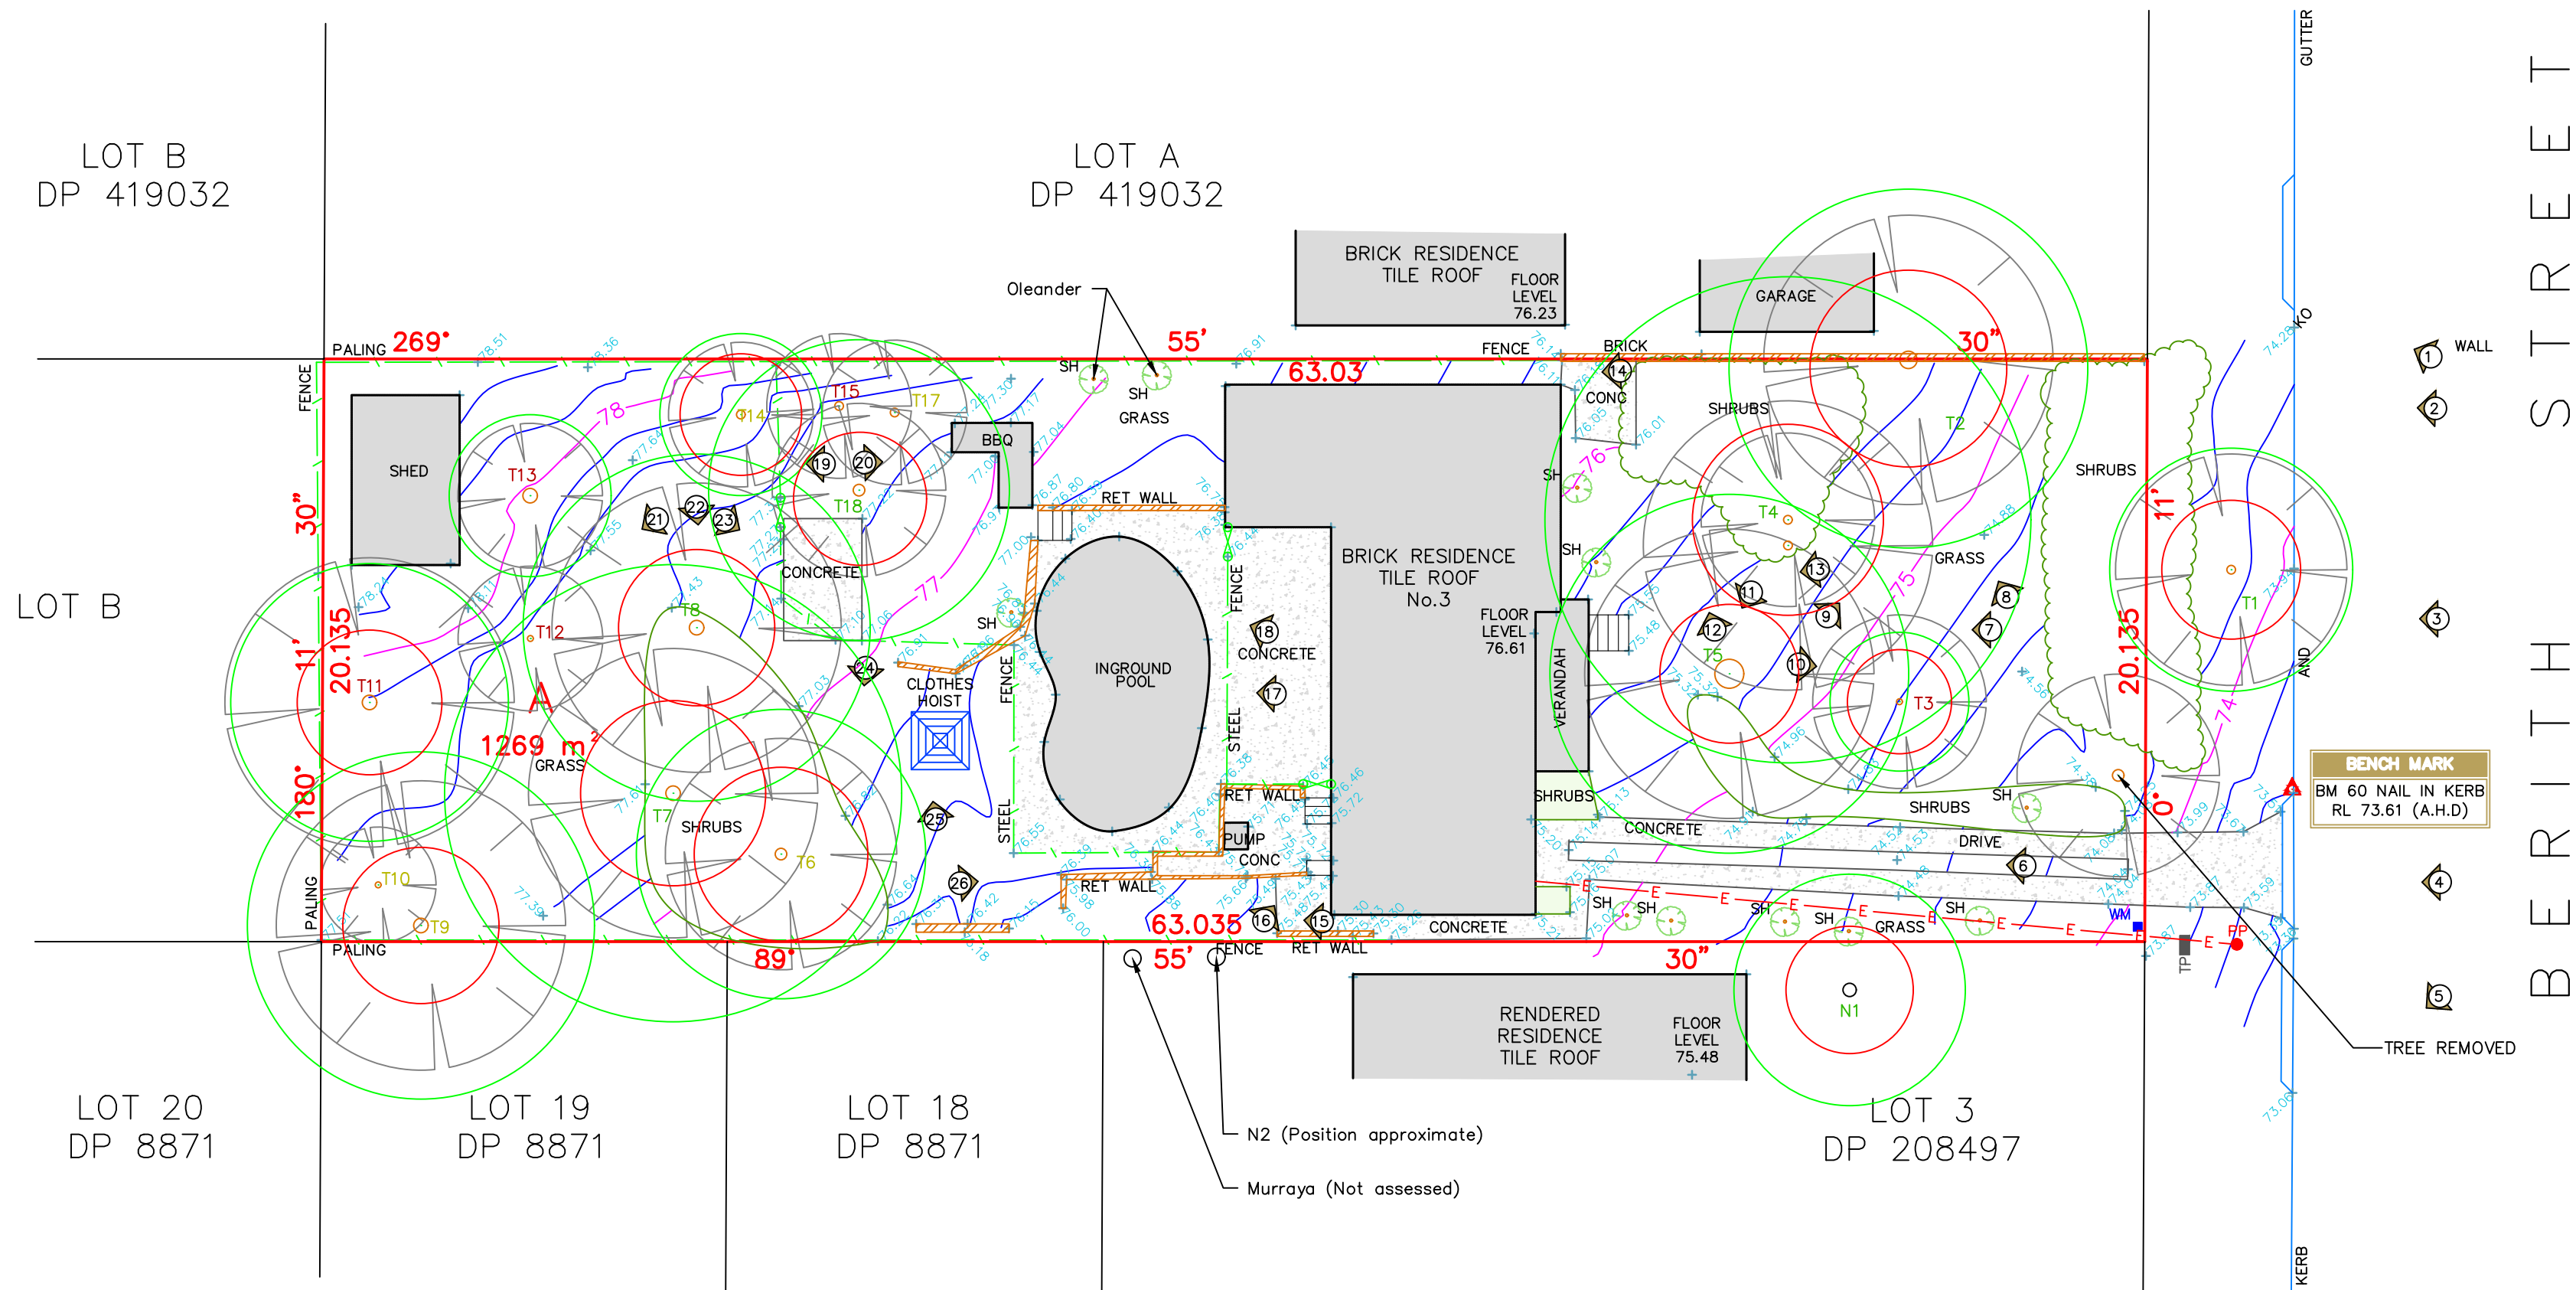
Tree Numbering Key:  
(To be read in accordance with supplied tree data spreadsheet)  
Dark Green: High Retention  
Dark Yellow: Medium Retention  
Dark Red: Low Retention

Tree Protection Key:  
Green: Tree Protection Zone (TPZ) – Encroachment of more than 10% is considered Major under AS4970:2009 (Protection of Trees on Development Sites)  
Red: Structural Root Zone (SRZ) – The minimum area required for the tree's stability under AS4970:2009
